# MASCONOMET REGIONAL SCHOOL DISTRICT CAPITAL ASSET ASSESSMENT

20 Endicott Road  
Boxford, MA 01921

January 31, 2017  
JN 1607.00

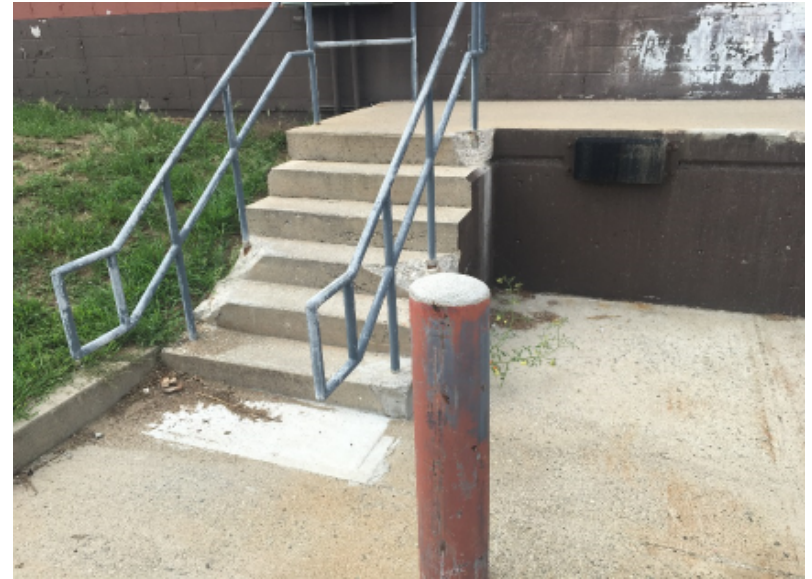
Photo A7- Loading Dock Stair

<b>A4.3 Mill and repave all parking lots and drives</b>			3	550	spaces	\$1,700.00	\$935,000	\$1,262,250				\$1,262,250
<b>A.5 Parking Lot Curbing:</b> Extruded or Precast sections used throughout adjacent to sidewalks and islands. Minor damage throughout by snowplows and vehicular contact, most occurring at and of islands or at curves.	A4	5										
<b>A5.1 Replacement of damaged sections with granite or new PCC curbing.</b>			2	300	LF	\$35.00	\$10,500	\$14,175		\$14,175		
<b>A.6 Parking Lot Islands:</b> Portions at curbs Islands are subject to damage from snow plows and impact plowing.	A5	20										
<b>A.6.1 Remove ends of Islands as part of repaving/upgrades to circulation.</b>			3	1,700	SY	\$38.00	\$64,600	\$87,598				\$87,598
<b>A.7 Loading Dock:</b> The Concrete loading dock & stair have failures at edges and stair rail posts. Other stairs at site have some nosing deterioration.	A6/A7	5

<b>A.7.1 Patch and repair concrete. Repaint handrails.</b>			2	1	LS	\$2,300.00	\$2,300	\$3,105		\$3,105		
<b>A.8 Exterior Handrails:</b> At locations other than the loading dock, the handrails are in good condition and are galvanized. Repainting is for cosmetic purposes.		30										
<b>A8.1 Repaint.</b>			3	1	LS	\$1,000.00	\$1,000	\$1,350				\$1,350
<b>TOTAL</b>									<b>\$10,548</b>	<b>\$28,215</b>	<b>\$271,350</b>	<b>\$1,351,198</b>

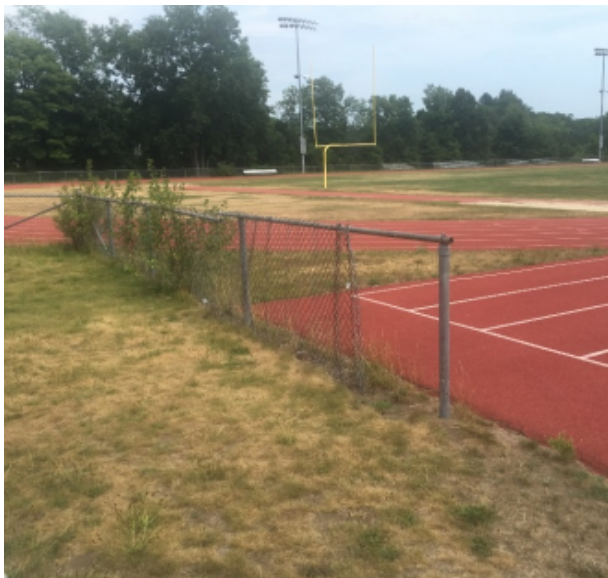
**Photo B3 - Track Fencing**

<b>B.3 Track Fencing:</b> Chain link fence surround is rusting with some damaged sections.	B3	7										
<b>B.3.1 Replace fencing.</b>			1	1,800	LF	\$14.00	\$25,200	\$34,020		\$34,020		
<b>B.4 Aluminum bleachers / Concession stand / Announcer's booth:</b> The aluminum bleachers, platforms and structure are in good condition. No defects noted.	0	IND	2									
<b>B.5 Tennis Courts:</b> Hard courts, some cracking to pavement. Nets in fair condition. No apparent structural defects. Gate hardware needs repair. Aluminum benches need minor repair.	B5	10										
<b>B.5.1 Repair cracks and divots in pavement. Repair gate hardware.</b>			1*	1	LS	\$900.00	\$900	\$1,215	\$1,215			
<b>B.5.2 Resurface tennis courts.</b>			1	3	EA	\$9,000.00	\$27,000	\$36,450		\$36,450		
<b>B.6 Tennis Courts Fencing:</b> Chain link fence surround is rusting but in fair condition. No apparent structural defects. Gate hardware needs repair.	B6	10

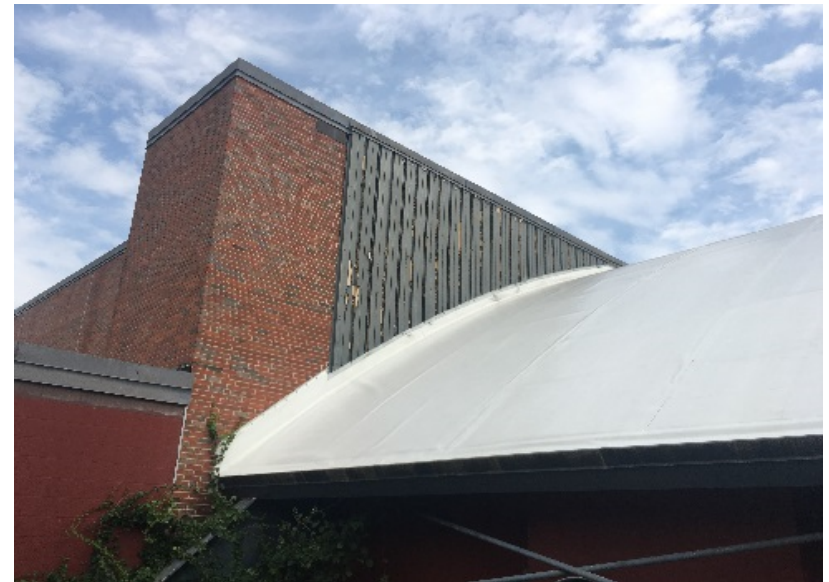
**Photo C4 - PVC Roof**

<b>C.4 Arched PVC Roof:</b> Arched roofing at weight room, white PVC roofing, 6 years old, 20 year expected life. No reports or evidence of current leaks.	C4	15	NA									
<b>C.5 Exterior Cladding- Brick Masonry:</b> Floors 1 and 2 of the High and Middle schools are clad in "Jumbo" sized brick masonry. No evidence of spalling, broken or damaged brick, minimal fluorescence. No evidence of improper flashings or improperly installed lintels.	C5	IND	NA									
<b>C.6 Exterior Cladding- Aluminum Metal Panel:</b> Floor 3 of the High School is clad with prefinished aluminum panel. No discoloration or substantial weathering of panels or joint failure detected.		30+	NA									
<b>C.7 Exterior Cladding - Concrete Masonry Units:</b> Rear of building 1968 construction. CMU exterior walls. Cracking, patching and peeling paint. Dependent on location. Interior finishes vary. Lacking in insulation/temperature control to prevent migration of water vapor from interior spaces to exterior, causing delamination of paint	C6	5

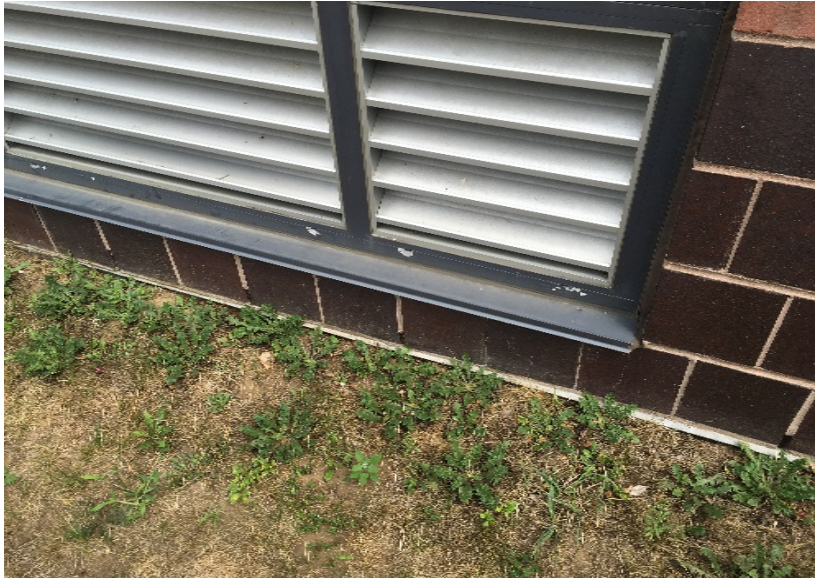
**Photo C9 - Aluminum Storefront**

<b>C.10.1 Insect &amp; Bird screens at operable windows.</b>			1	506	EA	\$56.00	\$28,336	\$38,254		\$38,254		
<b>C.11 Aluminum storefront at classrooms:</b> Good condition, pitting, delamination of finish near weep holes.	C9	20+										
<b>C.11.1 Refinish Weep Holes.</b>			1	1	LS	\$3,600.00	\$3,600	\$4,860		\$4,860		
<b>C.12 Exterior Aluminum entrances:</b> Good condition, some minor weather stripping issues, joint failures and hardware repairs required.	C10	20+										
<b>C.12.1 Repair weatherstripping and joint and hardware.</b>			1	1	LS	\$2,000.00	\$2,000	\$2,700		\$2,700		
<b>C.13 Exterior hollow metal doors:</b> The doors and frames are generally in fair to poor condition. Missing or damaged weather stripping, thresholds, hardware, doors and frames, and joints noted. Transom and lite glazing not insulated and damaged/failure of units noted.	C11	5										
<b>C.13.1 Replace damaged hollow metal doors and frames.</b>			1	13	EA	\$6,400.00	\$83,200	\$112,320		\$112,320

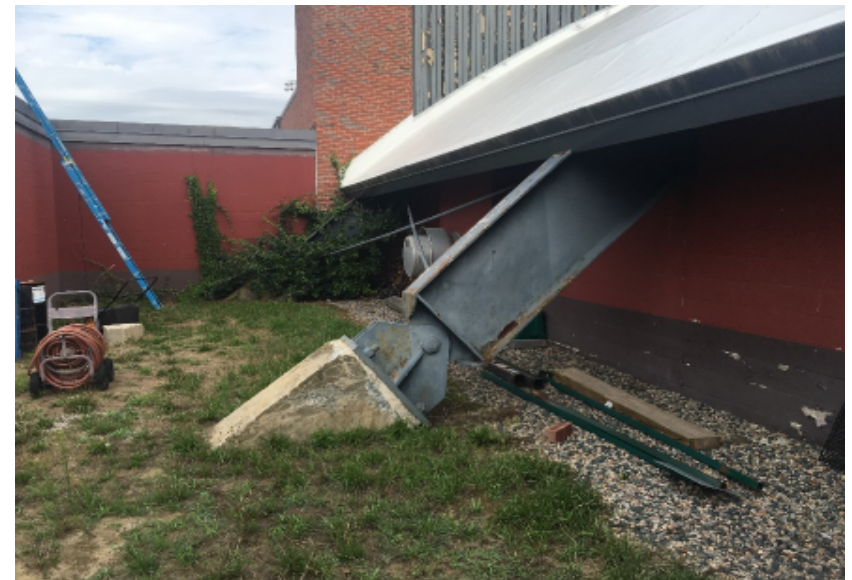
**Photo C12 - Steel Arch Base**

<b>C.14 Overhead Doors:</b> the overhead doors at the rear of the school are aged and showing signs of wear and damage.	C11	5										
<b>C.14.1 Replace overhead doors.</b>			2	2	EA	\$7,500.00	\$15,000	\$20,250		\$20,250		
<b>C.15 Caulking:</b> Minor delamination noted throughout, at window openings. If left untreated will begin to show signs of aging. Discoloration in caulk appears to indicate that some repointing has occurred in the past.		5										
<b>C.15.1 Repair joints on an as-needed basis.</b>			2	1	LS	\$10,000.00	\$10,000	\$13,500				\$13,500
<b>C.16 Steel Arch bases:</b> There are limited exterior surfaces at the school which require on-going maintenance. The steel arches at the weight room are exposed at the base and are anchored to concrete buttresses. The exposed steel is in need of repainting and the concrete is in need of repair to prevent further deterioration.	C12	1

<b>C.16.1 Properly prepare steel and repaint. Repair concrete buttresses including treatment of exposed rebar and repair of concrete.</b>			1	1	LS	\$8,000.00	\$8,000	\$10,800		\$10,800		
<b>C.17 Entrance Mats:</b> Entrance mats are aged and worn.	C10	3										
<b>C.17.1 Replace entrance mats at all entries.</b>			3	300	SF	\$26.00	\$7,800	\$10,530				\$10,530
<b>TOTAL</b>									\$0	\$6,507,184	\$233,280	\$24,030
