**LOW SLOPED ROOF EVALUATION
AT THE MASCONOMET REGIONAL SCHOOL
20 ENDICOTT ROAD
BOXFORD, MA 01921
GALE JN 834200**

October 3, 2018

Evaluation and Recommendations Report

**Masconomet Regional School District
District Central Office
20 Endicott Road
Boxford, MA 01921**

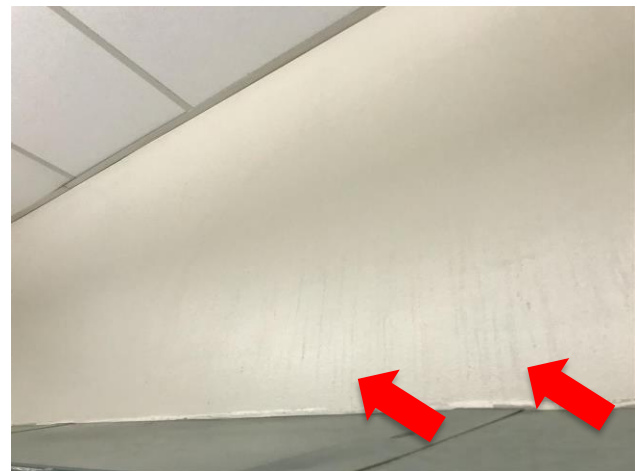
1. Roof Area A, Corridor HC301 – MRS representatives reported leaks above the lockers in the hallway at this location as recently as one year ago. Minor water staining was observed on the walls (Fig. 1).

Figure 1: Water staining observed above lockers in Corridor HC301.

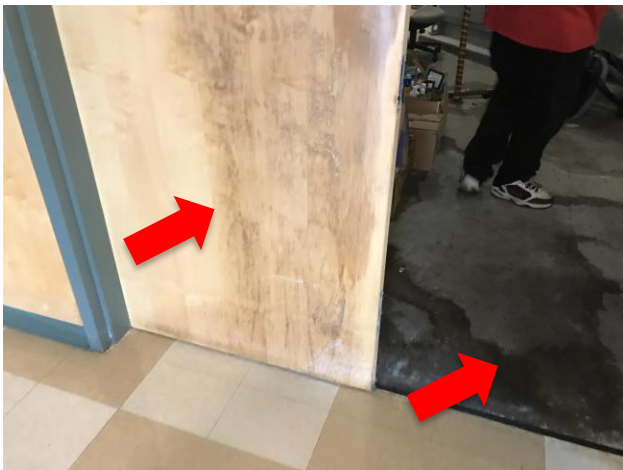
3. Roof Area A, Classroom H363 – MRS representatives reported an active leak in this classroom along the wall shared with the barrel roof.
4. Roof Area A, Mechanical Room H331 – MRS representatives reported an active leak in this room at the doorway. The door and floor were observed with evidence of water staining, and the door appeared warped from water damage (Fig. 2).

Figure 2: Water staining observed on door and floor of Mechanical Room H331.

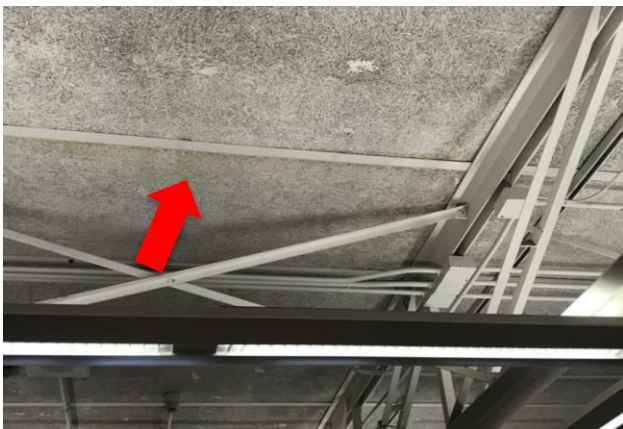
5. Roof Area A.2 – MRS representatives reported a previous leak at this roof. Repairs were reportedly made one year ago. Since repairs, the leak is reported to no longer be active.
6. Roof Area B, Cafeteria C106 – MRS representatives reported an active winter leak at this location. Stained roof deck was observed at the leak location (Fig. 3).

Figure 3: Stained roof deck observed in Cafeteria C106.

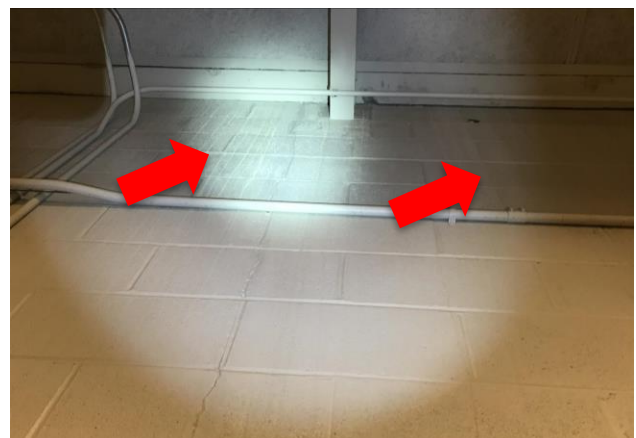
12. Roof Area E.2, Corridor EC108 – MRS representatives reported an active leak along the rising wall of this corridor. Water staining was observed along the wall. Representatives reported the leak was typical with wind-driven rain (Fig. 4).

Figure 4: Water staining observed along rising wall of Corridor EC108.

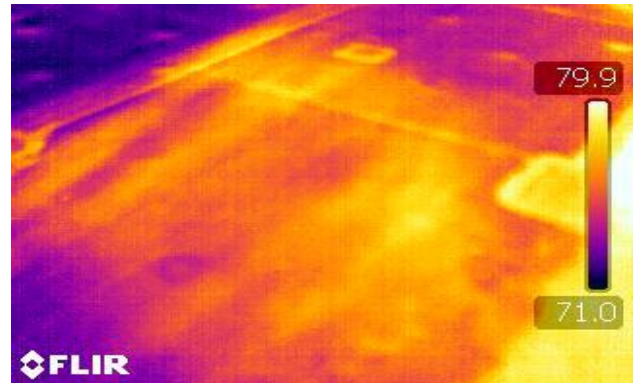
Figure 5 IR-1: Thermographic image shows an anomaly that is consistent with wet insulation in the field of the roof.

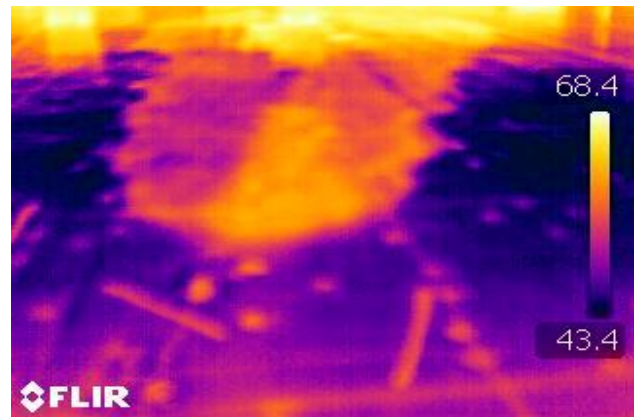
Figure 6 IR-2: Thermographic image shows an anomaly that is consistent with wet insulation within a tapered insulation drainage cricket

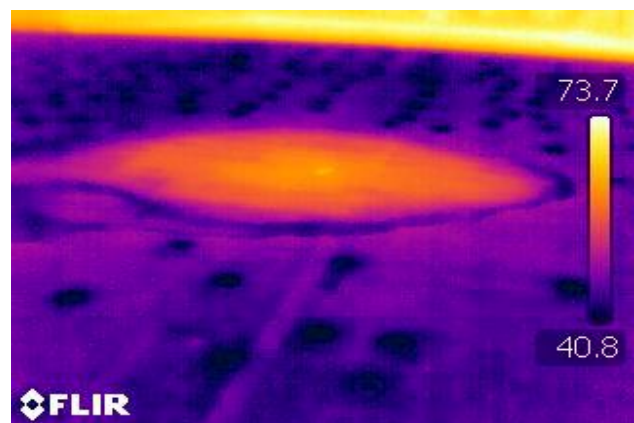
Figure 7 IR-3: Thermographic image shows an anomaly that is consistent with wet insulation adjacent to a drainage cricket.

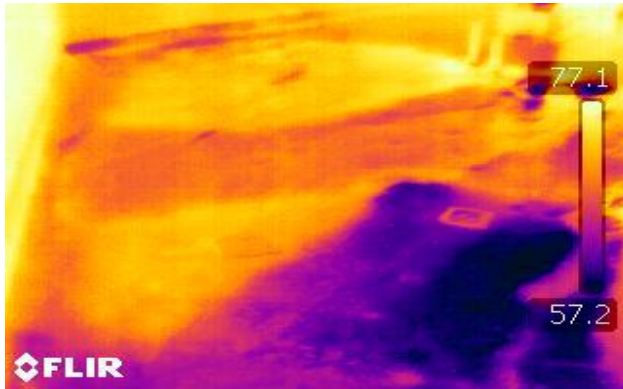
Figure 8 IR-4: Thermographic image shows an anomaly that is consistent with wet insulation at a rising wall transition.

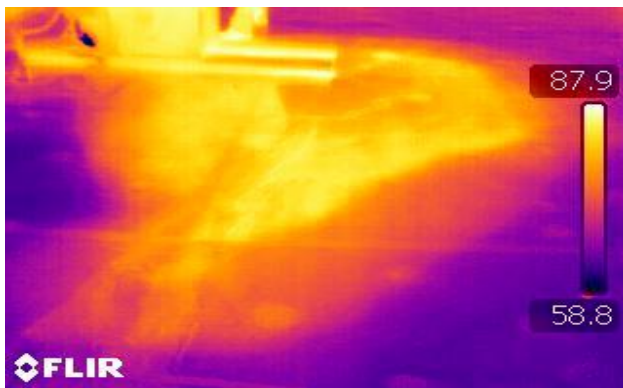
Figure 9 IR-5: Thermographic image shows an anomaly that is consistent with wet insulation around / adjacent to rooftop equipment.

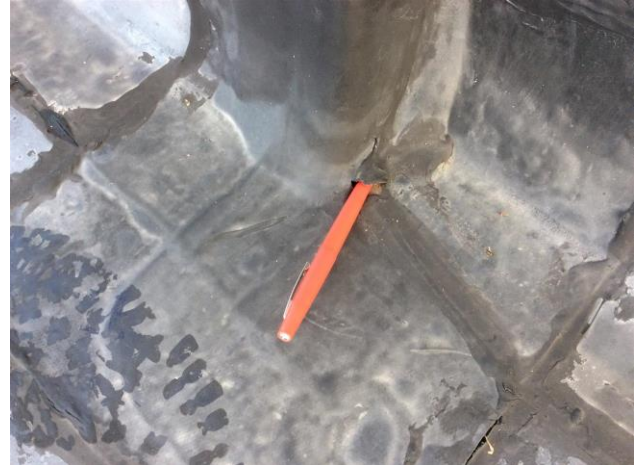
Figure 10: Open area of roof membrane were observed.

- IV. Patch all tears and open membrane areas.
- V. Remove and replace pitch pocket sealant at mechanical penetrations.
- VI. Re-secure and repair all edge metal defects.

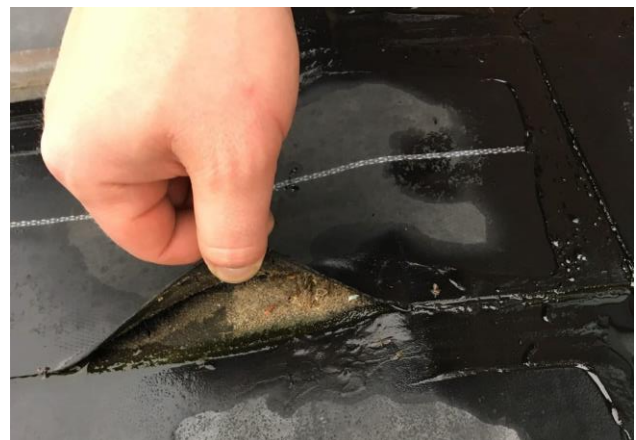
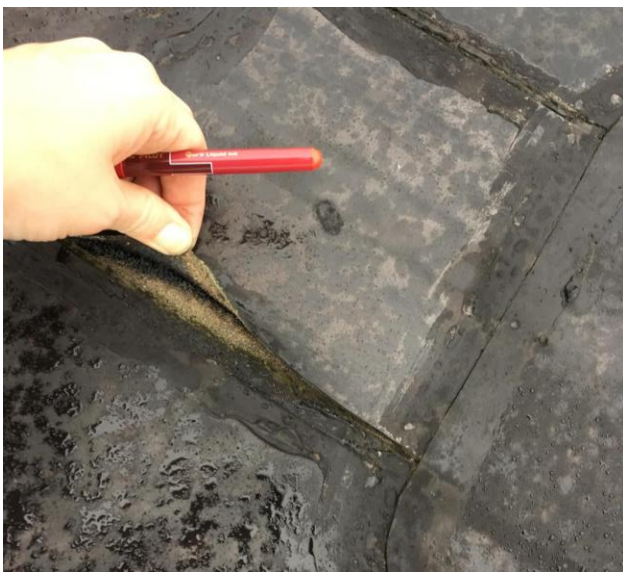
4. Delaminated roof membrane patches were observed throughout the roof areas. Refer to the attached plans for noted locations (Fig. 12 and 13).

Figure 12: Delaminated roof membrane patch observed on Roof Area B.2.

Figure 13: Delaminated roof membrane patch observed on Roof Area A.

- II. Install batten bars on areas of unadhered membrane to re-secure. Strip in with membrane.
- III. Replace delaminated or failed membrane patches and stripping membrane.

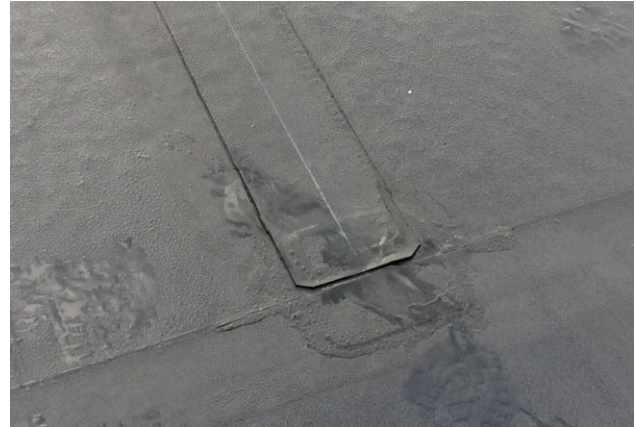
Figure 14: Delaminated stripping membrane observed on Roof Area F.3.

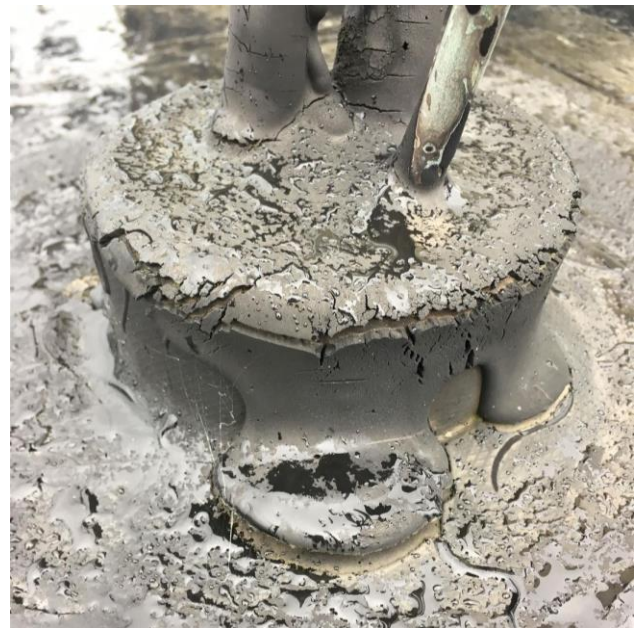
Figure 15: Failed sealant at the pitch pockets observed.

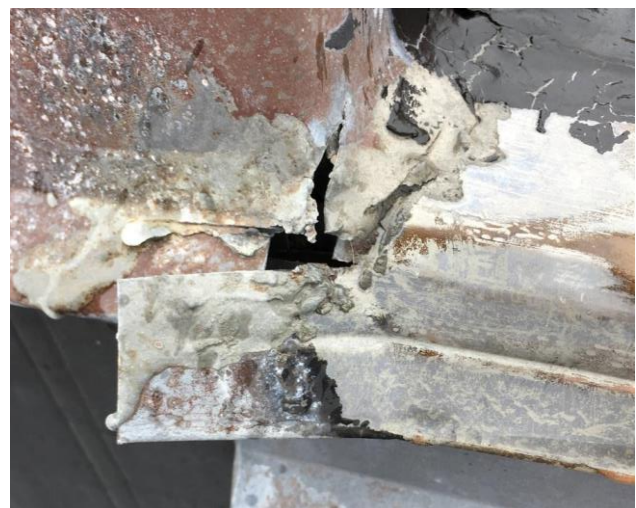
Figure 16: View of cracked solder and open sheet metal flashing seams at a scupper on Roof Area B.3.

- VII. Strip in cracked metal and solder joints.
- VIII. Strip in failed parapet cap flashing joints and seams.
- IX. Repair/replace low vent pipe flashings and other low flashing to provide better flashing heights.

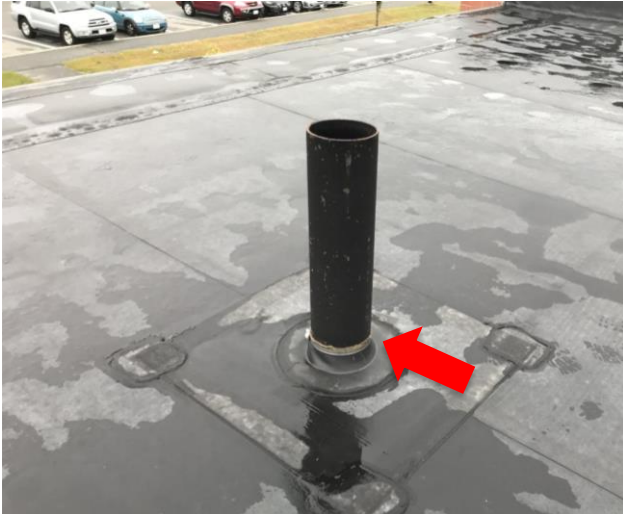
Figure 17: Low flashing height observed at a vent pipe on Roof Area B.

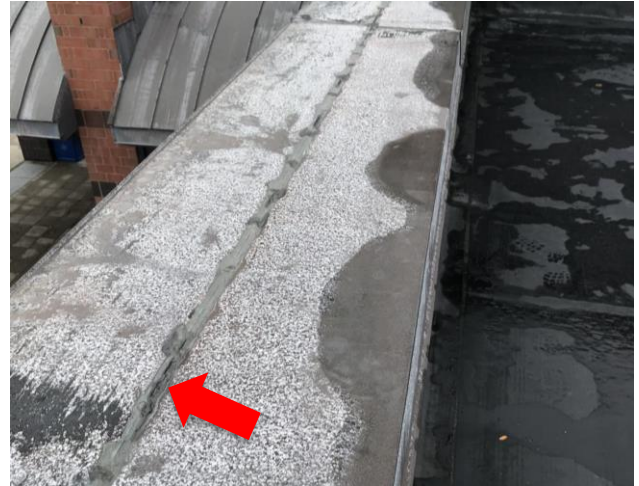
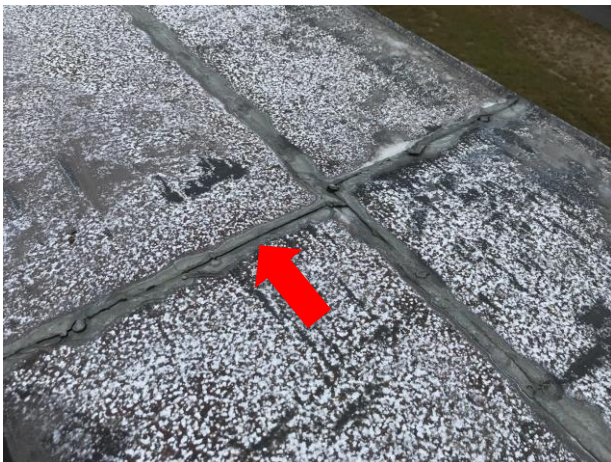
Figure 20: Failed seams observed in two-piece parapet cap flashing on Roof Area B.2.

Figure 19: Failed seams observed in two-piece parapet cap flashing on Roof Area B.2.

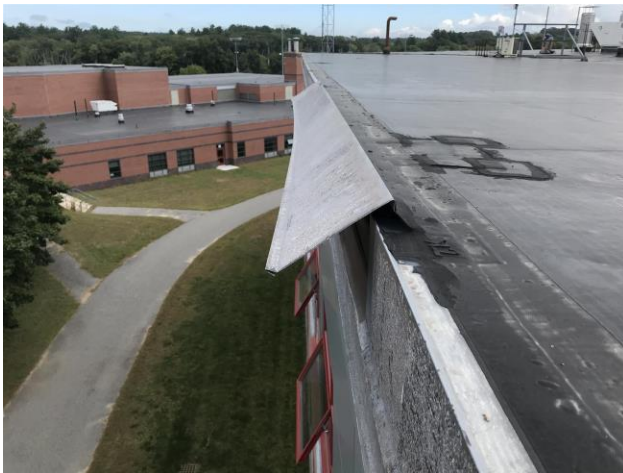
Figure 18: Displaced edge metal observed on Roof Area A.

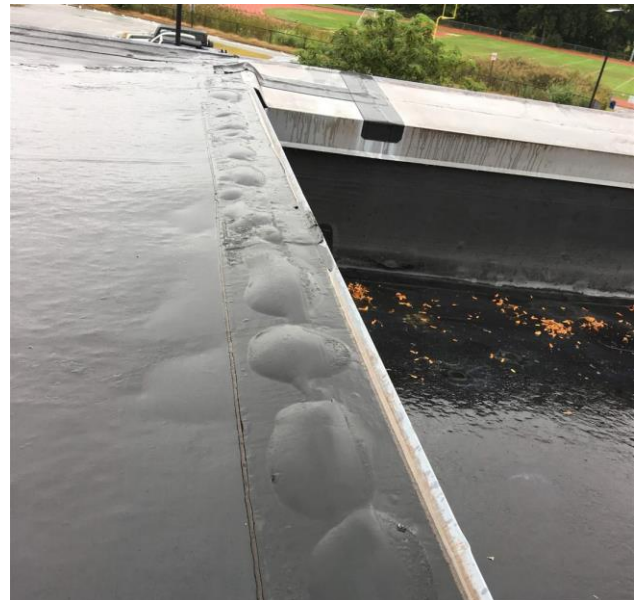
5. Delaminated stripping membrane was observed at isolated areas across the building (Fig. 14).
6. Failed and cracked sealant was observed at isolated pitch pockets penetrations near air conditioners and other mechanical units (Fig. 15).
7. Open sheet metal flashing seams were observed at isolated areas. Cracked solder and open seams can allow of moisture infiltration. Refer to the attached plans for locates noted (Fig. 16).
8. Low flashing heights at mechanical curbs, roof top units, and vent pipes were observed. Flashing heights varied but were well below the 8-inch industry standard for roof flashings at the locations noted (Fig. 17).
9. Area of displaced edge metal were observed on Roof Area A (Fig. 18).
10. Failed seams were observed in the two-piece parapet cap flashing (Fig. 19 and 20).
11. Bubbled stripping membrane was observed at roof edges throughout the building (Fig. 21).

Figure 21: View of bubbled stripping membrane at edge of Roof Area C.1.

- X. Strip in bubbled stripping membrane at roof edges.
- XI. Reset and repair failed reglet joint flashings. Please note that reglet flashings have the potential to allow moisture in the brick masonry to travel down into the building and below the surface of the roof and appear like a roof leak. Gale recommends that during future roof replacement that these reglet joint be removed and replaced with throughwall flashing to provide a more watertight detail.

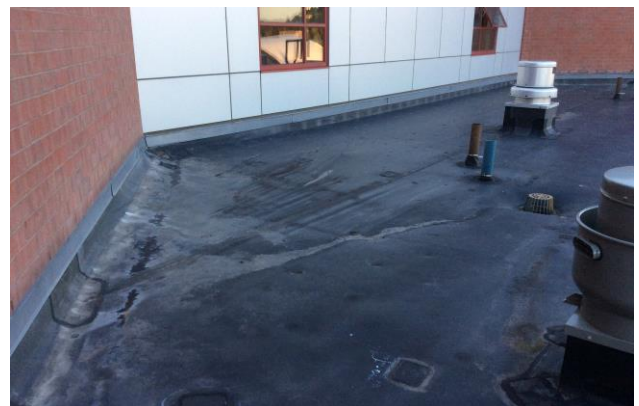
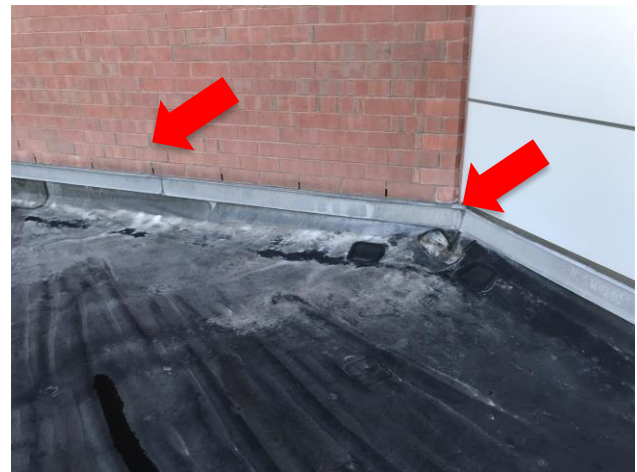
Figure 22: Scope 1 area, wet insulation and unadhered membrane was observed.

12. Scope 1 is located on Roof Area A.2. Gale observed a large area of wet insulation with loose and bridging membrane. Gale did not observe failed membrane patches or punctures in this area. It appears that the leak is related to the joint of the throughwall flashing in the corner of the wall between the masonry and panel assemblies. Gale observed this corner joint to be open and has recommended throughwall flashing replacement in conjunction with full roof is repair (Fig. 22 and 23).

Figure 23: Scope 1 area, throughwall flashing joint in the corner appears to be open.

- XIV. Remove and replace Scope 1 roof area, open masonry wall and metal wall panels to repair throughwall flashing joint.
- XV. Remove and replace Scope 2 roof area, remove and repair flashings on rising wall.

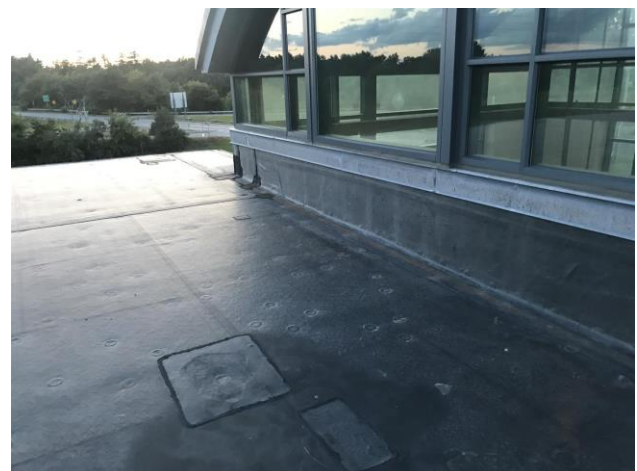
13. Scope 2 is located on Roof Area A near a rising wall at the stairwell location associated with an interior reported leak. No visible roof defect was observed in the field of the roof. The adjacent curtainwall has a sealant bead installed over the weeps which may direct water inwards. It is recommended to remove the curtainwall mullion snap cover and sealant and repair any observed defects and reinstall the covers. Additional leak testing to confirm water patch is path is recommended (Fig. 24).

Figure 24: Scope 2 area active leak on rising wall on Roof Area A

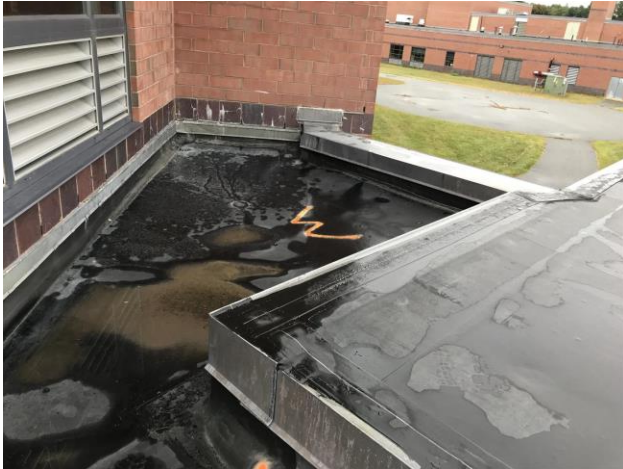
14. Scope 3 consists of a small triangular roof area on the edge of Roof Area B.1. This entire section of roofing was observed to be wet and delaminated. Multiple defects associated with the throughwall flashing were observed. The throughwall flashing do not appear to have end dams and do not overlap allowing for water to bypass the flashing and leak into the roof system. In order to address the wet insulation, Gale recommends that the throughwall flashing repairs are performed (Fig. 25).

Figure 25: Scope 3 area.

- XVI. Remove and replace Scope 3 roof area, remove and raise throughwall flashings, provide 8" overlaps at steps and end dams in flashing.
- XVII. Remove and replace Scope 4 roof area. Gale recommends that the door pan flashing be repaired or replaced. If no active leaks are reported on the interior of the building at this location, the door and pan flashing could be replaced as part of the full roof replacement in the future.

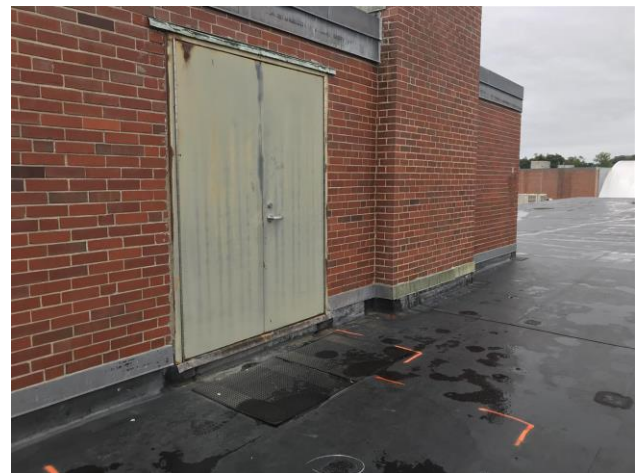
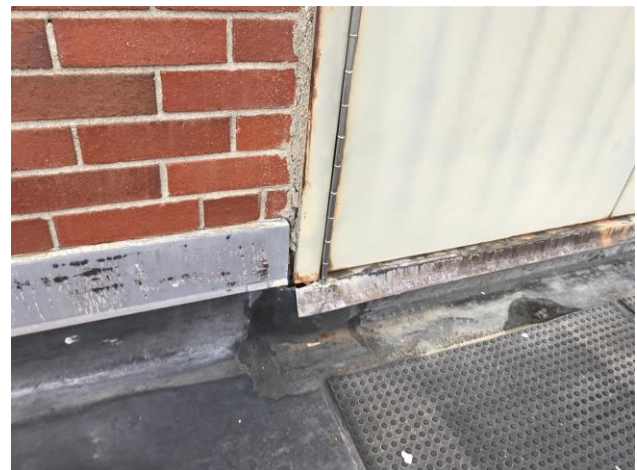
15. Scope 4 is located on Roof Area C.2. This area of wet roofing appears to be related deficient door flashing. Gale observed a large wet area of insulation located directly around the base of the door. The wet roofing in this area appears to be related to the door pan flashing. To address this area the pan flashing would be required (Fig. 26 and 27) to be removed and replaced.

Figure 26: Scope 4 area overall view.

Figure 27: Scope 4 area close up view of the poor door pan flashing.

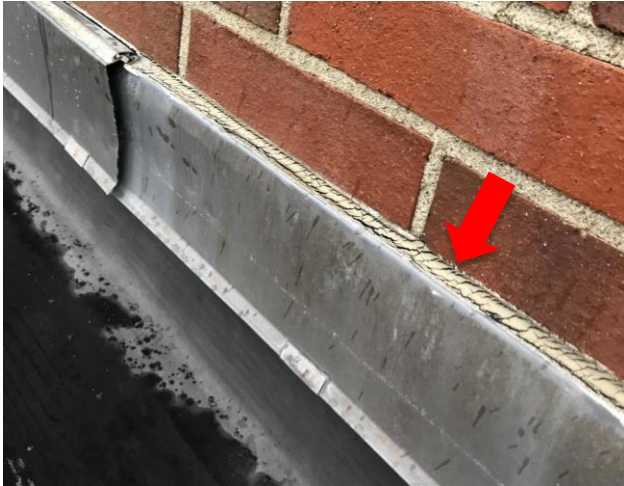
16. Reglet joint flashing terminations are installed on the base of the wall on the original building sections. Failed sealants were typically observed at the roof system termination on the rising wall reglet joint flashings (Fig. 28).

Figure 28: Failed sealant observed at reglet joint flashing terminations on the rising wall of Roof Area B.3.

- XII. Remove and replace all failed sealant joint at reglet flashings.
- XIII. Remove spray foam insulation from weep and replace damaged or clogged weep baffles.

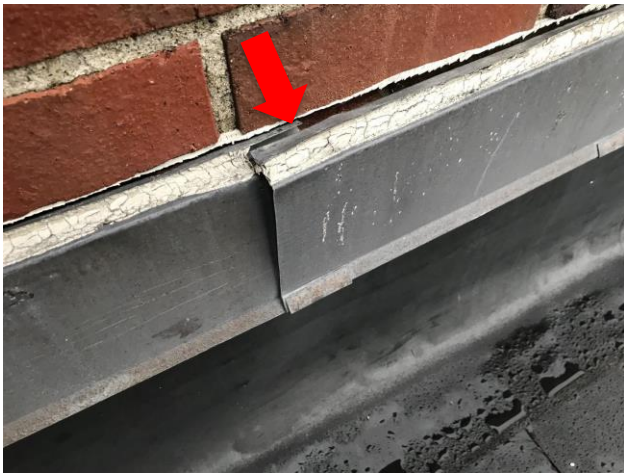
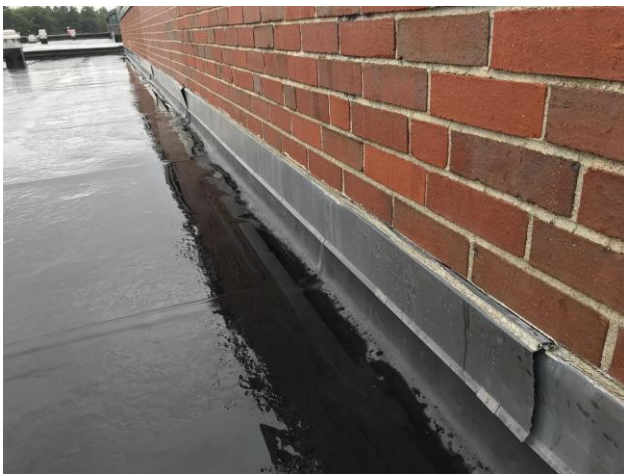
17. Isolated areas of failed, loose, and open reglet joints were observed at isolated locations (Fig. 29 and 30).
18. Rising walls typically appeared to have throughwall flashing installed at roofing system termination. Condition of the throughwall flashing varied, some locations appeared to be in good condition while other locations exhibited open joints and damaged throughwall flashing (Fig. 31).

Figure 29: Reglet joint observed pulled out of wall and open.

Figure 30: Failed sealants were typically observed at reglet joints.

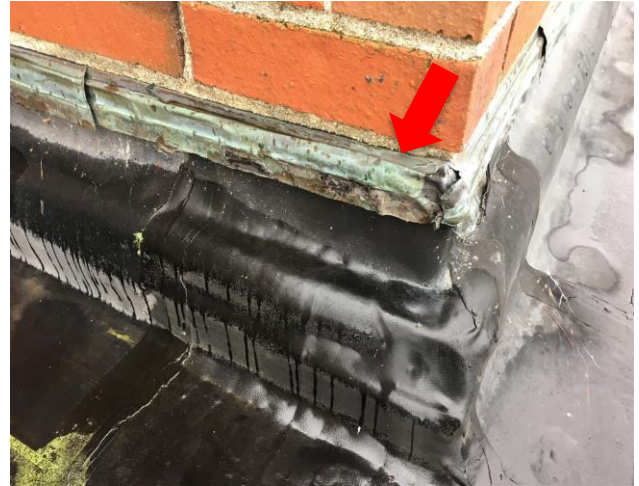
Figure 31: View of throughwall flashing with open joints.

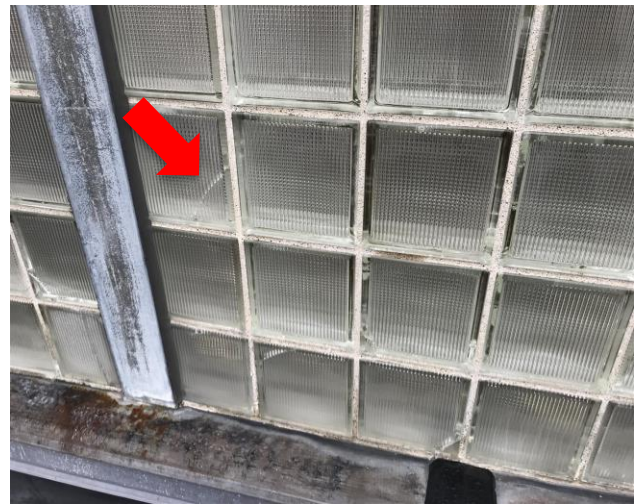
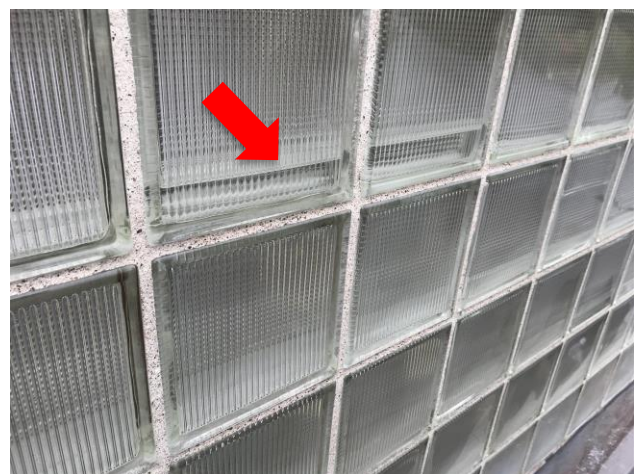
19. Glass blocks rising walls were observed to be in poor condition, multiple cracked blocks were observed. Isolated blocks were observed to be partially filled with water (Fig. 32 and 33).

Figure 32: View of cracked glass block.

Figure 33: View of glass block filled with water.

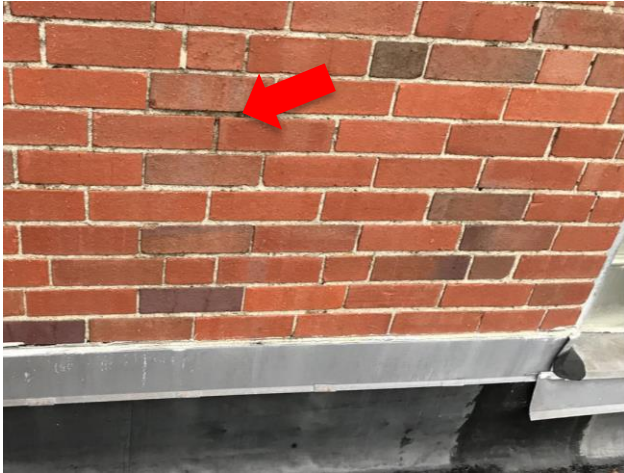
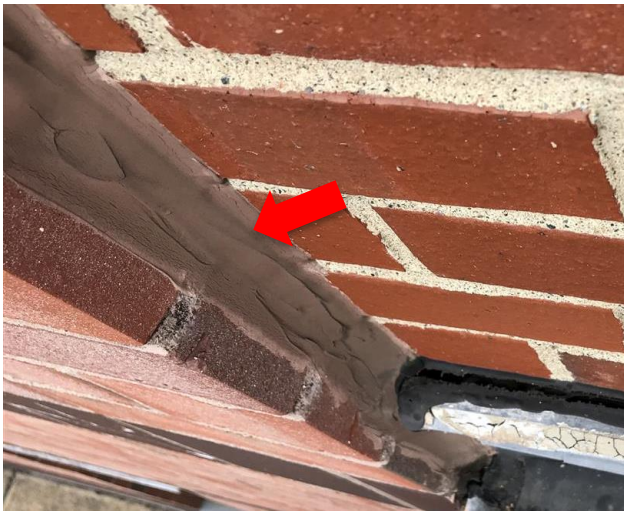
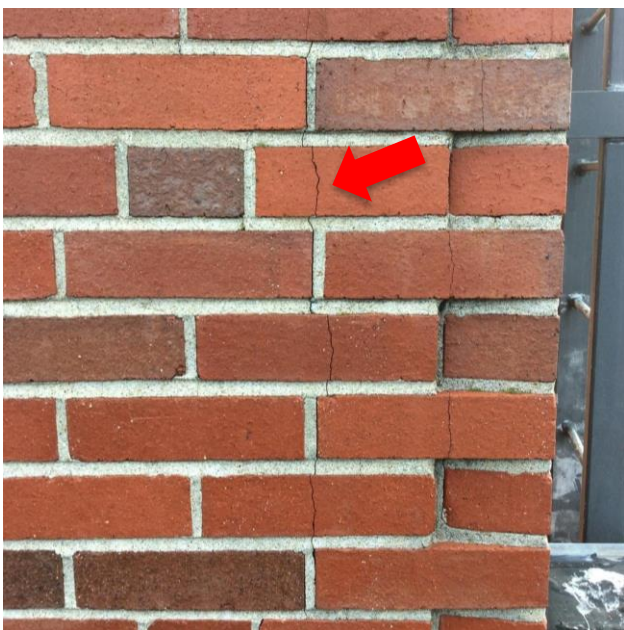
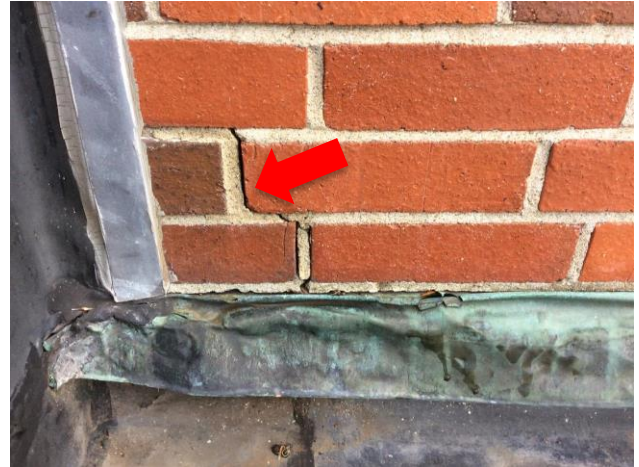
20. At rising brick masonry wall typical masonry defects were observed throughout, including areas of deteriorated mortar, failed expansion joint sealant, and areas of step cracking. Gale recommends that the rising walls are fully reviewed and repairs are incorporated prior to

full roof system is replaced as these defects may be contributing to the deterioration of the roof system (Fig. 34, 35, 36 and 37).

Figure 34: View of deteriorated mortar.

Figure 37: View of step cracking.

Figure 35: View of failed expansion joint sealant.

Figure 36: View of step cracking.

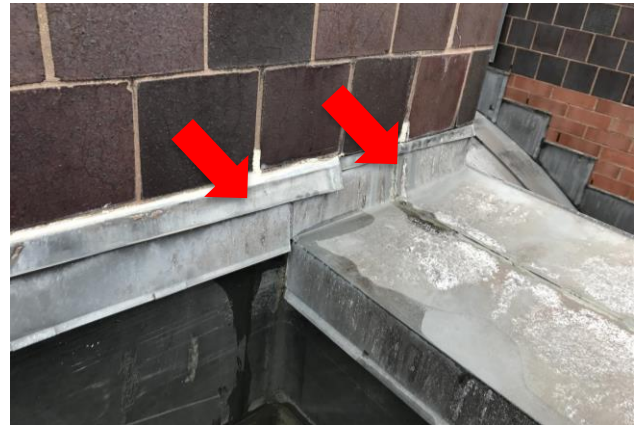
21. Masonry weeps filled with spray foam were observed on the rising wall of Roof Area B.1. (Fig. 38).

Figure 38: View of masonry weeps filled with spray foam.

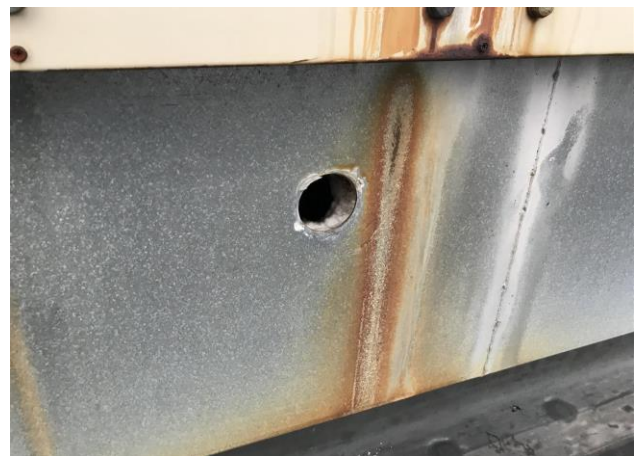
Figure 39: Open penetrations in RTU curbs.

22. Open pipe penetrations in roof top unit (RTU) curbs were observed throughout the building. These opening can allow moisture and air infiltration into the building (Fig. 39).

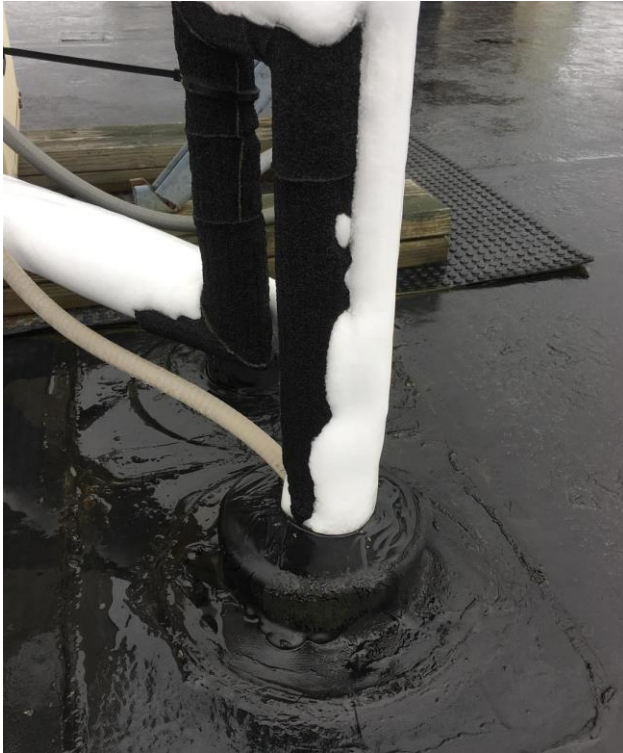
Figure 40: View of frozen air conditioner lines on Roof Area A.

23. Frozen air conditioner lines were observed at a unit on Roof Area A. Frozen lines can indicated that there is an issue with the unit. Gale notified MRS personnel prior to leaving the site. Gale recommends that MRS have a mechanical contractor review the unit (Fig. 40).

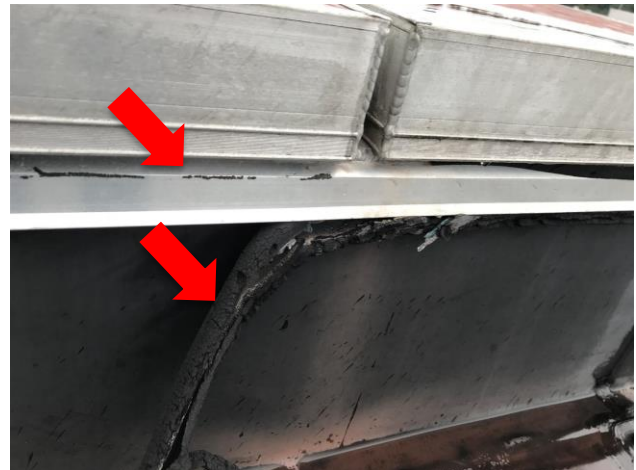
25. Three smoke hatches were observed on roof area E.3. with failed weatherstripping and without full perimeter sealant (Fig. 41).
26. An exposed edge of the metal panel wall cladding above the white barrel roof of the field house appears to be separating from the wall (Fig 42 and 43). The panels appear to be loose or missing closure trim which creates a potential

Figure 41: View of smoke hatch with failed weatherstripping and missing sealant.

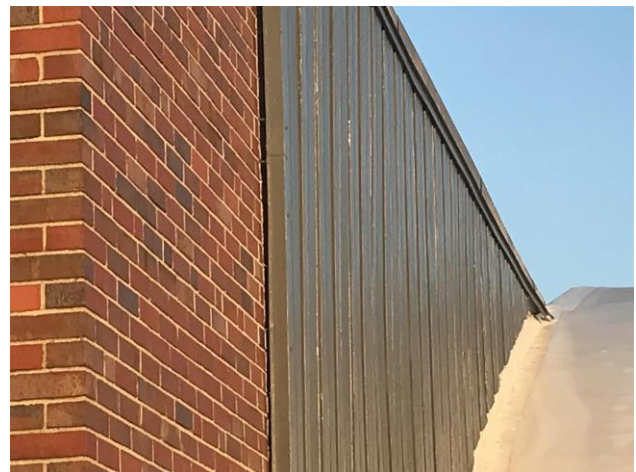
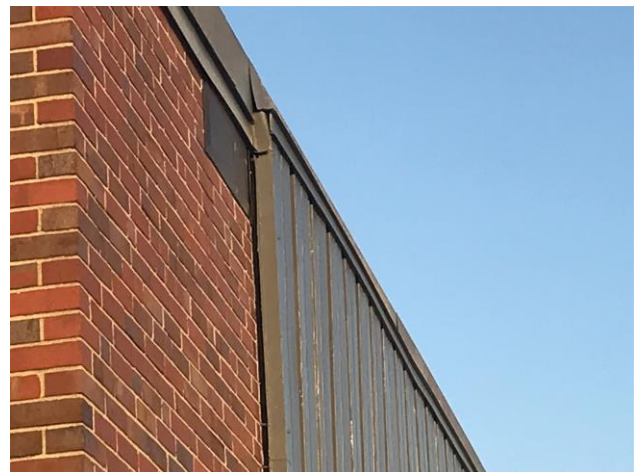
Figure 42: View of open wall panels edge on field house wall.

Figure 43: View of open wall panels edge on field house wall.

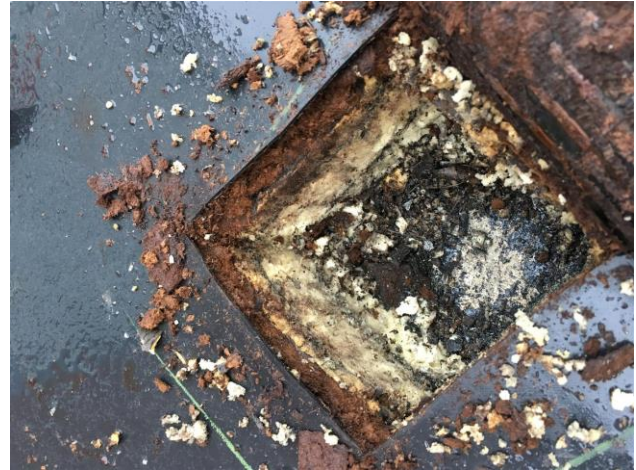
Test cuts typically revealed wet and deteriorated roofing materials. Wet and deteriorated coverboard was observed in the majority of the test cuts, some test cuts consisted of dry deteriorated coverboard that possibly indicates a previous leak that was patched and has started to dry out. In isolated test cuts Gale observed standing water above the vapor retarder.

Figure 44: View of wet roofing material.

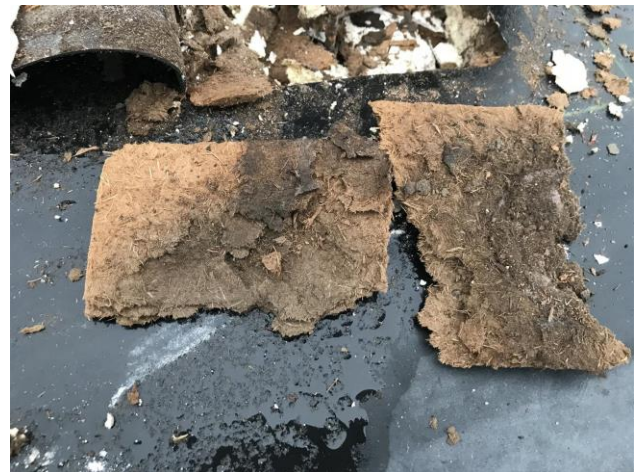
Figure 45: View of deteriorated coverboard.

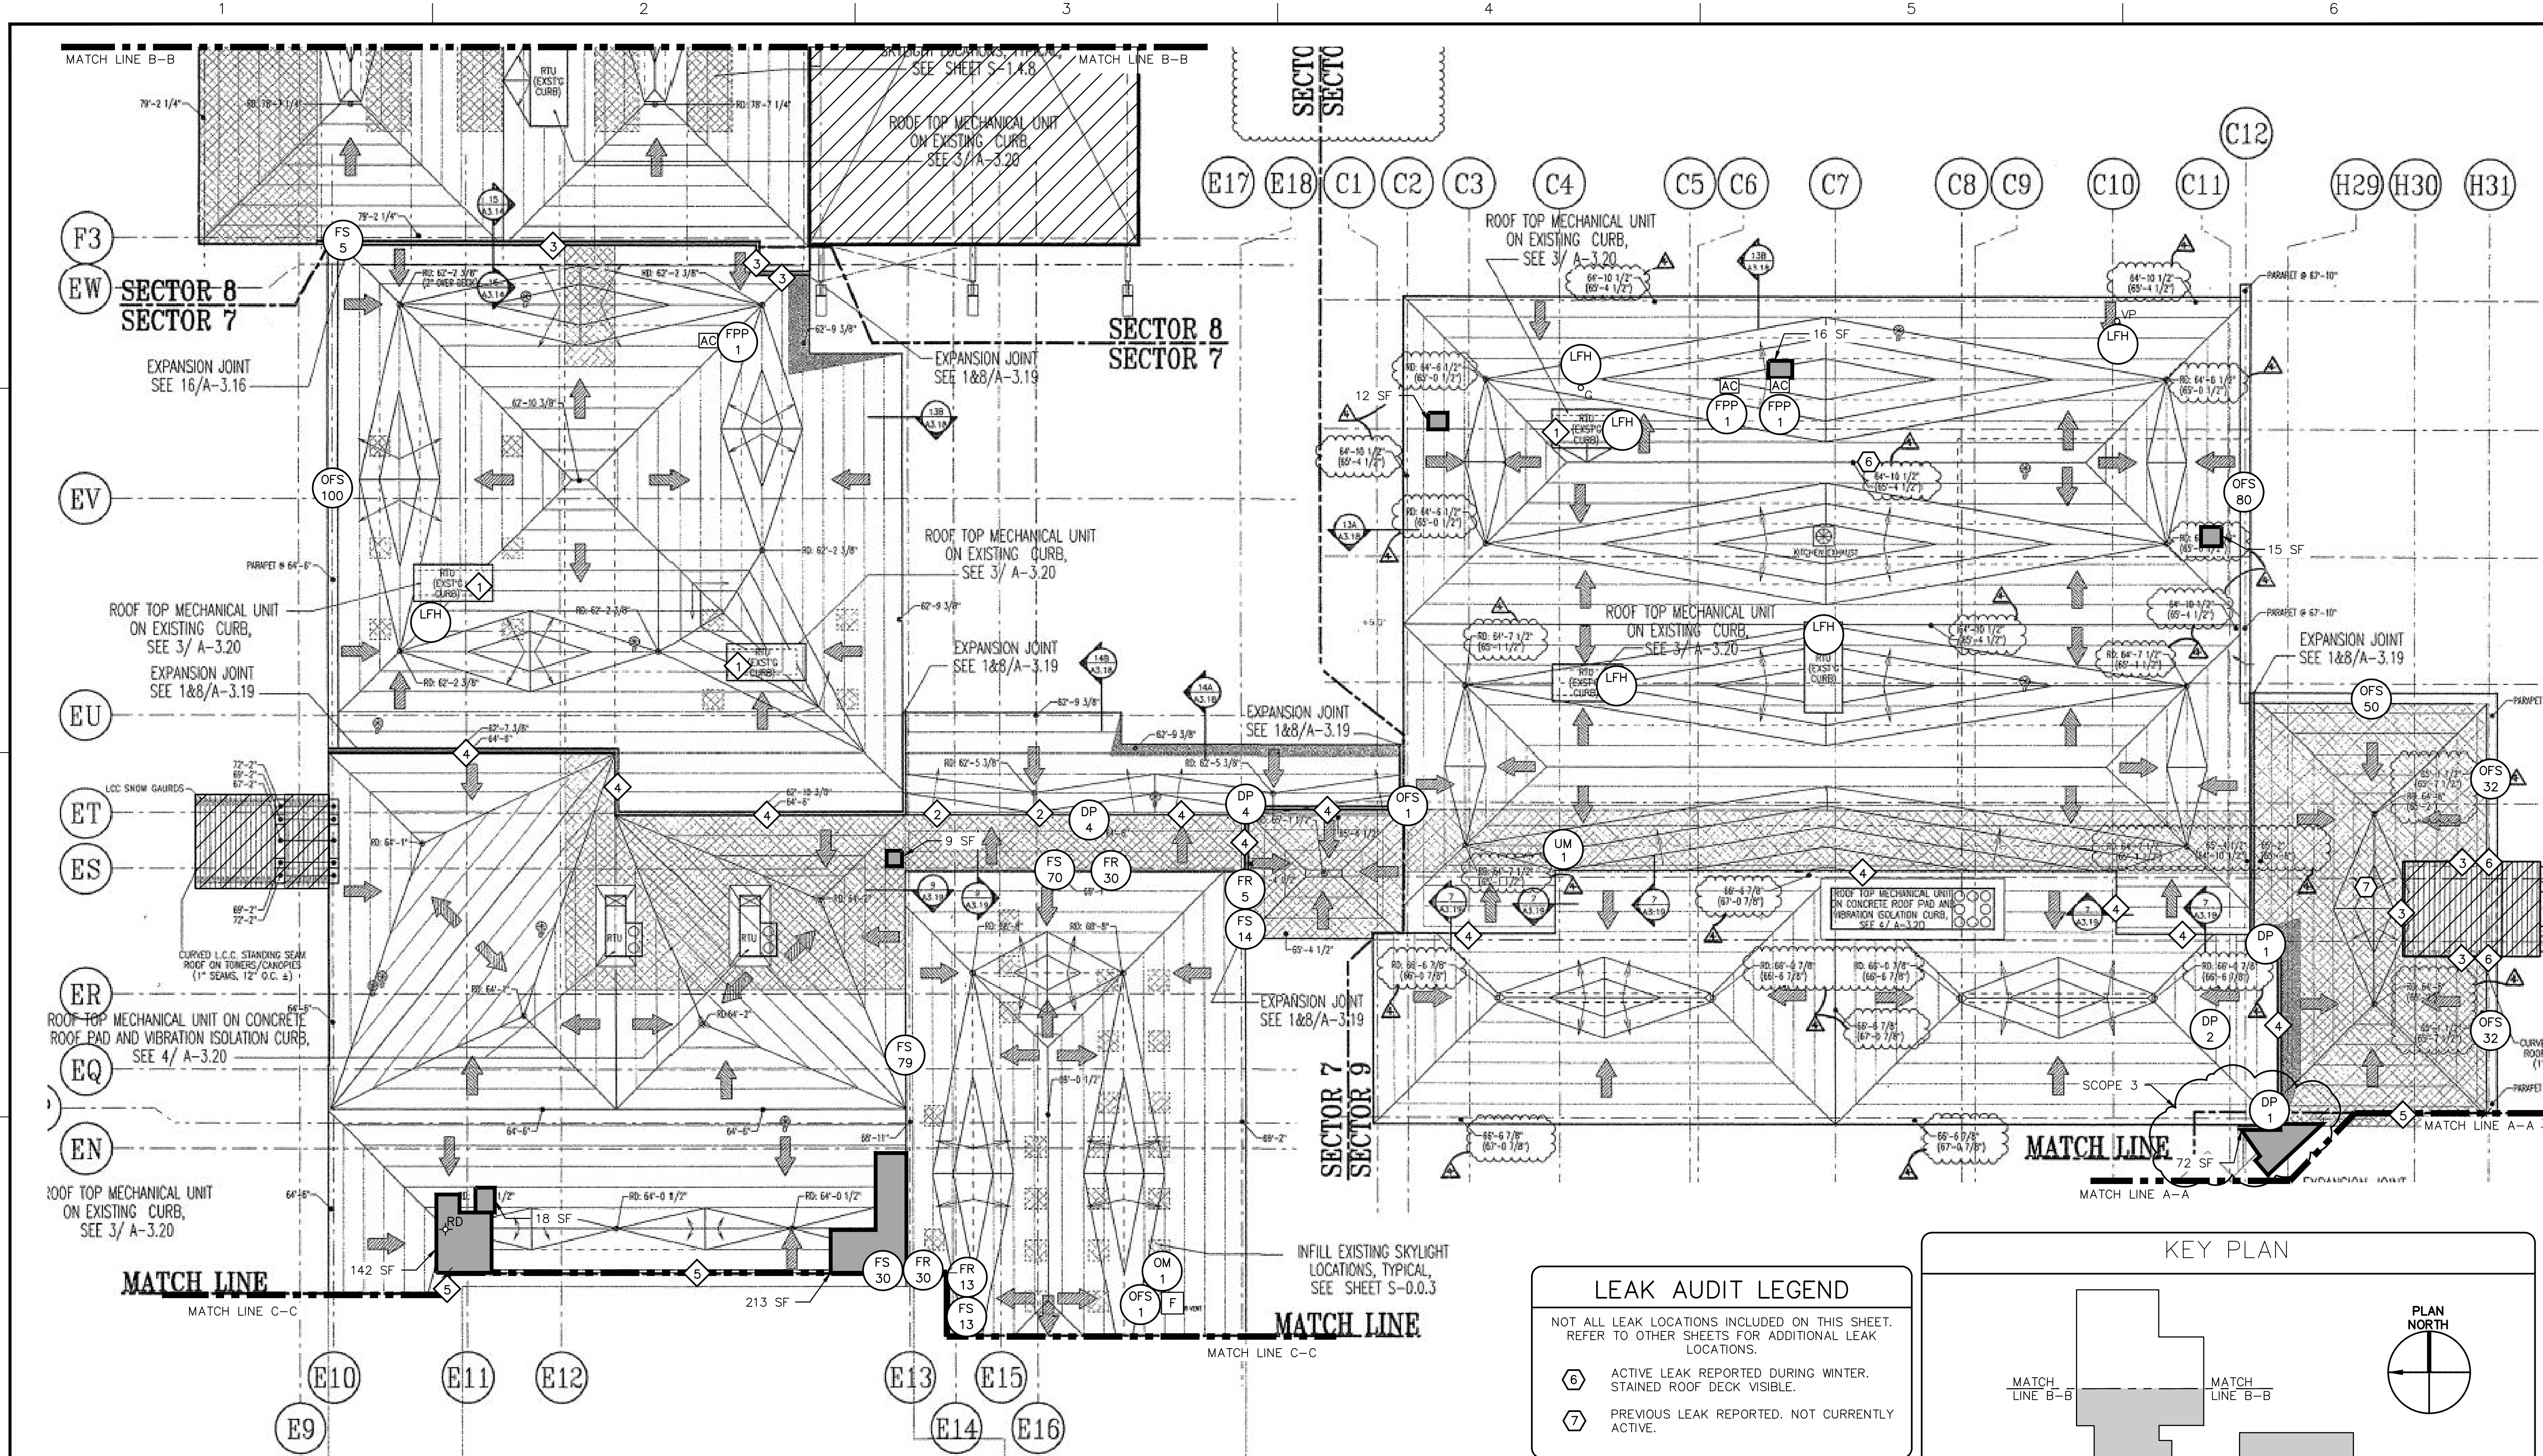
DRAWING NO.
A101

SHEET NOTES	
1	OPEN PENETRATIONS AND ELECTRIC OBSERVED AT MECHANICAL UNITS.
2	CRACKED SOLDER OBSERVED AT METAL JOINTS.
3	THROUGH WALL FLASHING OBSERVED WITH OPEN JOINTS.
4	BUBBLED STRIPPING MEMBRANE AT ROOF EDGE; TYPICAL.
5	GLASS BLOCK RISING WALLS WITH THROUGH WALL FLASHING OBSERVED.
6	MASONRY WEEPS OBSERVED FILLED WITH SPRAY FOAM.

LEAK AUDIT LEGEND	
NOT ALL LEAK LOCATIONS INCLUDED ON THIS SHEET. REFER TO OTHER SHEETS FOR ADDITIONAL LEAK LOCATIONS.	
6	ACTIVE LEAK REPORTED DURING WINTER. STAINED ROOF DECK VISIBLE.
7	PREVIOUS LEAK REPORTED. NOT CURRENTLY ACTIVE.
