**LOW SLOPED ROOF EVALUATION
AT THE MASCONOMET REGIONAL SCHOOL
20 ENDICOTT ROAD
BOXFORD, MA 01921
GALE JN 834200**

October 3, 2018

Evaluation and Recommendations Report

**Masconomet Regional School District
District Central Office
20 Endicott Road
Boxford, MA 01921**

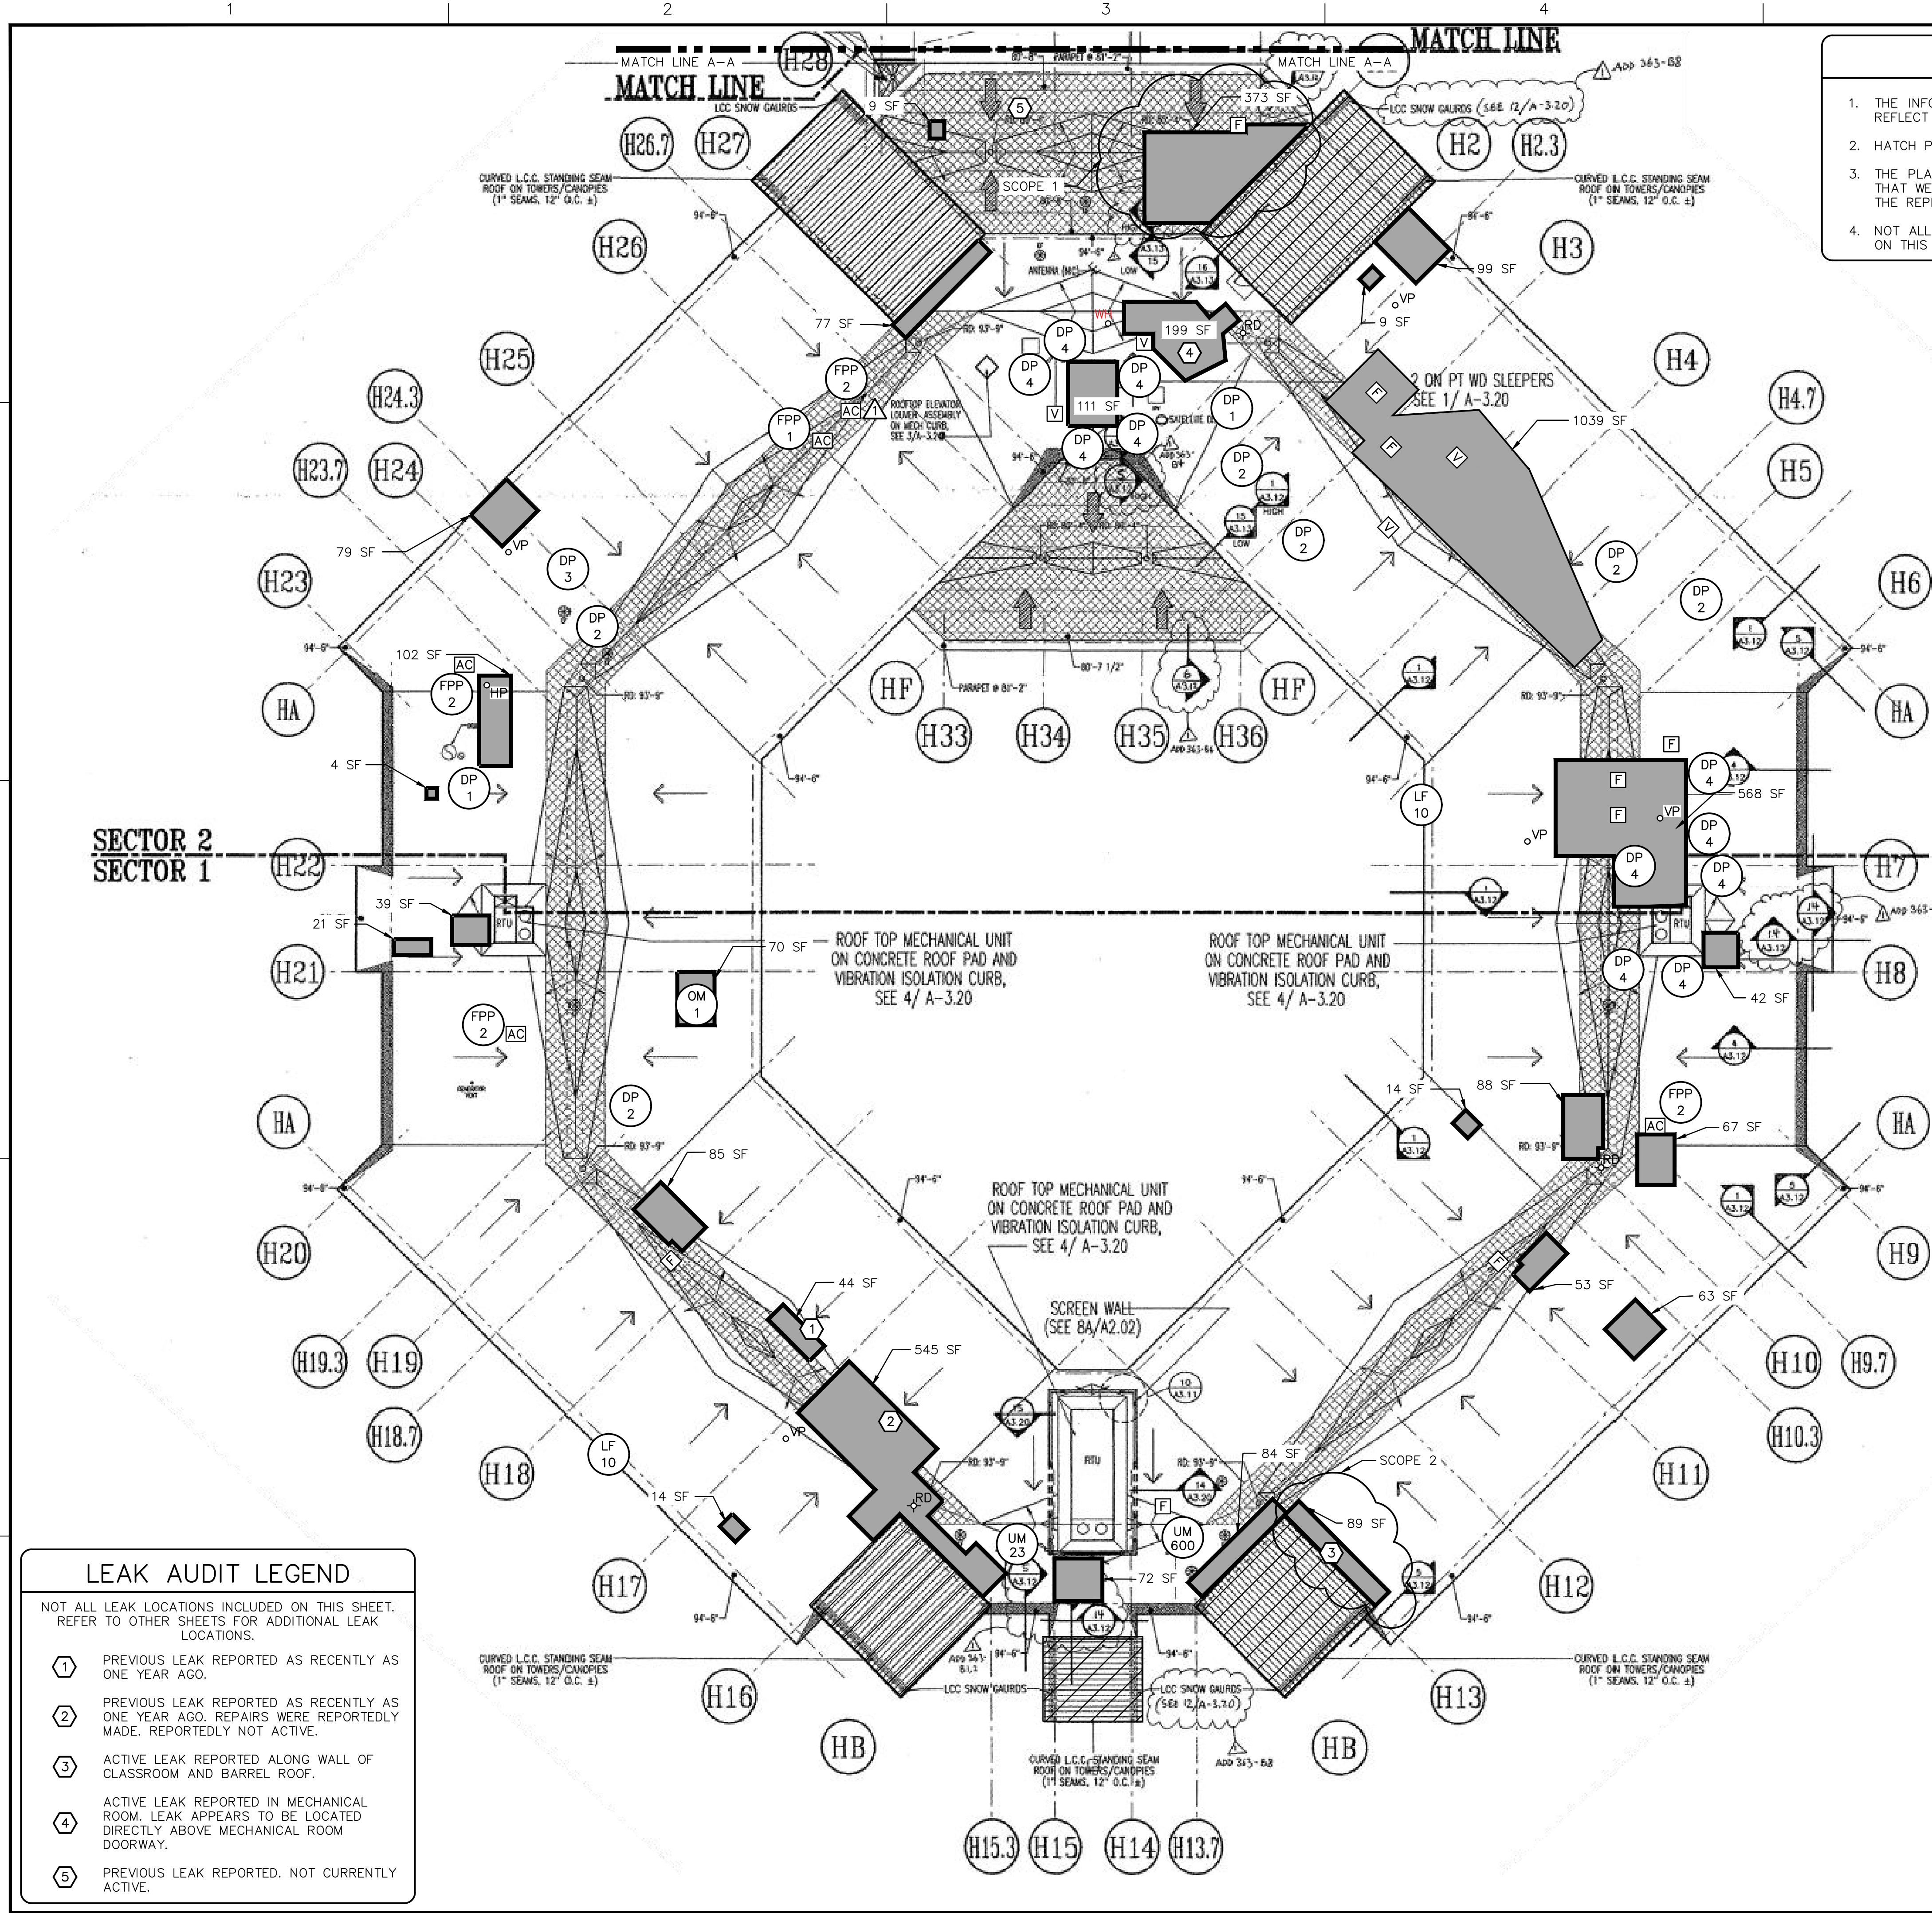
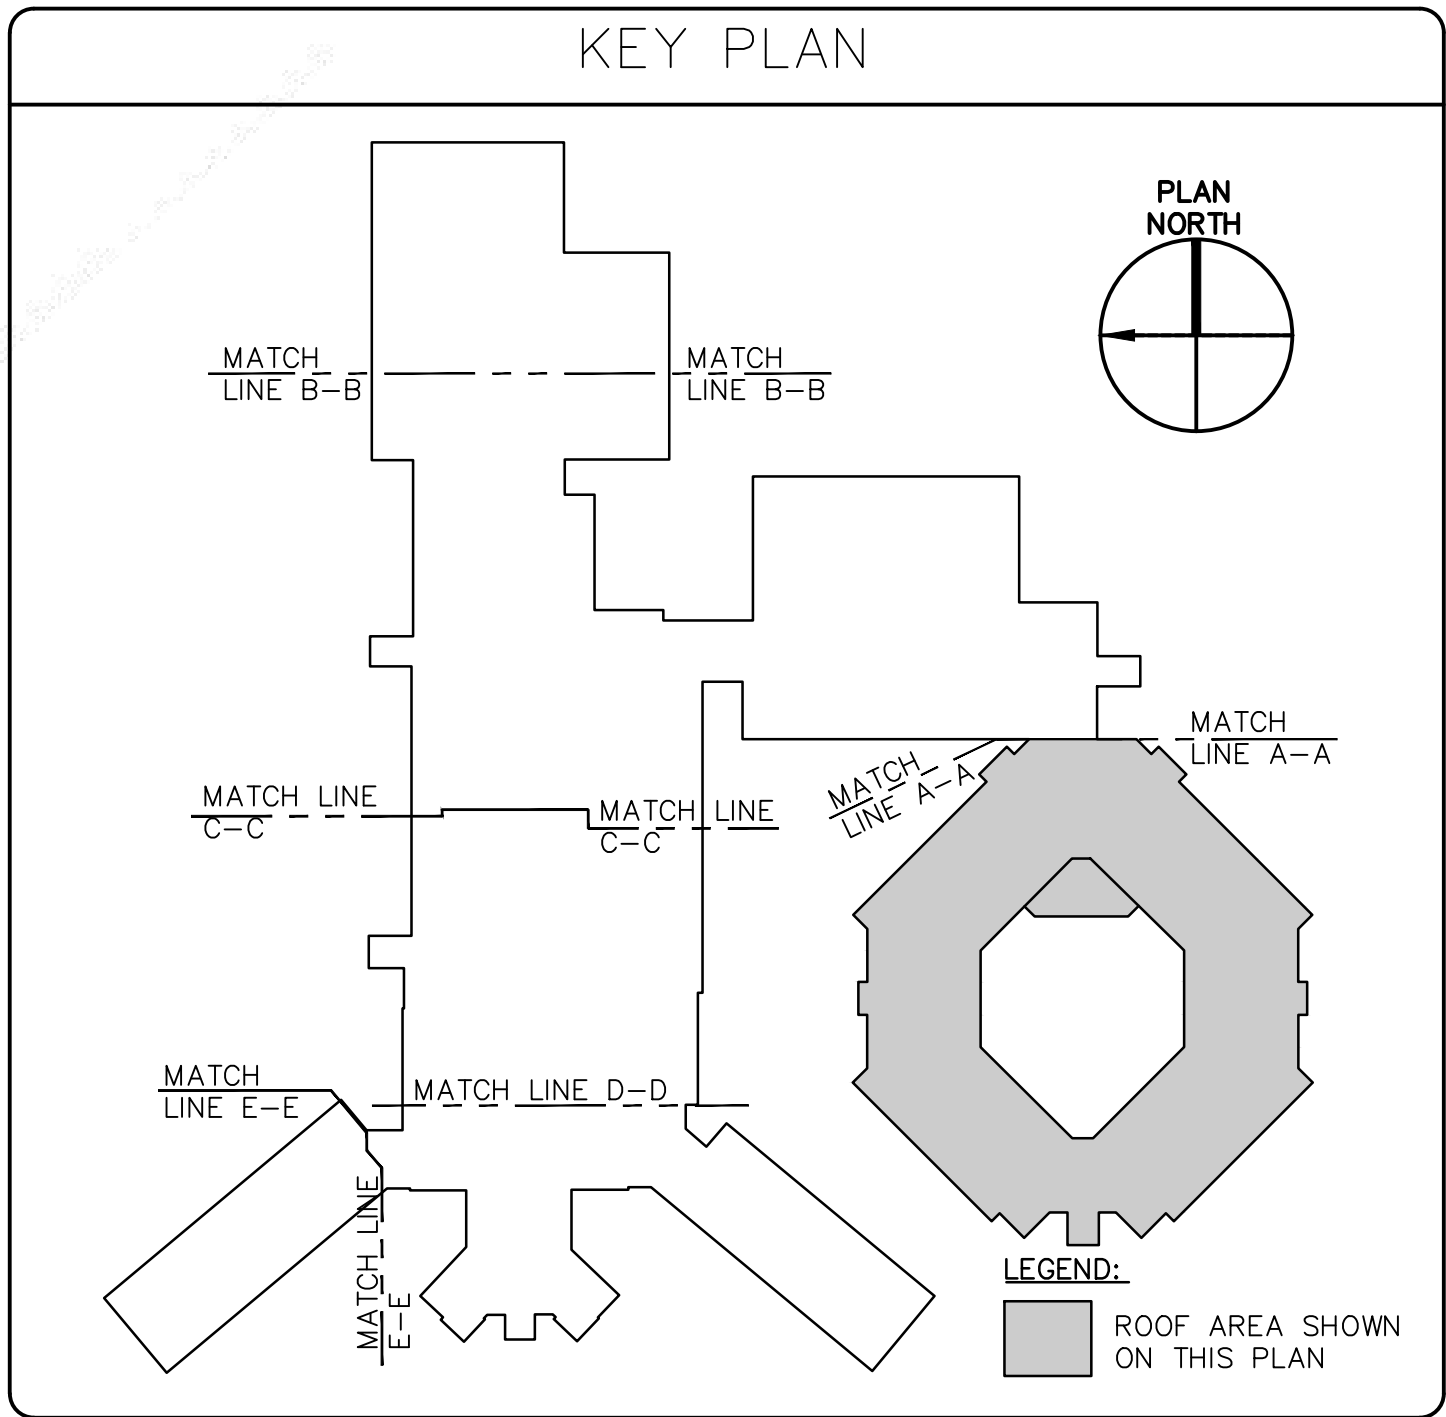
OVERALL ROOF PLAN AND EXISTING ROOF CROSS SECTIONS	
DRAWING NO.	G101

- ICE OBSERVED ON AIR CONDITIONER UNIT. UNIT SHOULD BE RE-INSULATED

- 1 PREVIOUS LEAK REPORTED AS RECENTLY AS ONE YEAR AGO.
- 2 PREVIOUS LEAK REPORTED AS RECENTLY AS ONE YEAR AGO. REPAIRS WERE REPORTEDLY MADE. REPORTEDLY NOT ACTIVE.
- 3 ACTIVE LEAK REPORTED ALONG WALL OF CLASSROOM AND BARREL ROOF.
- 4 ACTIVE LEAK REPORTED IN MECHANICAL ROOM. LEAK APPEARS TO BE LOCATED DIRECTLY ABOVE MECHANICAL ROOM DOORWAY.
- 5 PREVIOUS LEAK REPORTED. NOT CURRENTLY ACTIVE.

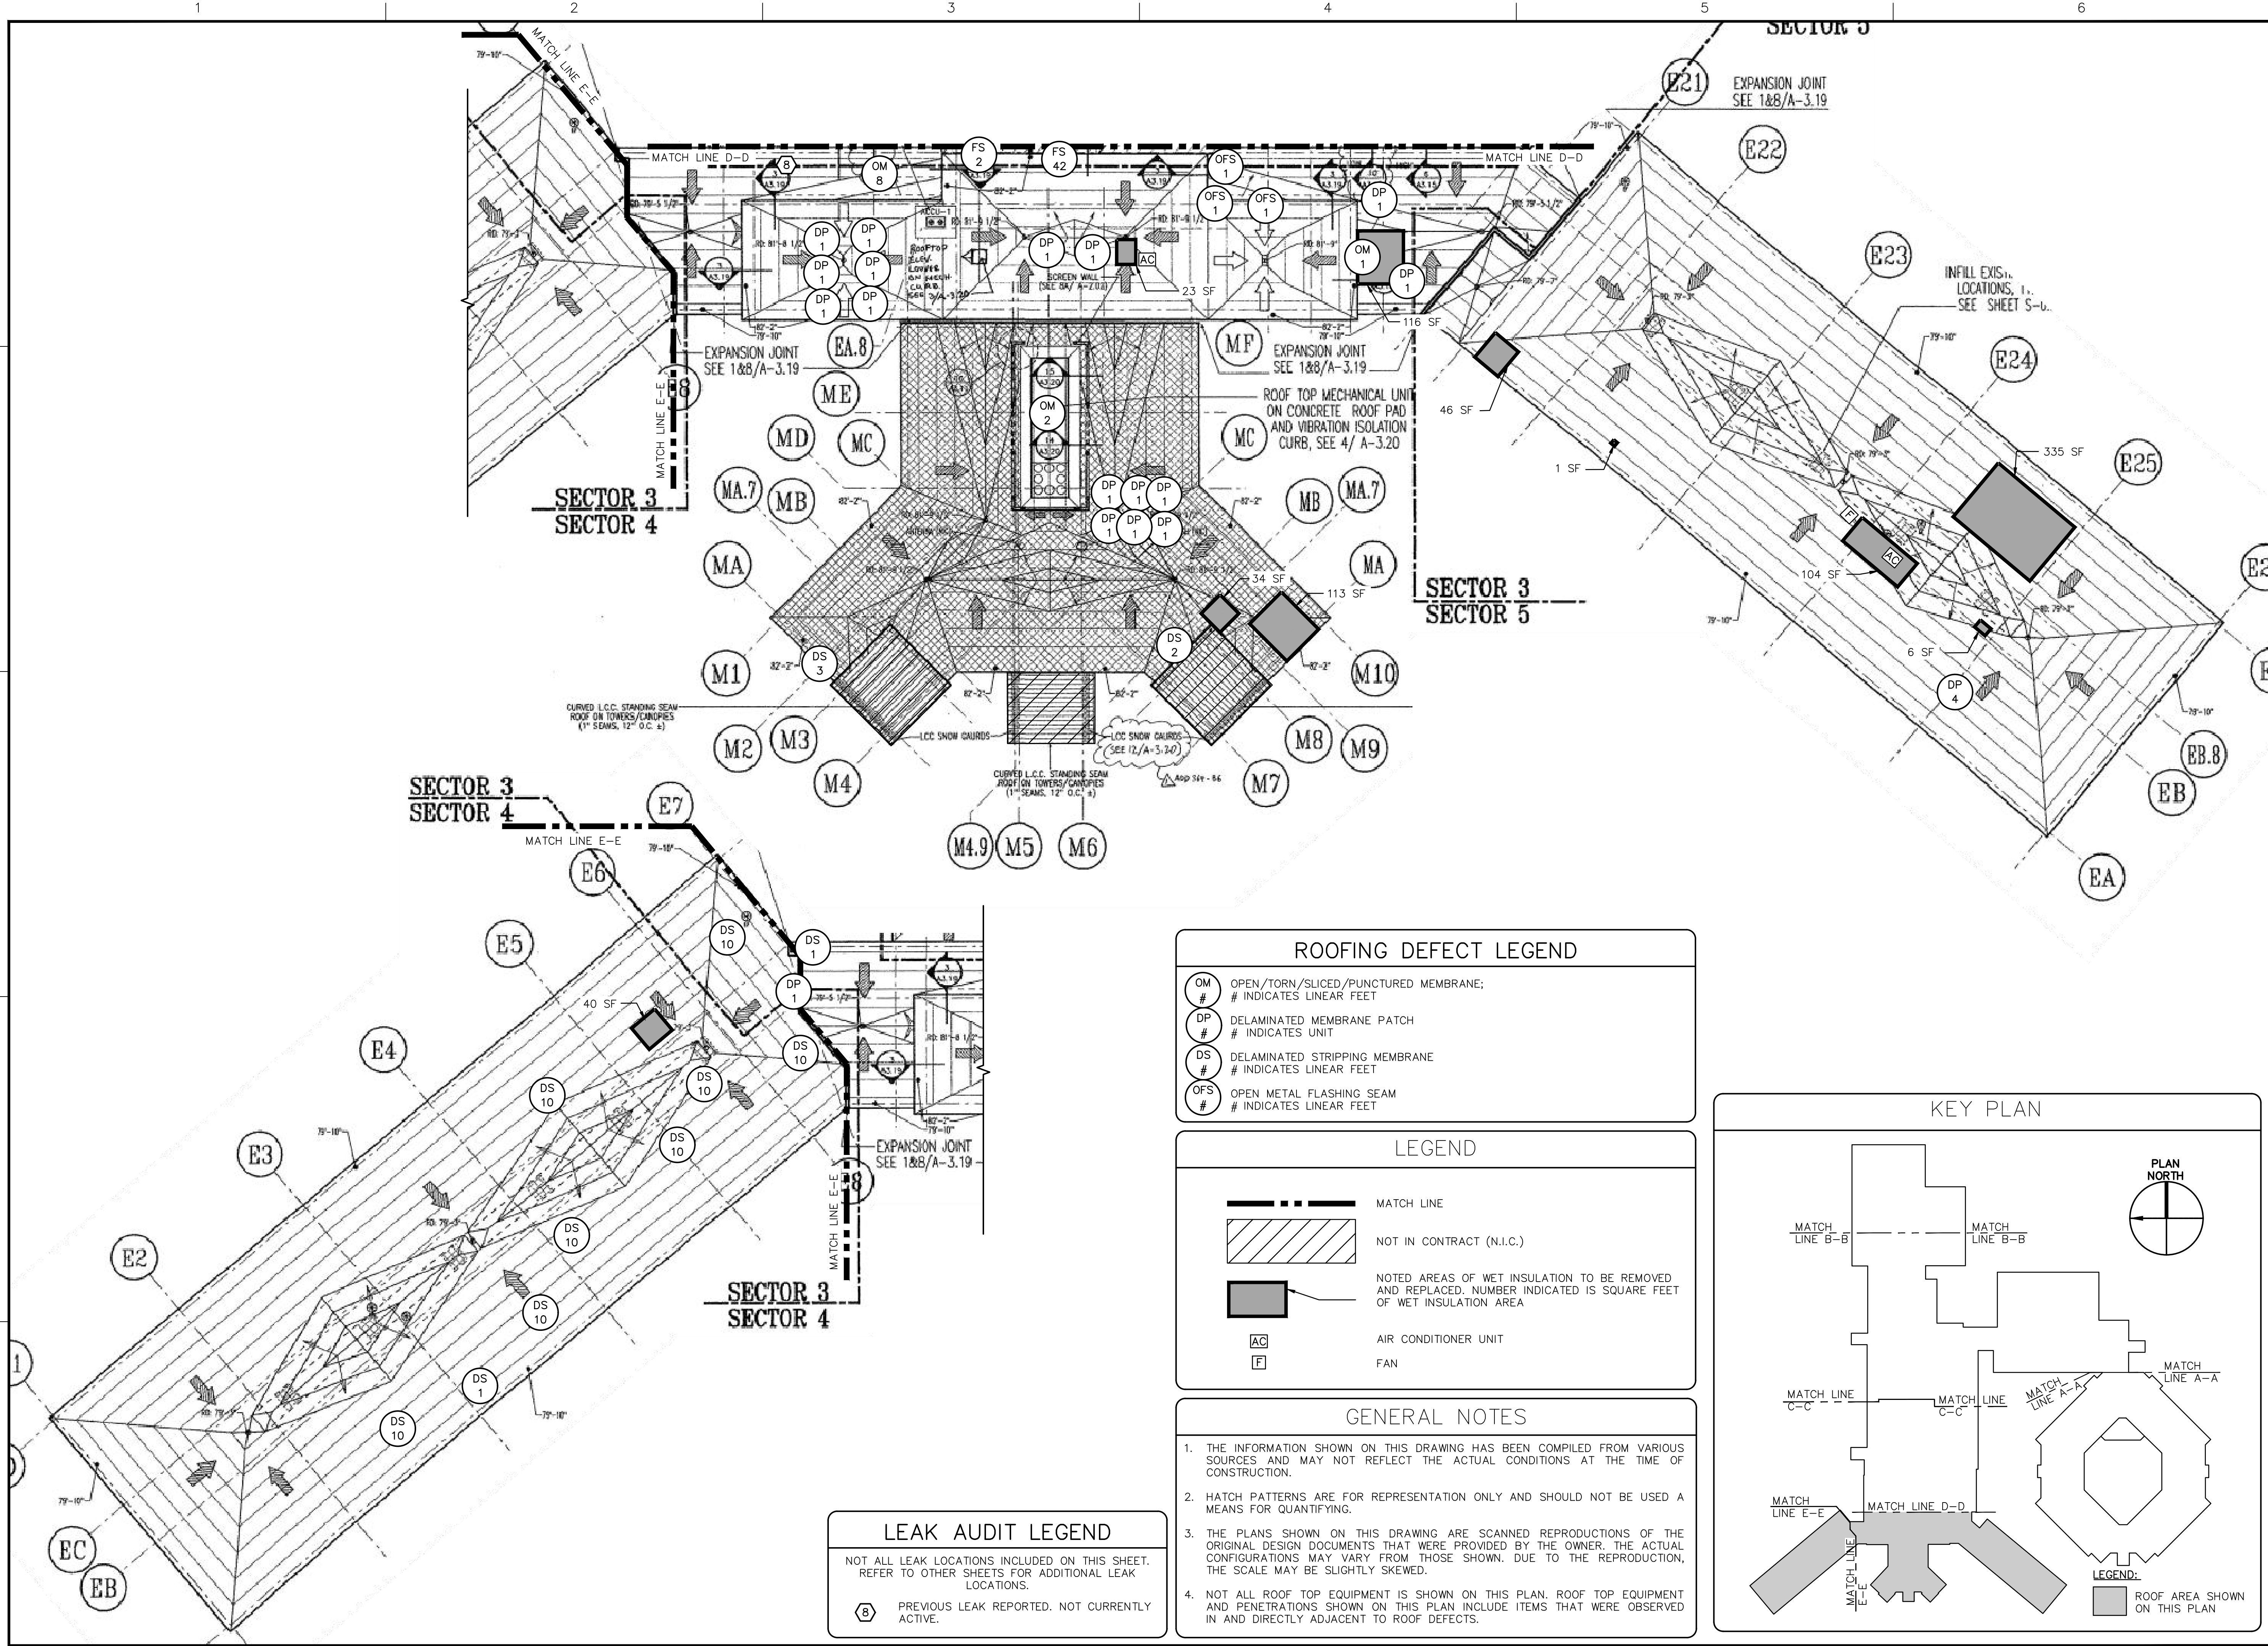
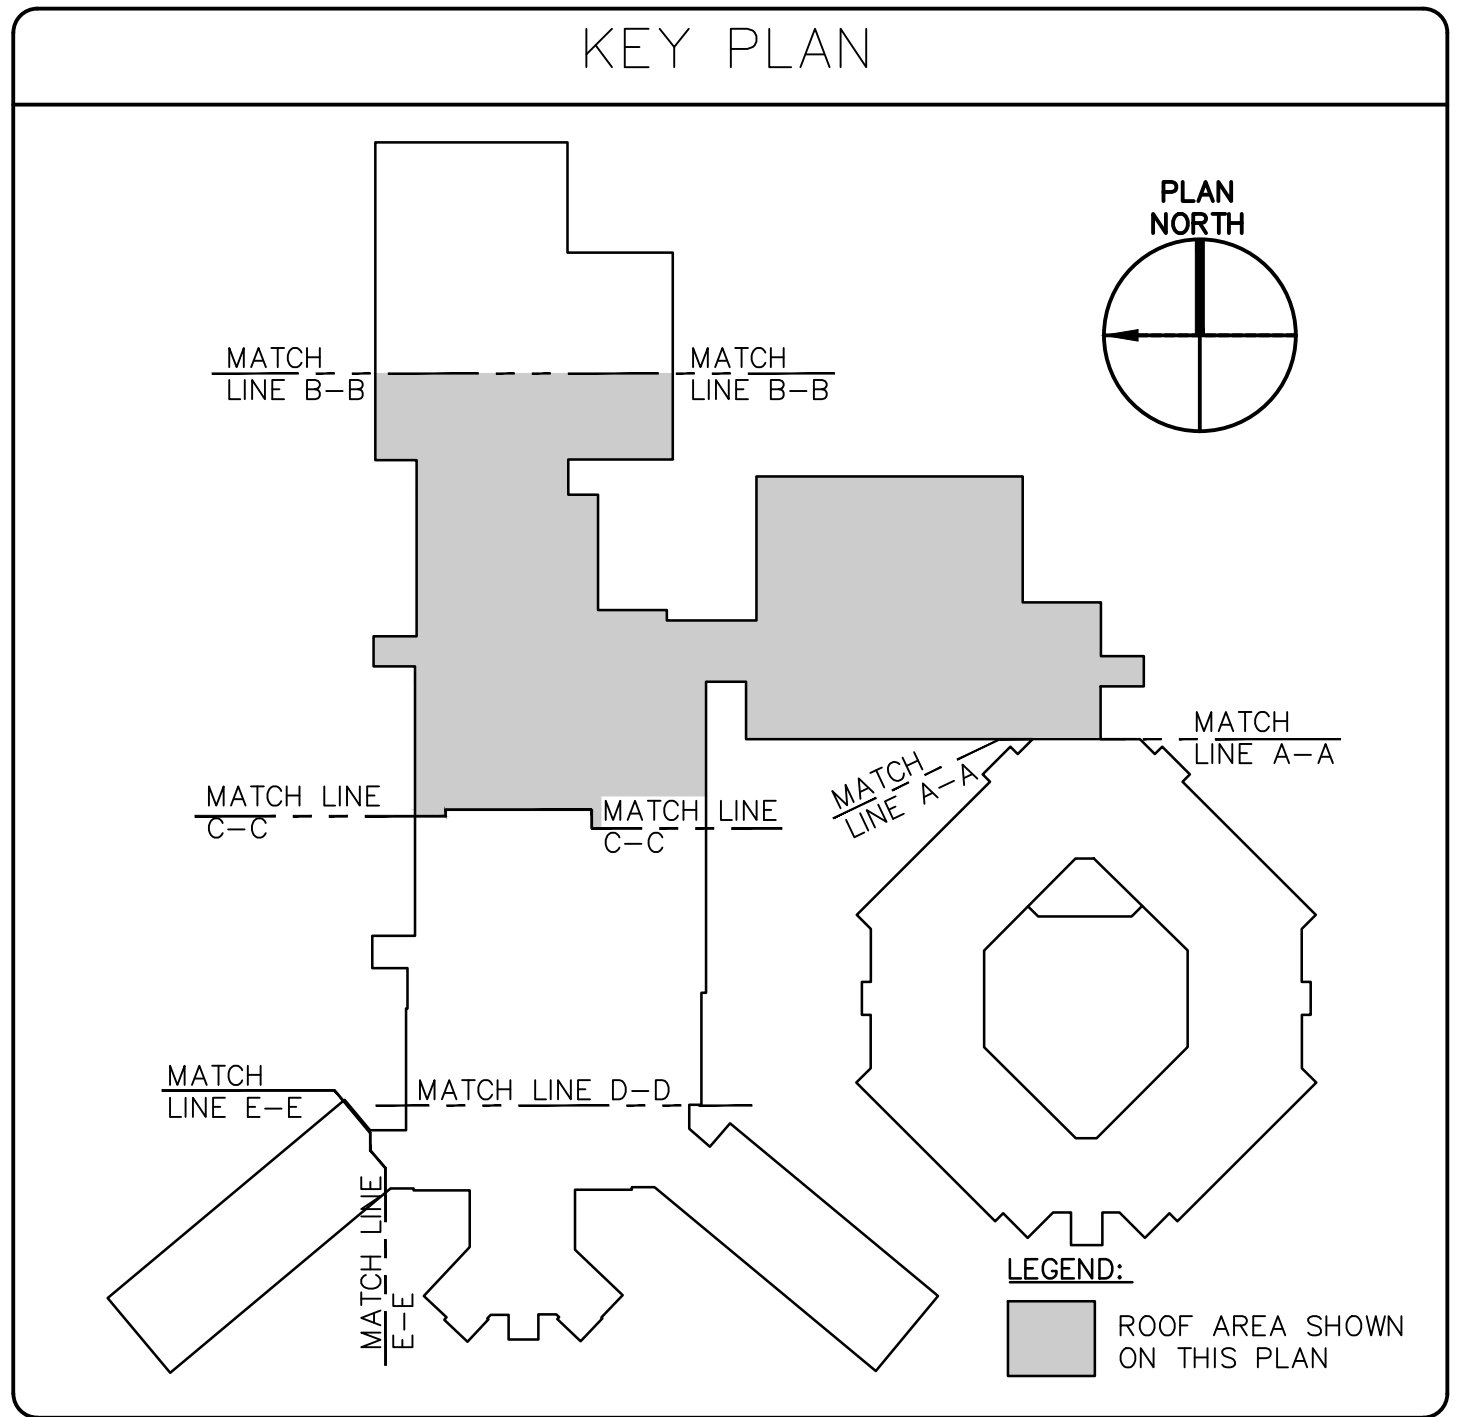
NO.	DATE	DESCRIPTION	BY
PROJECT NO.	834200		
CADD FILE	834200 A100s		
DESIGNED BY	JMZ		
DRAWN BY	DJK/CGK		
CHECKED BY	BHN		
DATE	10/03/18		
DRAWING SCALE	1/16"=1'-0"		
GRAPHIC SCALE			
SHEET TITLE			
PARTIAL ROOF AREA PLAN			
DRAWING NO.			
A102

SHEET NOTES	
1	OPEN PENETRATIONS AND ELECTRIC OBSERVED AT MECHANICAL UNITS.
2	CRACKED SOLDER OBSERVED AT METAL JOINTS.
3	THROUGH WALL FLASHING OBSERVED WITH OPEN JOINTS.
4	BUBBLED STRIPPING MEMBRANE AT ROOF EDGE; TYPICAL.
5	GLASS BLOCK RISING WALLS WITH THROUGH WALL FLASHING OBSERVED.
6	MASONRY WEEPS OBSERVED FILLED WITH SPRAY FOAM.

LEAK AUDIT LEGEND	
NOT ALL LEAK LOCATIONS INCLUDED ON THIS SHEET. REFER TO OTHER SHEETS FOR ADDITIONAL LEAK LOCATIONS.	
6	ACTIVE LEAK REPORTED DURING WINTER. STAINED ROOF DECK VISIBLE.
7	PREVIOUS LEAK REPORTED. NOT CURRENTLY ACTIVE.

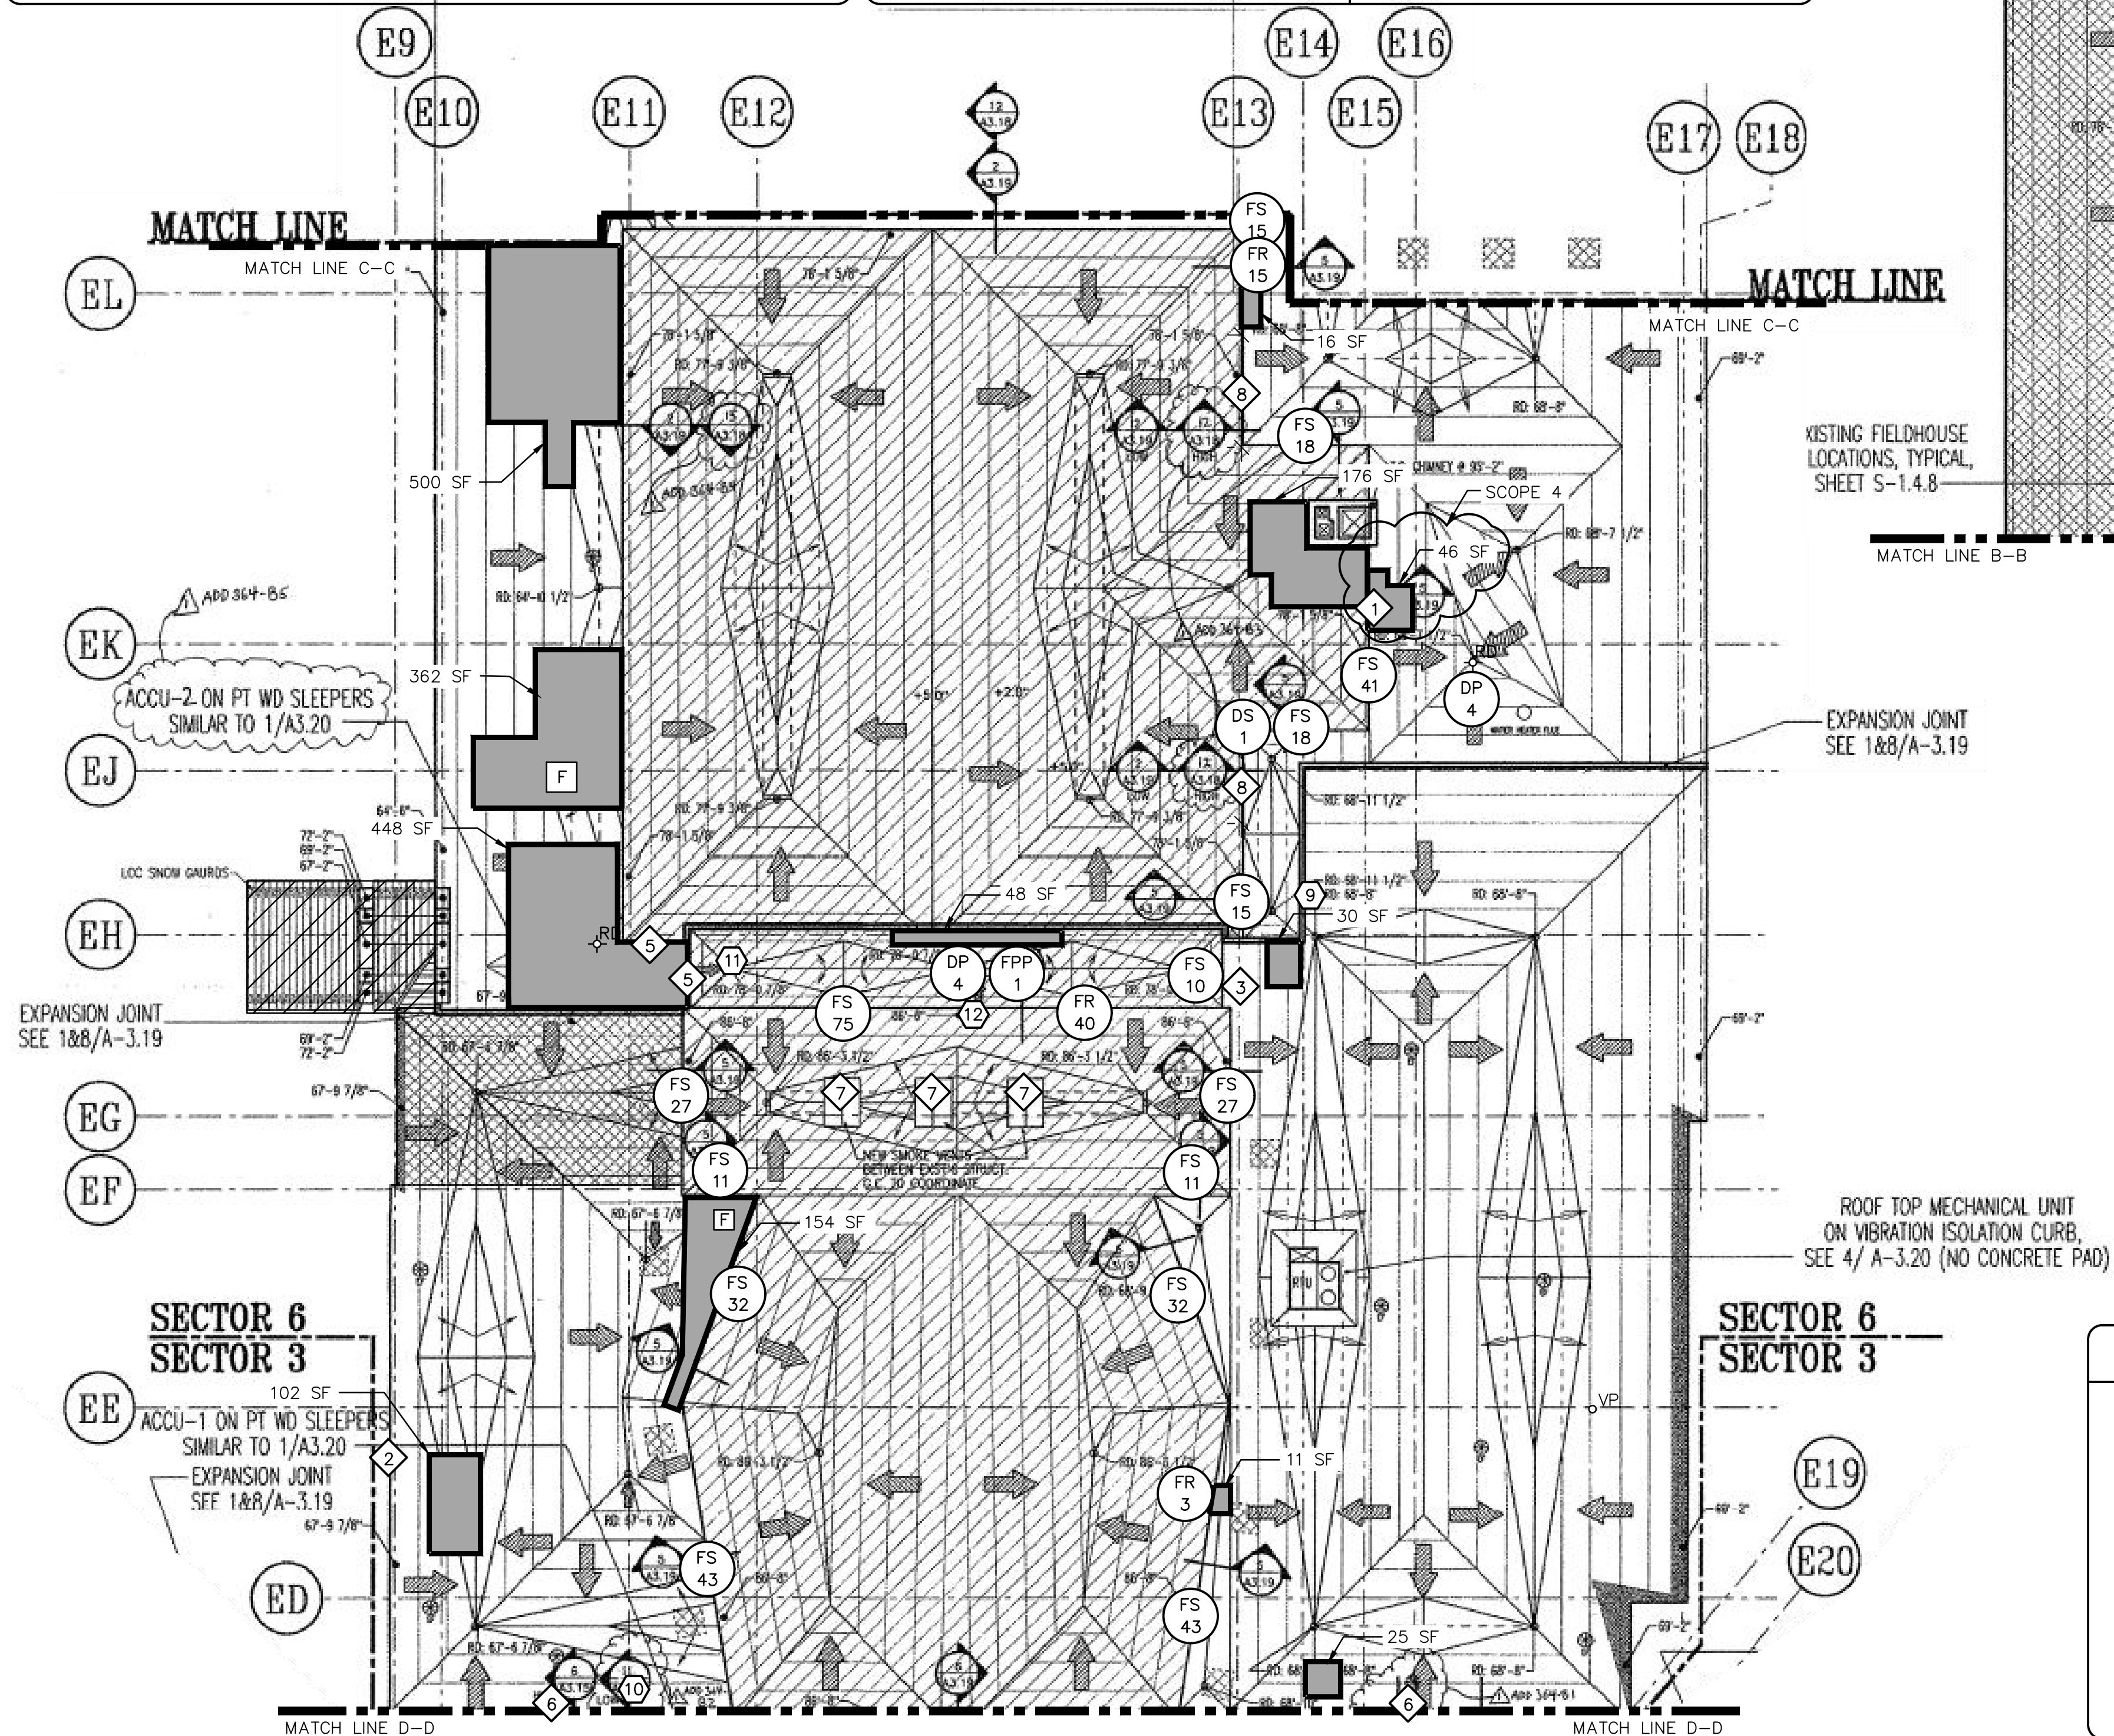
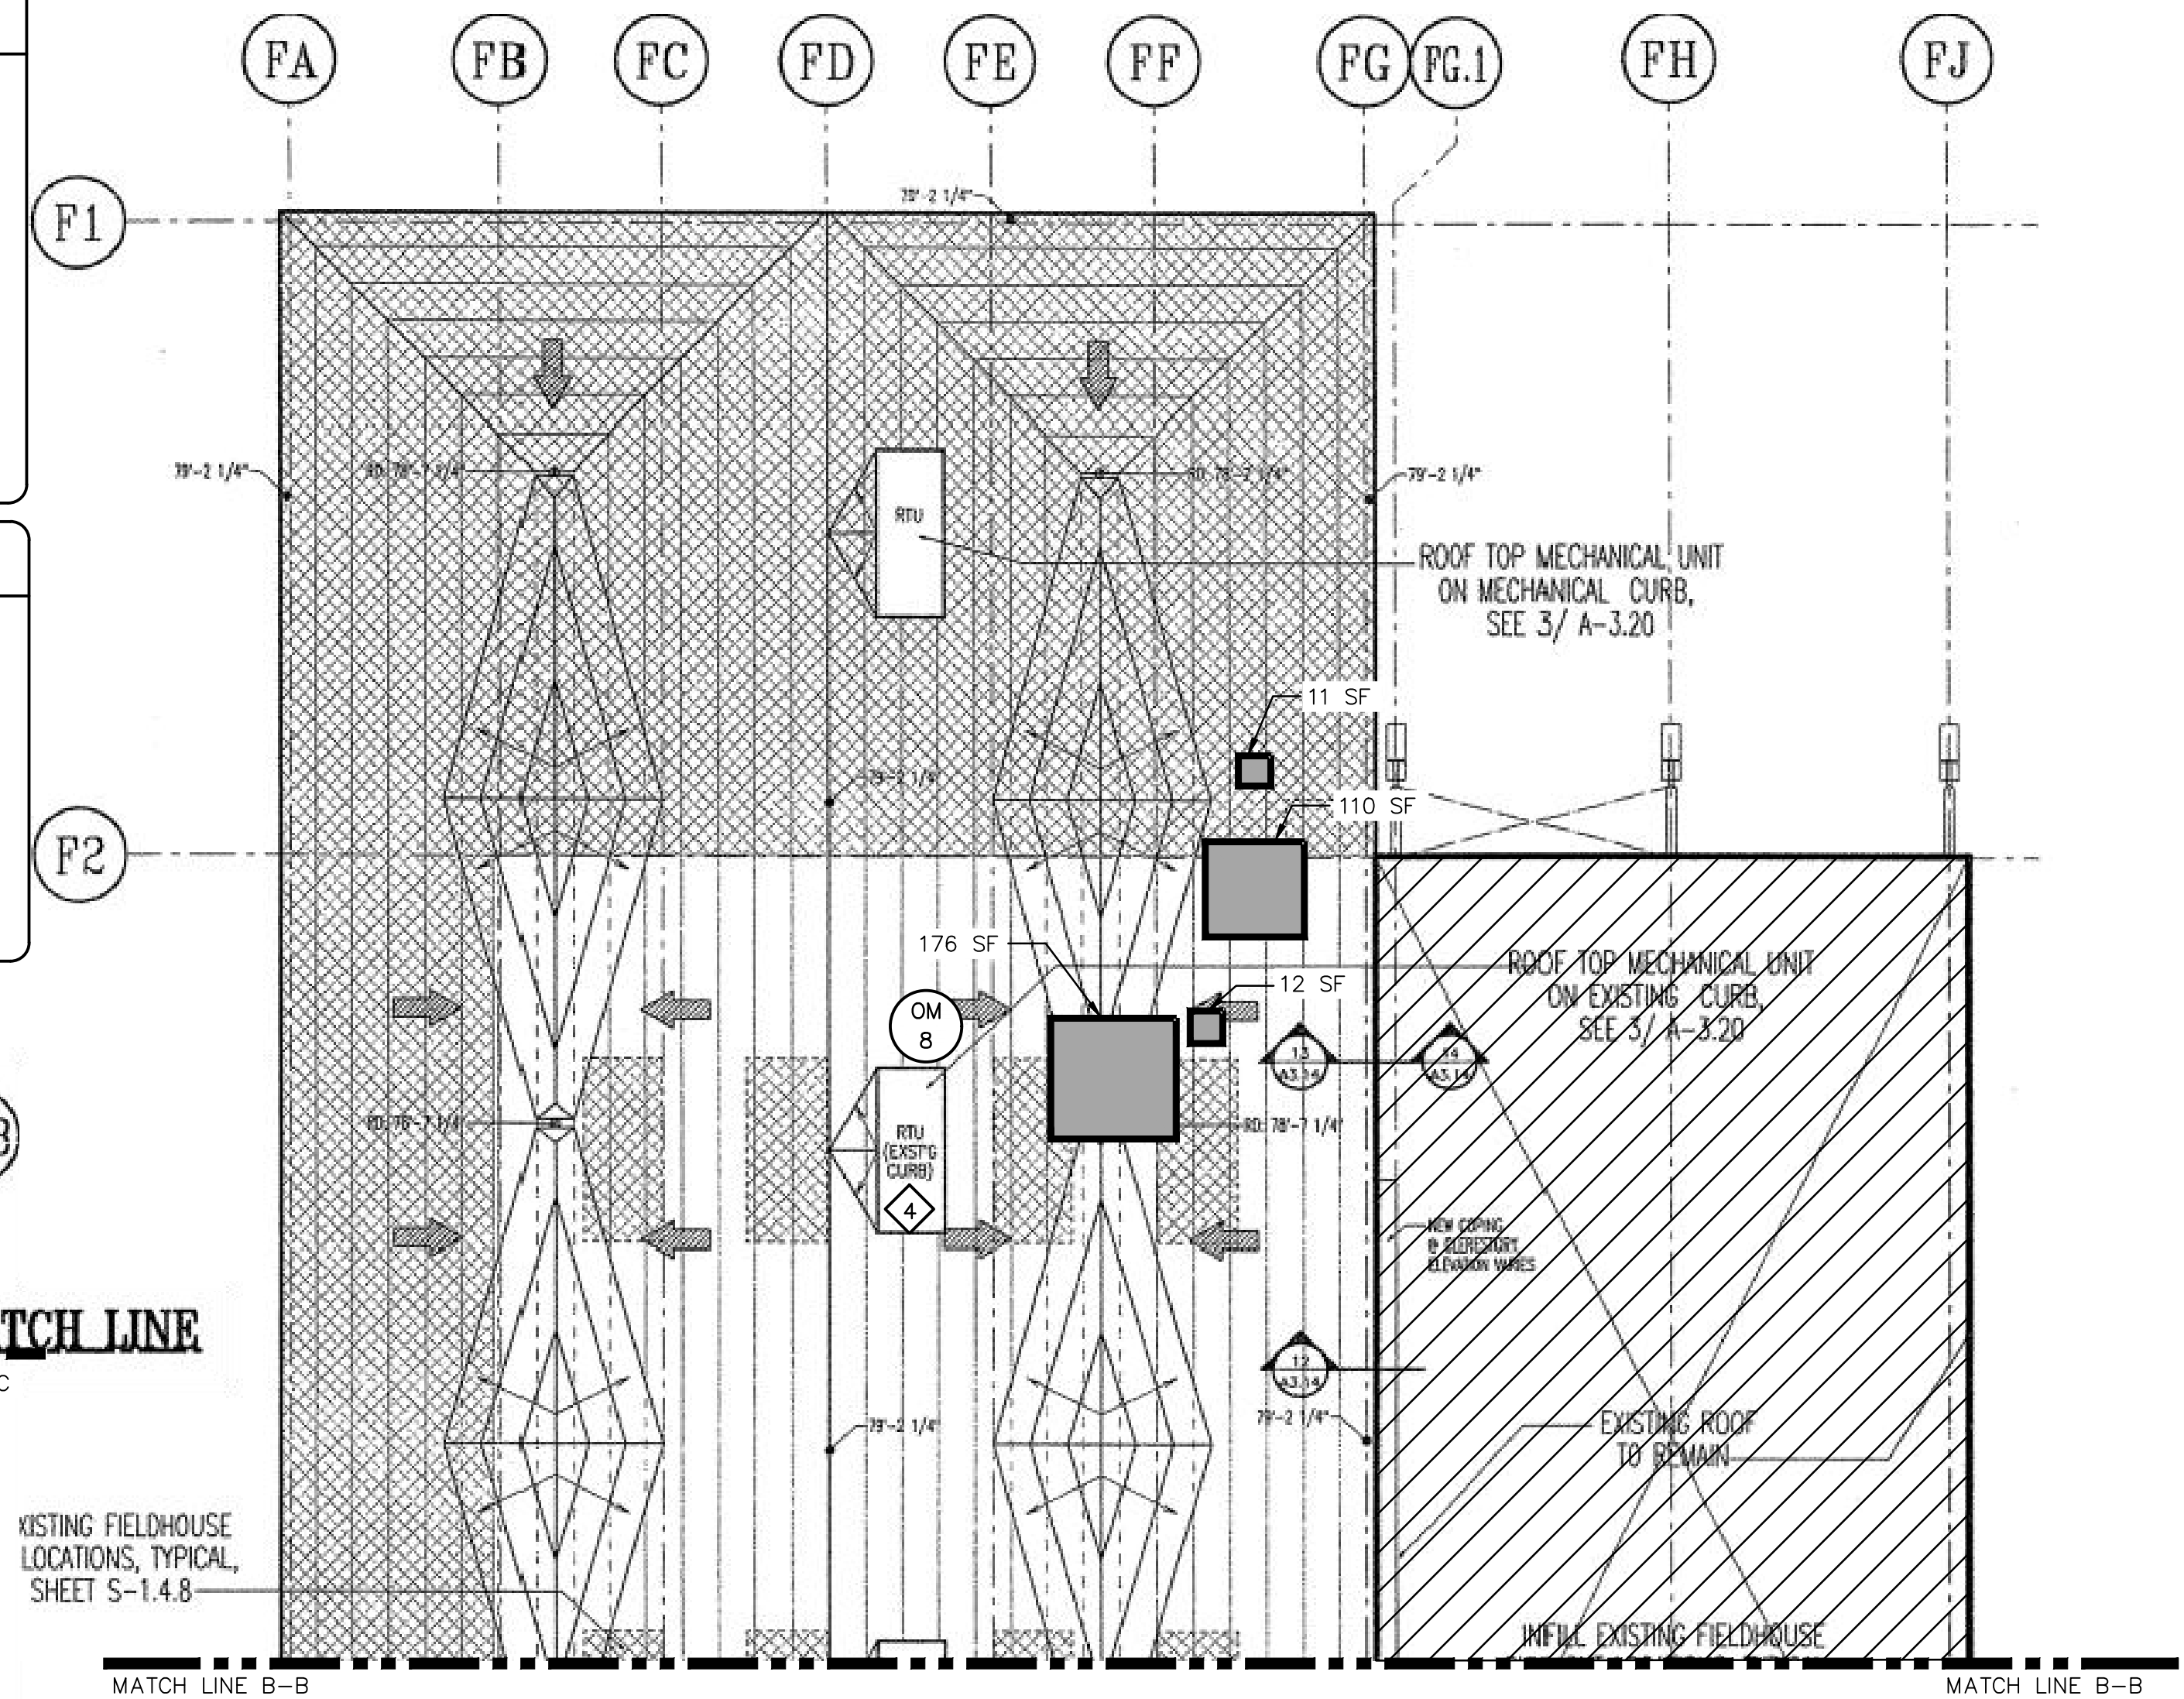
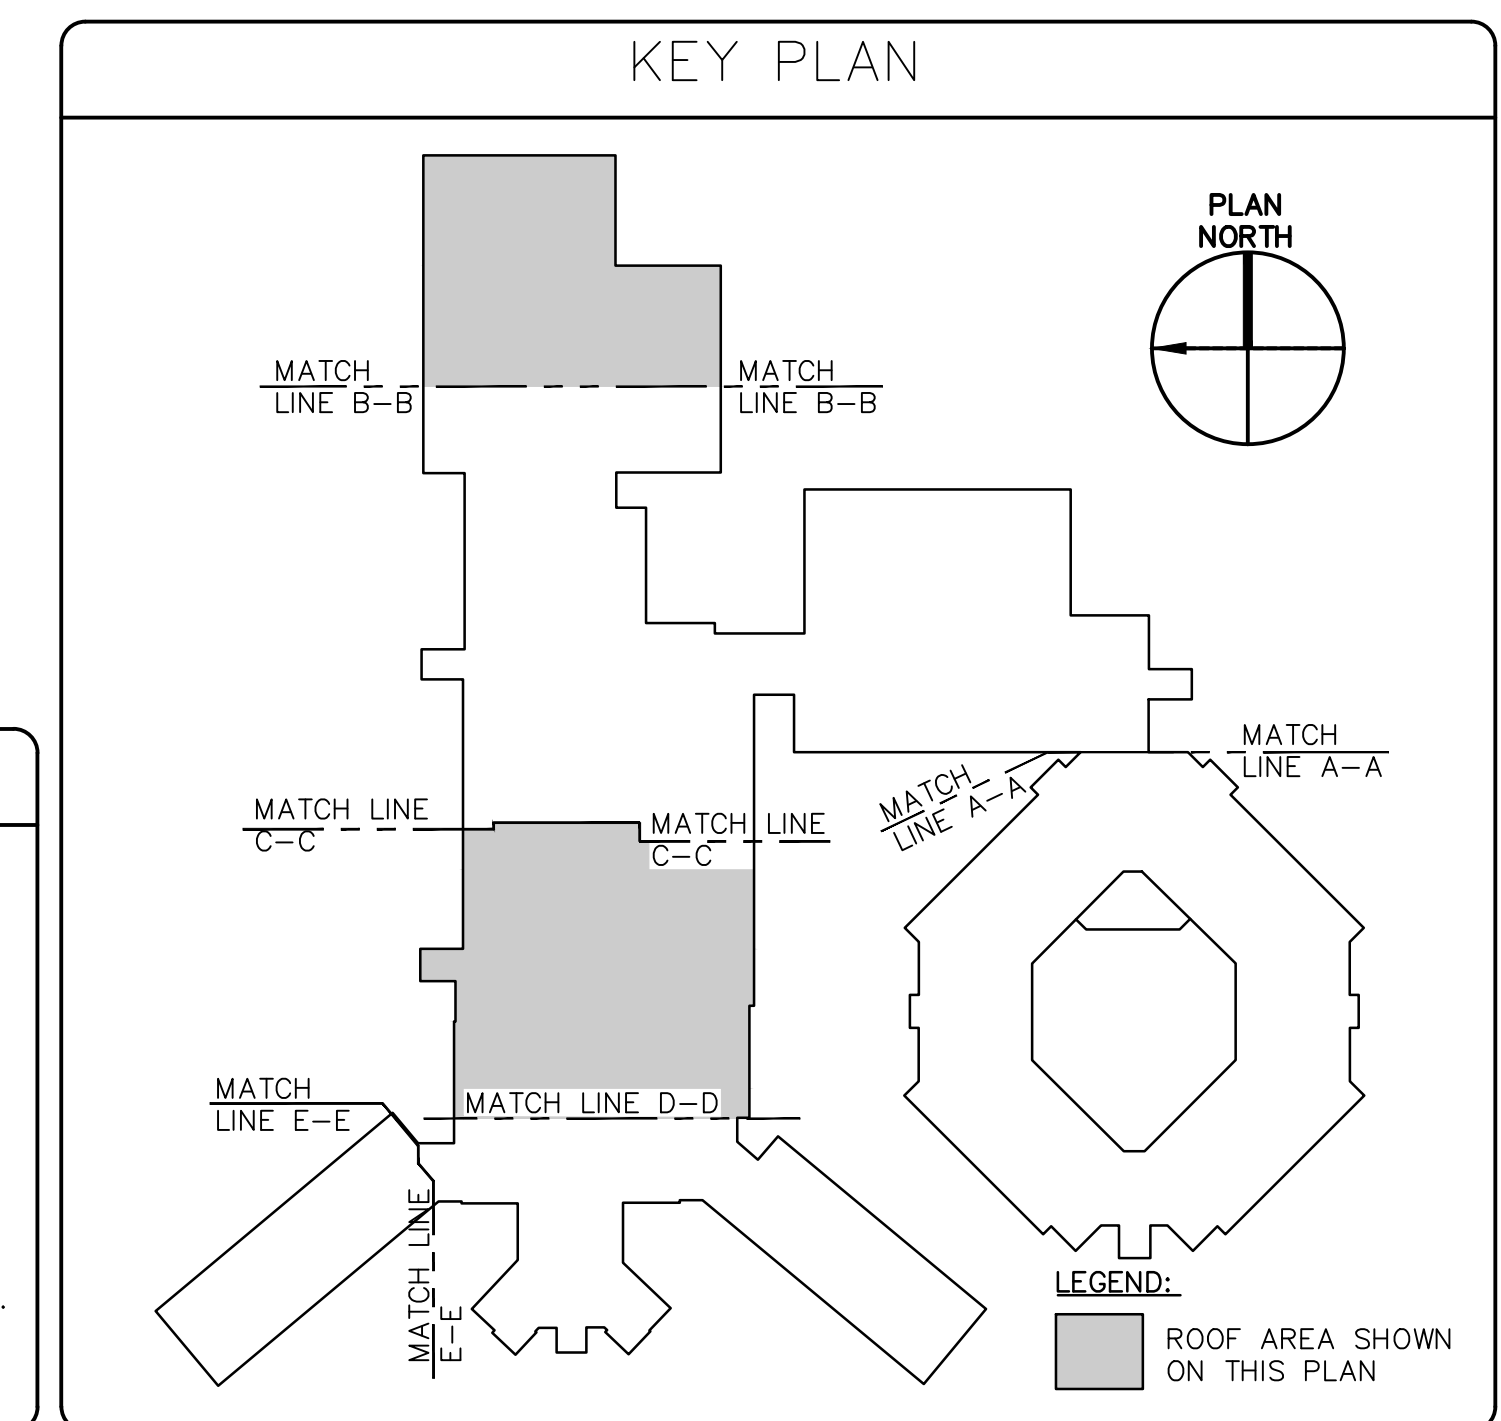
A104

1	DOOR SILL HAS MULTIPLE GAPS IN SILL FLASHING AND ROOFING MEMBRANE.
2	BUBBLED STRIPPING MEMBRANE AT ROOF EDGE; TYPICAL.
3	DOOR HAS 18 LF OF FAILED PERIMETER SEALANT. OPEN GAPS WERE OBSERVED AT THE HEAD OF THE DOOR AND EXPOSED PLYWOOD WAS OBSERVED BEHIND THE DOOR HINGES.
4	SEAL ALL OPEN PENETRATIONS AT MECHANICAL UNITS.
5	THROUGH WALL FLASHING OBSERVED WITH OPEN JOINTS.
6	THROUGH WALL FLASHING OBSERVED IN GOOD CONDITION WITH COUNTERFLASHING AND WEEPS AT 2 FT± O.C.
7	SMOKE HATCHES OBSERVED WITH FAILED WEATHERSTRIPPING AND WITHOUT FULL SEALNT.
8	GLASS BLOCK RISING WALLS WITH THROUGH WALL FLASHING OBSERVED.

NOT ALL LEAK LOCATIONS INCLUDED ON THIS SHEET. REFER TO OTHER SHEETS FOR ADDITIONAL LEAK LOCATIONS.	
9	PREVIOUS LEAK REPORTED. NOT CURRENTLY ACTIVE.
10	PREVIOUS LEAK REPORTED. NOT CURRENTLY ACTIVE.
11	ACTIVE LEAK REPORTED. LEAK IS POTENTIALLY RELATED TO ROOF DRAIN LEADER.
12	ACTIVE LEAK REPORTED ALONG RISING WALL STAINING VISIBLE ALONG LENGTH OF WALL. LEAK TYPICALLY REPORTED WITH WIND-DRIVEN RAIN.
