# MASCONOMET REGIONAL SCHOOL DISTRICT CAPITAL ASSET ASSESSMENT

20 Endicott Road  
Boxford, MA 01921

January 31, 2017  
JN 1607.00

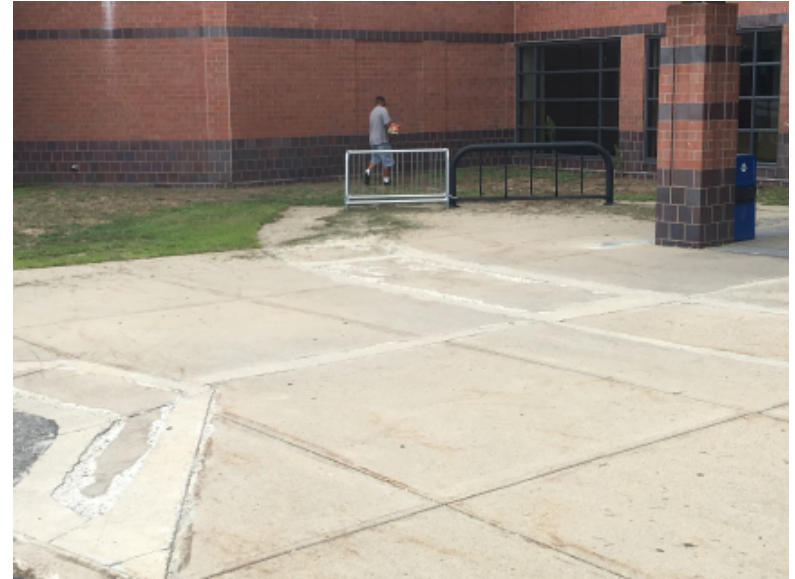
**Photo A1 - Concrete Walks**

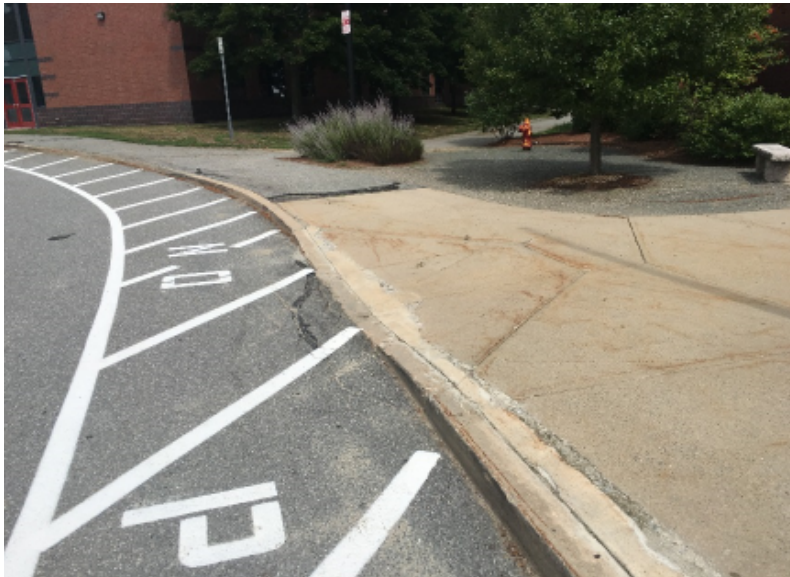
**Photo A2 - Accessible Curb Cuts/Bituminous Walks**

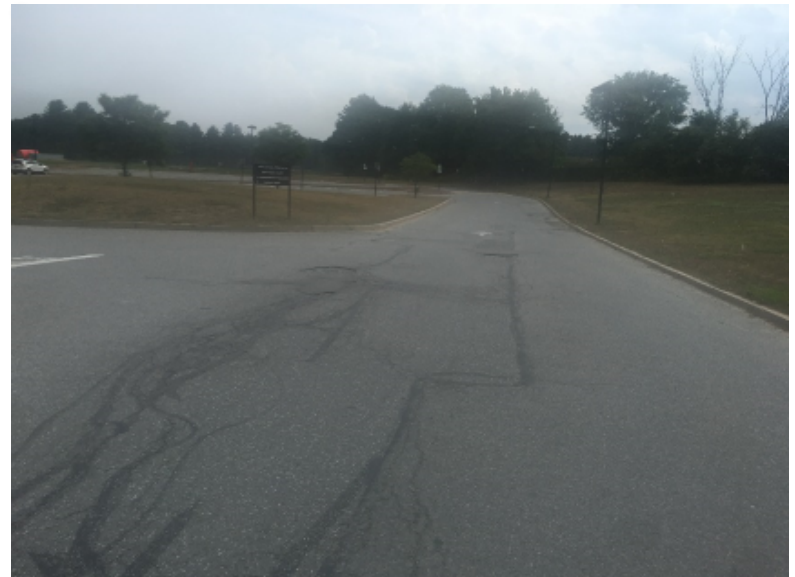
**Photo A3 - Parking Lot Paving**

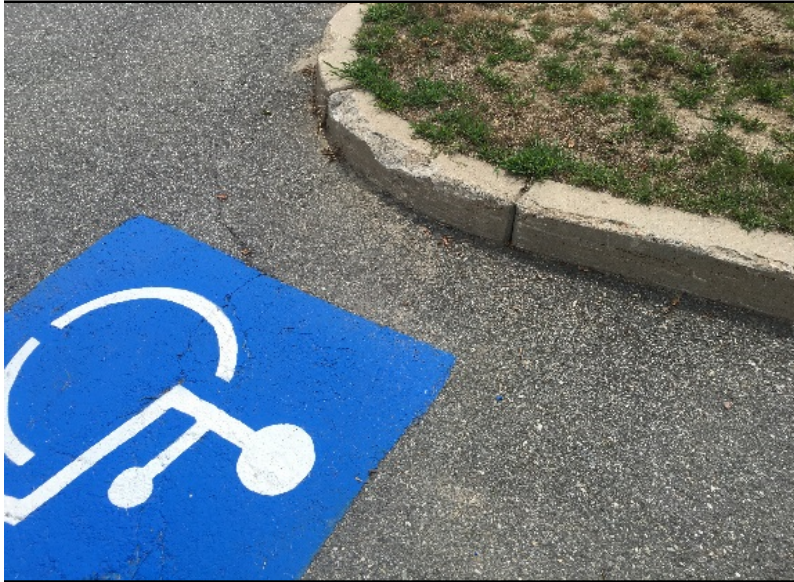
Photo A4 - Parking Lot Curbing

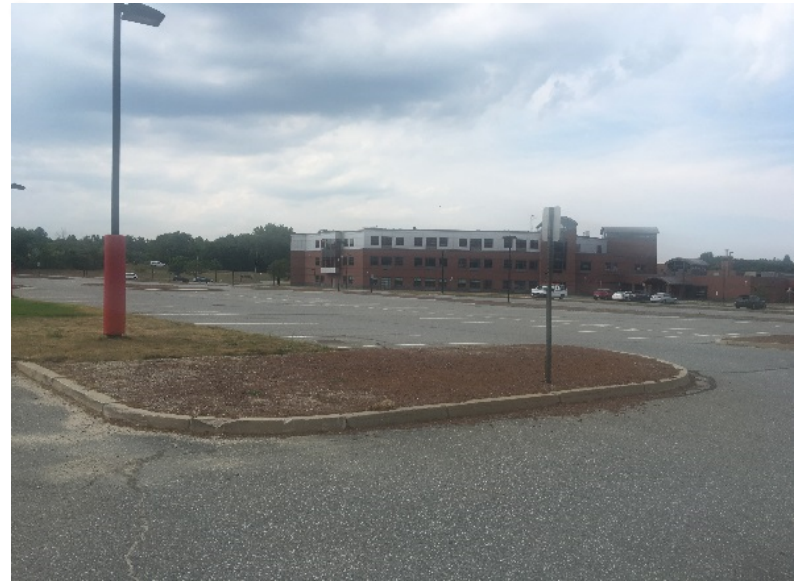
Photo A5 - Parking Lot Island

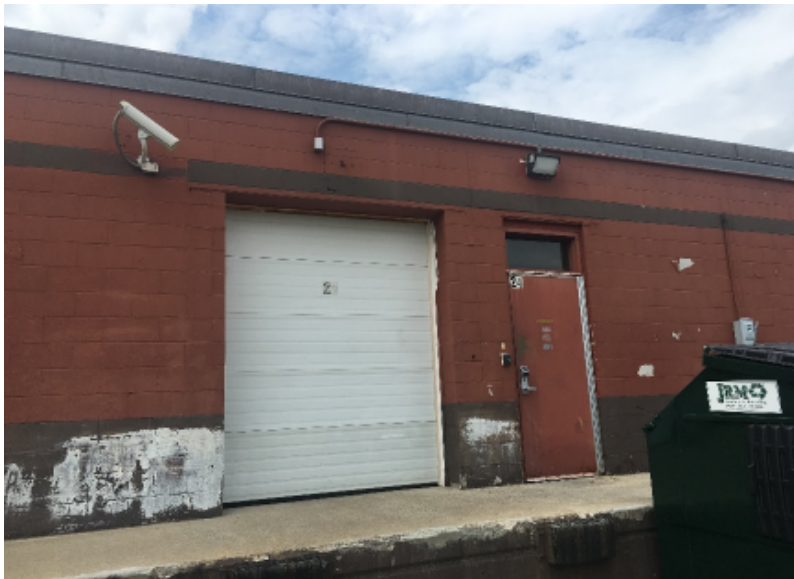
Photo A6 - Loading Dock

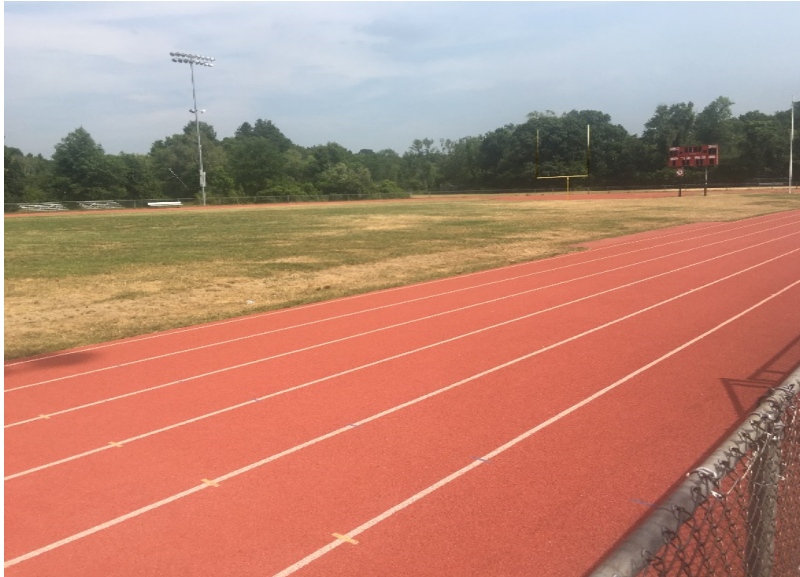
**Photo B1 - Football Field and Track**

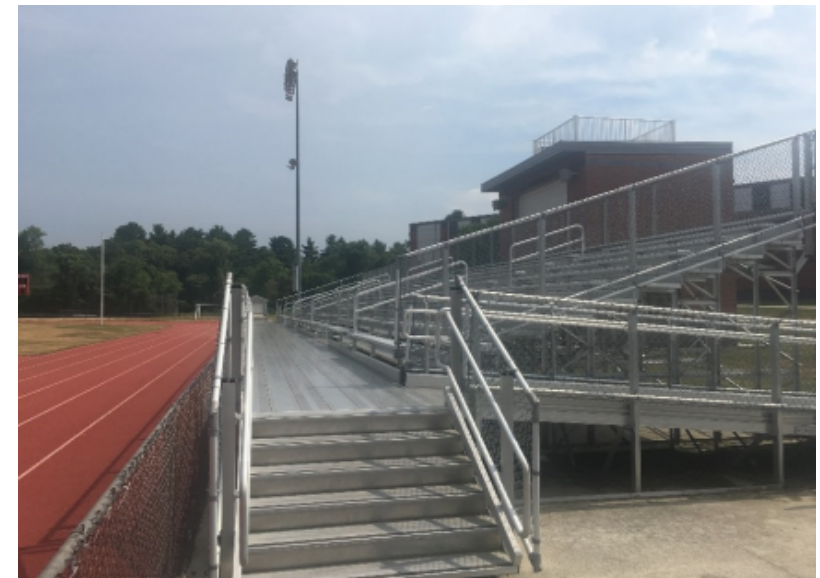
**Photo B4 - Bleachers**

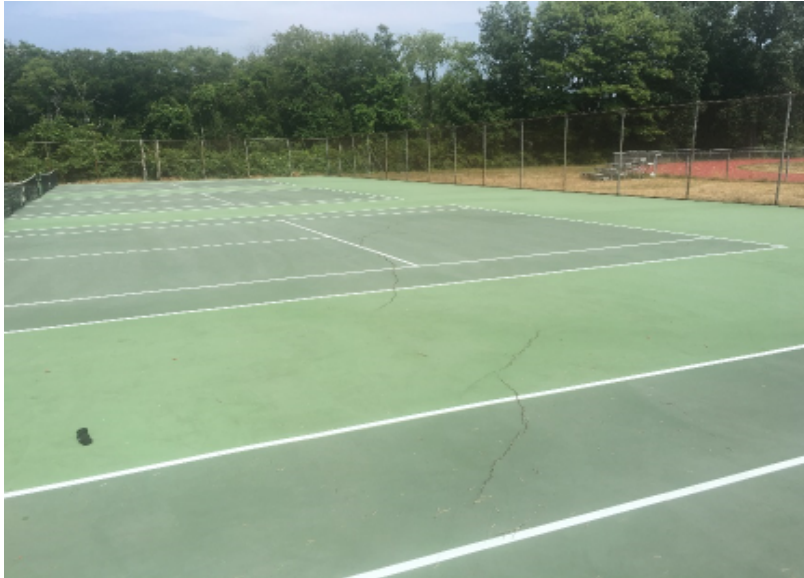
**Photo B5 - Tennis Courts**

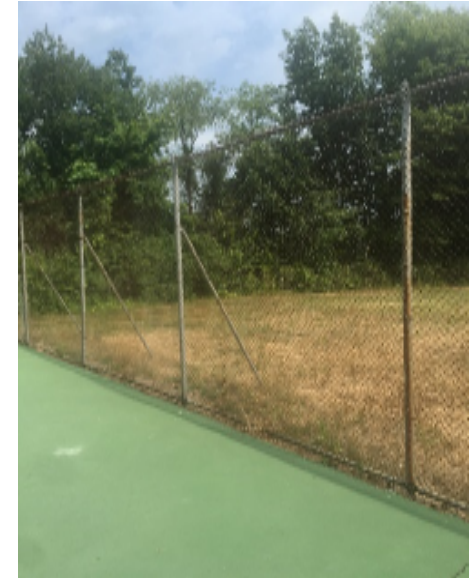
**Photo B6 - Tennis Court Fencing**

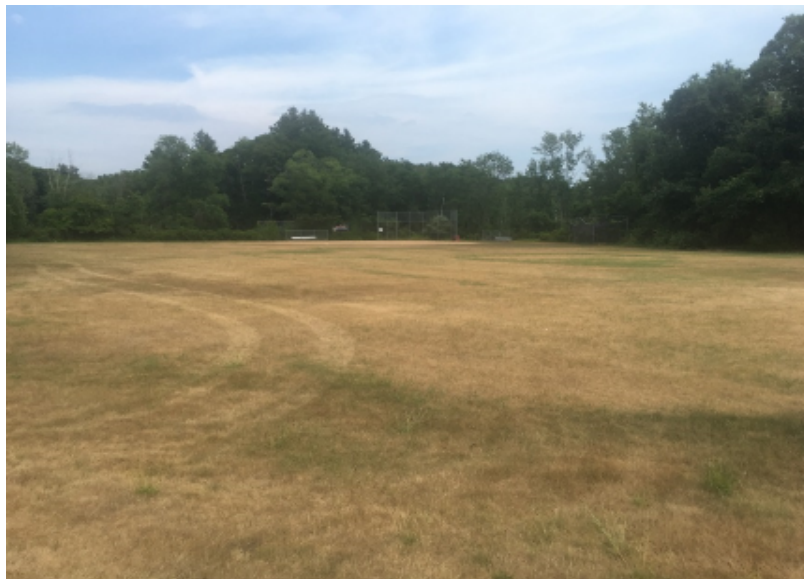
**Photo B7 - Softball Field**

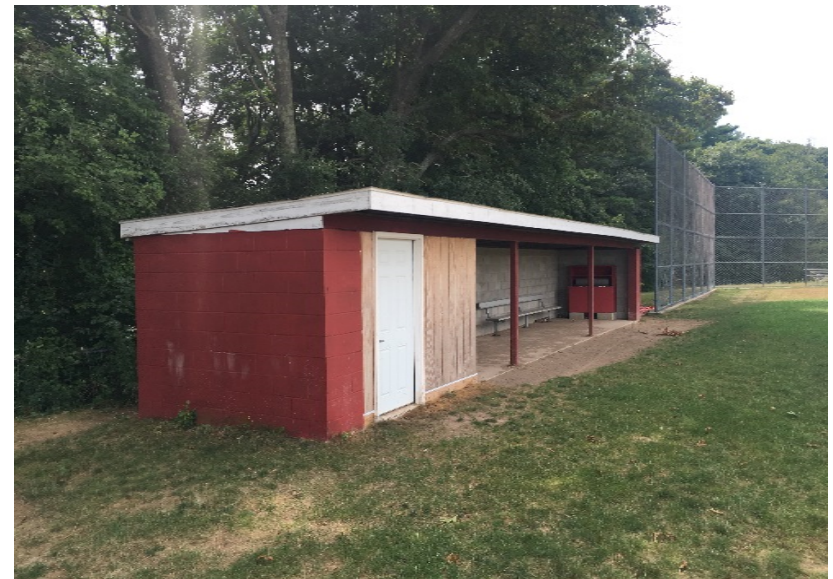
**Photo B8 - Dugout**

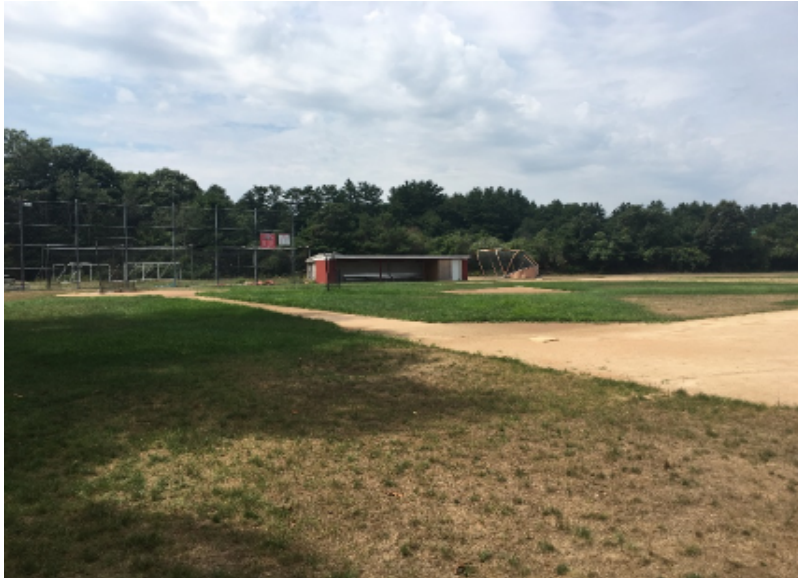
**Photo B9 - Baseball Infield**

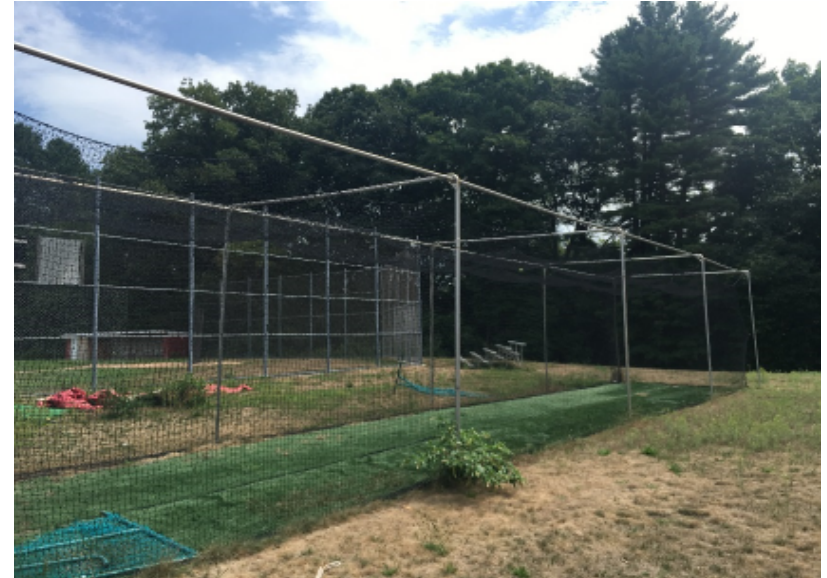
**Photo B10 - Batting Cage**

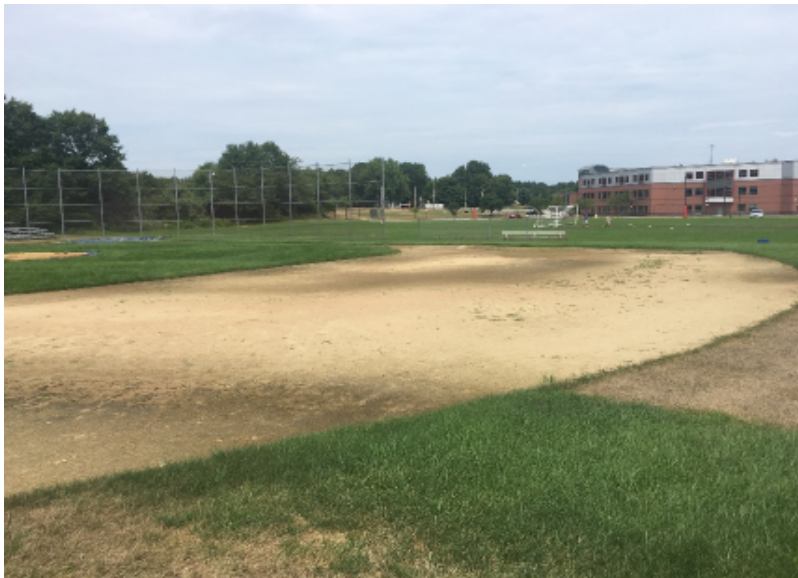
**Photo B11 - Baseball Infield**

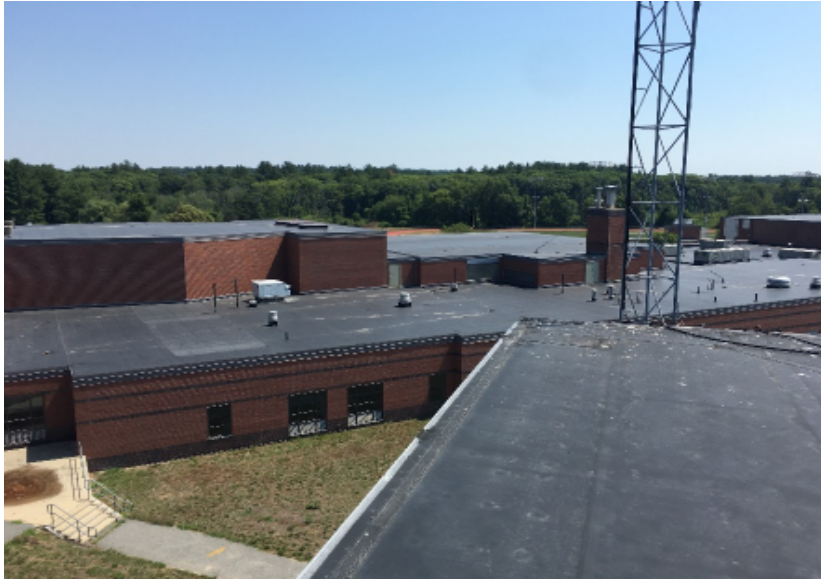
**Photo C1 - EDPM Roof**

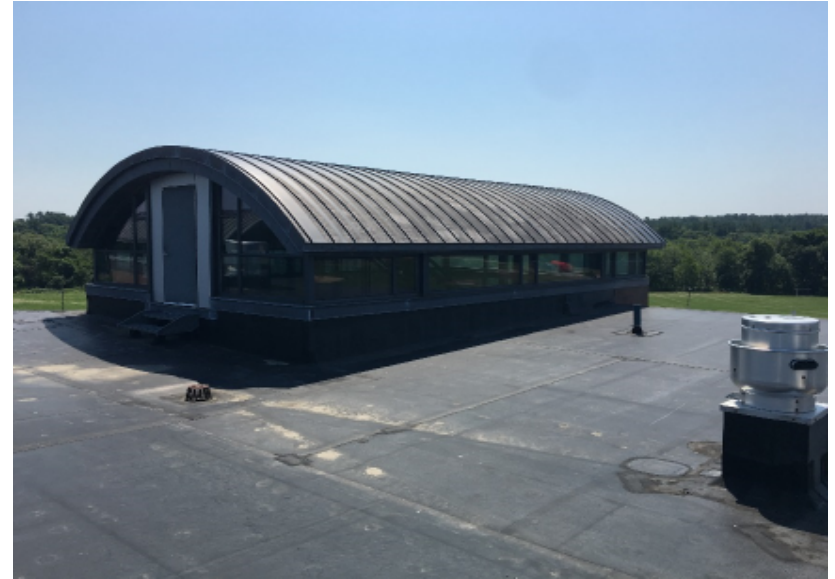
**Photo C2 - Lead Coated Copper (Metal) Roofing**

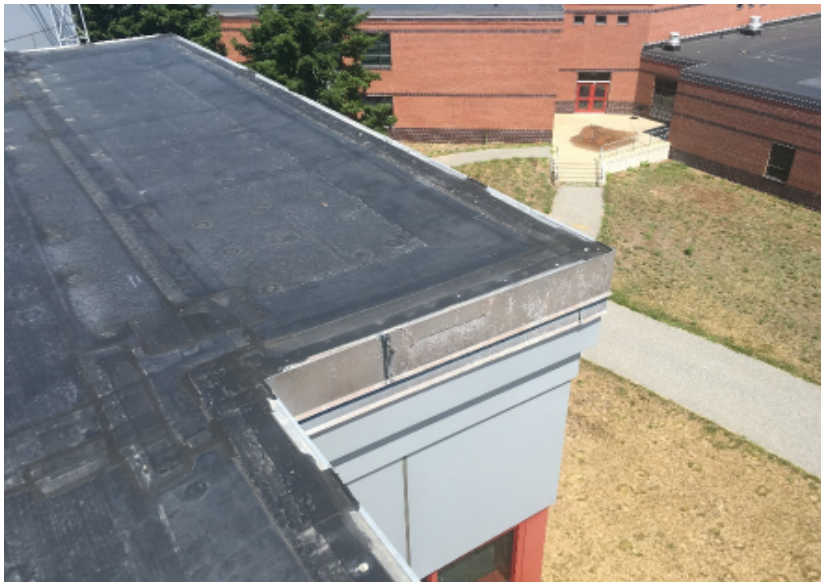
**Photo C3 - Metal Gravel Stop**

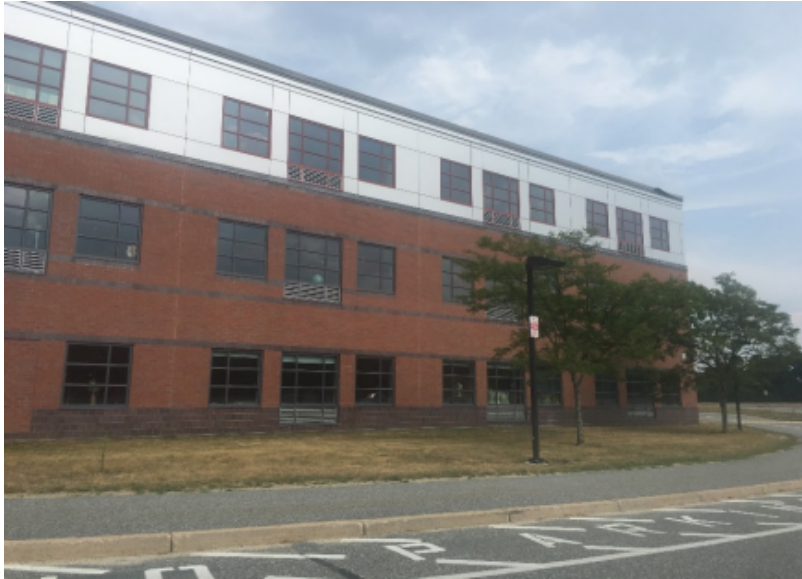
Photo C5 - Typical Exterior

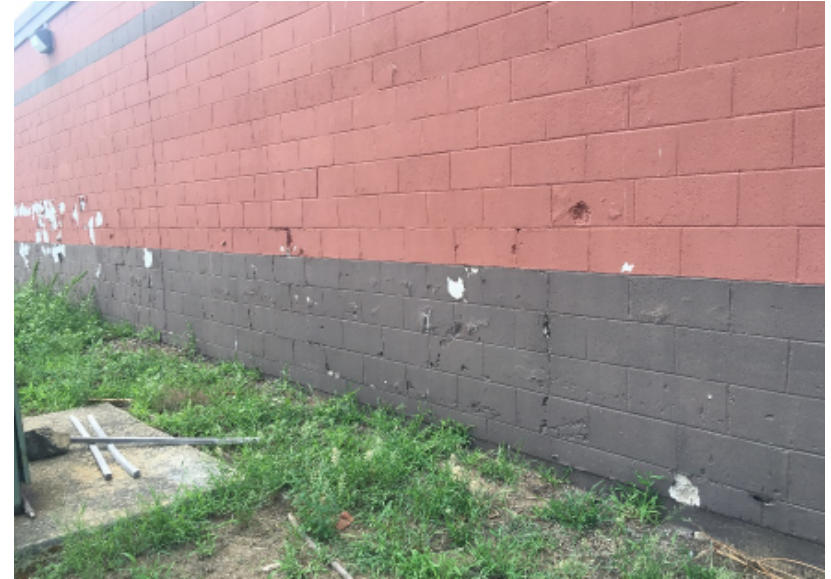
Photo C6 - CMU at Exterior

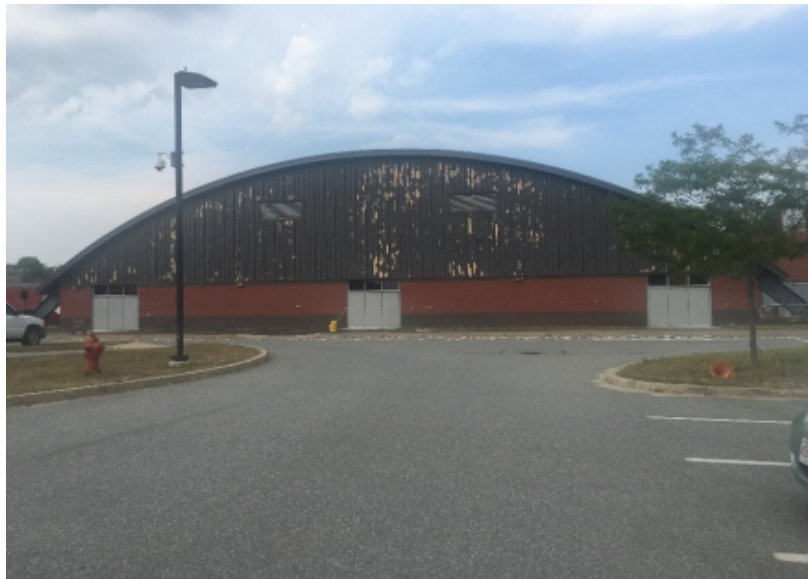
Photo C7 - Metal Wall Panel

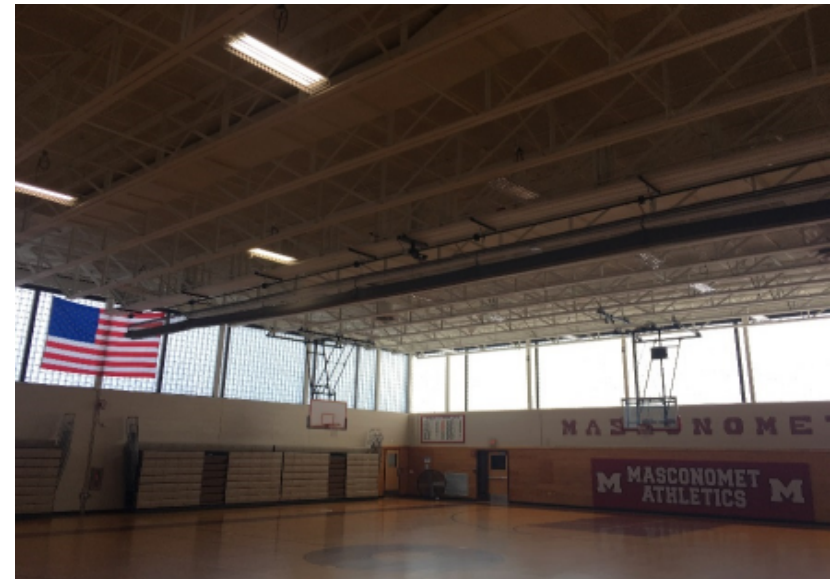
Photo C8 - Glass Block @ Gymnasium

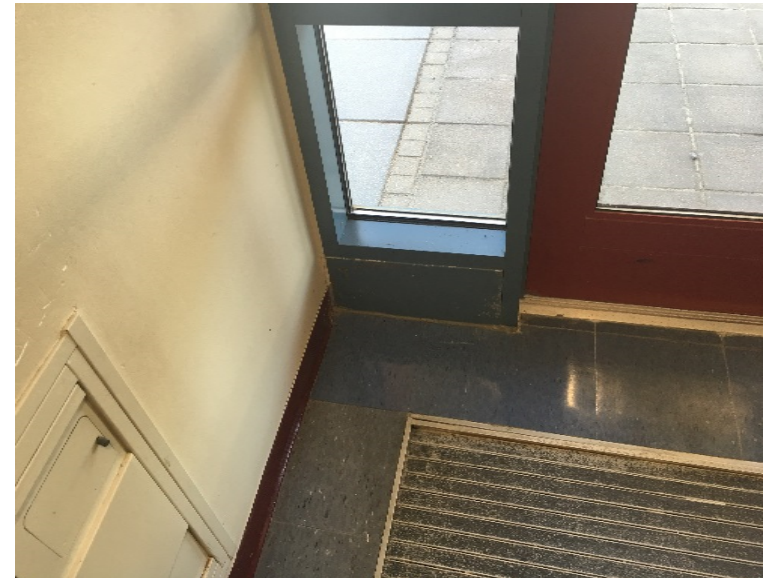
**Photo C10 - Entrances**

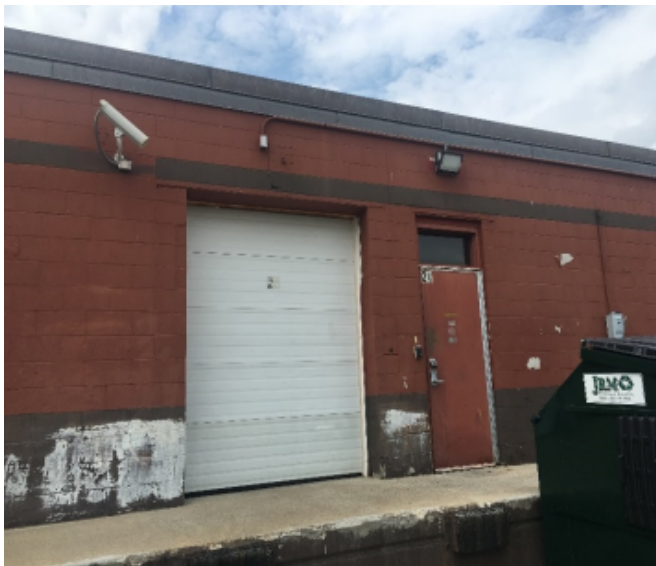
**Photo C11 - Exterior Overhead and Hollow Metal Doors**

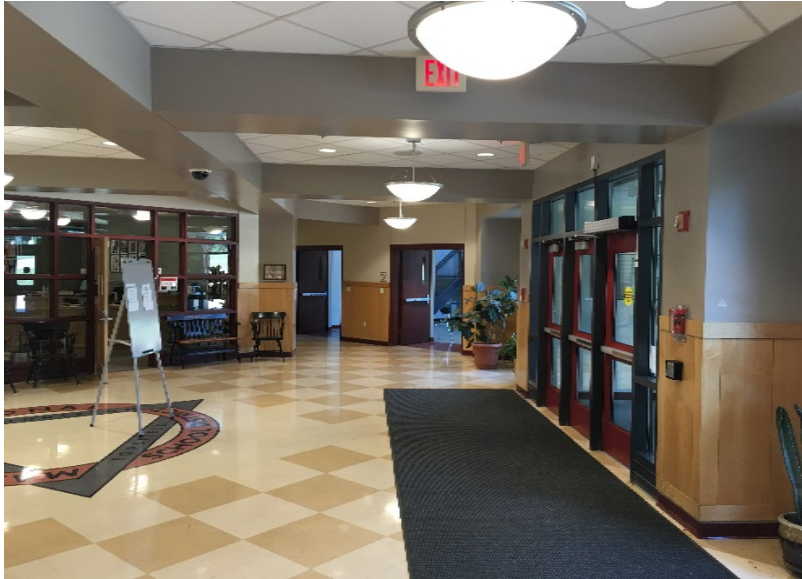
Photo D1 - Interior

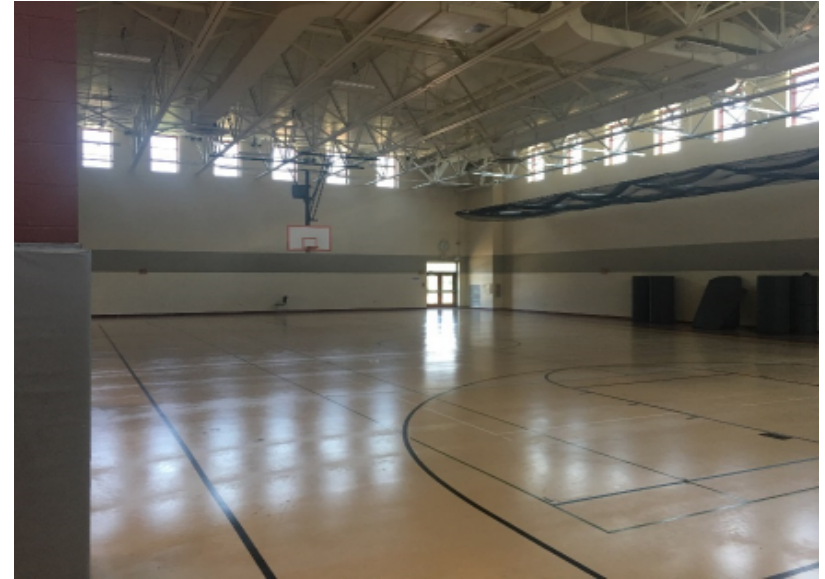
Photo D2 - Acoustical Metal Deck

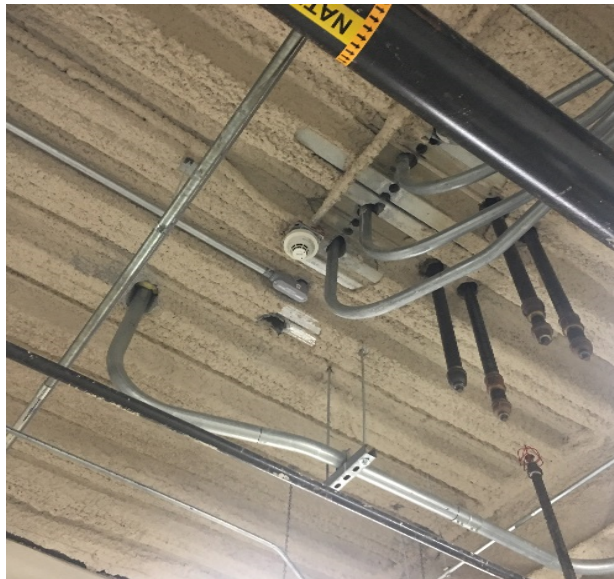
Photo D3 - Exposed Metal Deck

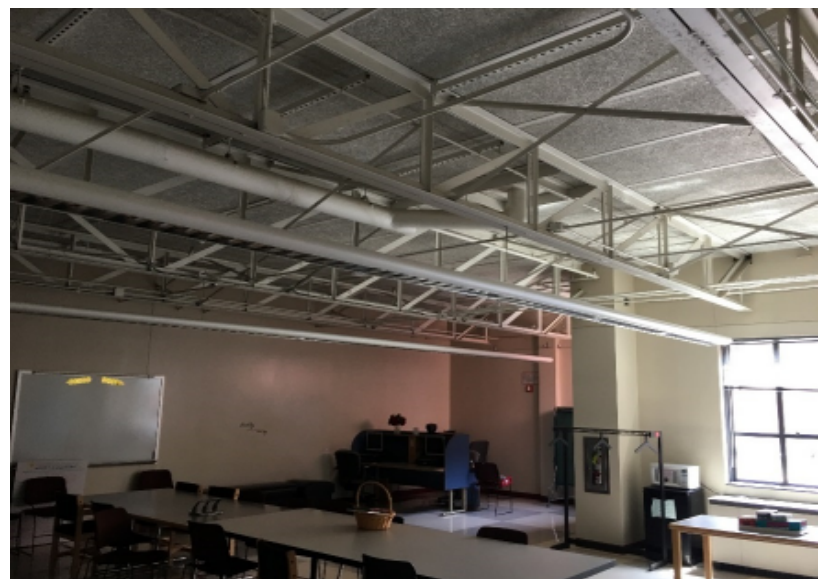
Photo D4 - Tectum Deck

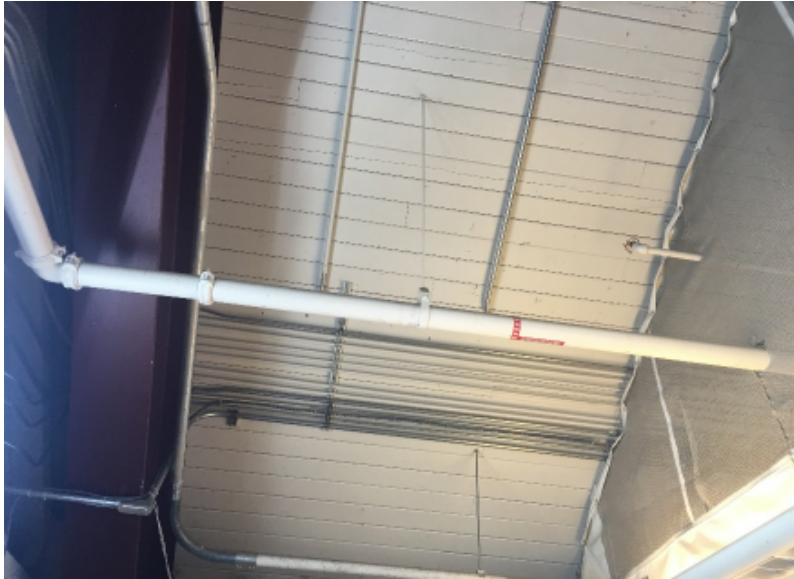
**Photo D5 - Exposed Wood Deck**

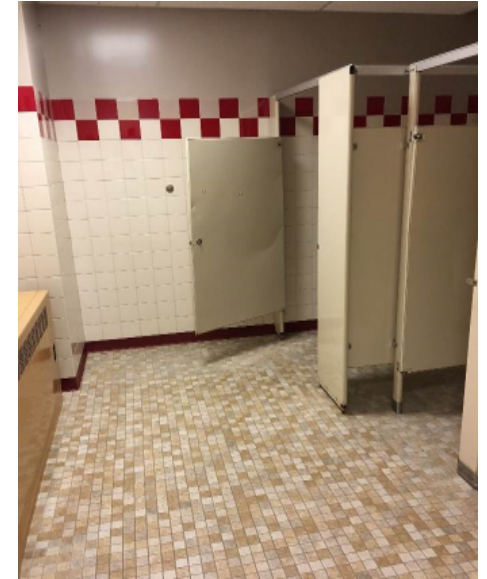
**Photo D6 - Ceramic Tile Wall and Floor**

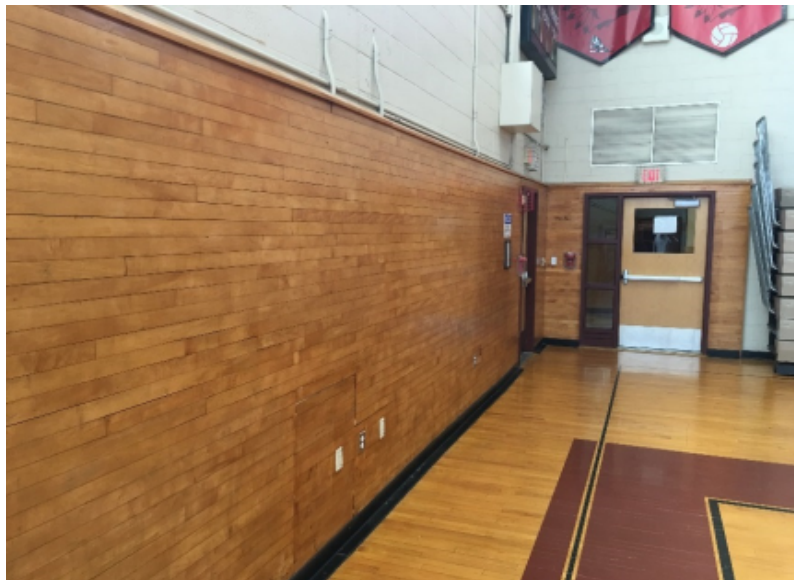
**Photo D7 - Wood Strip Cladding**

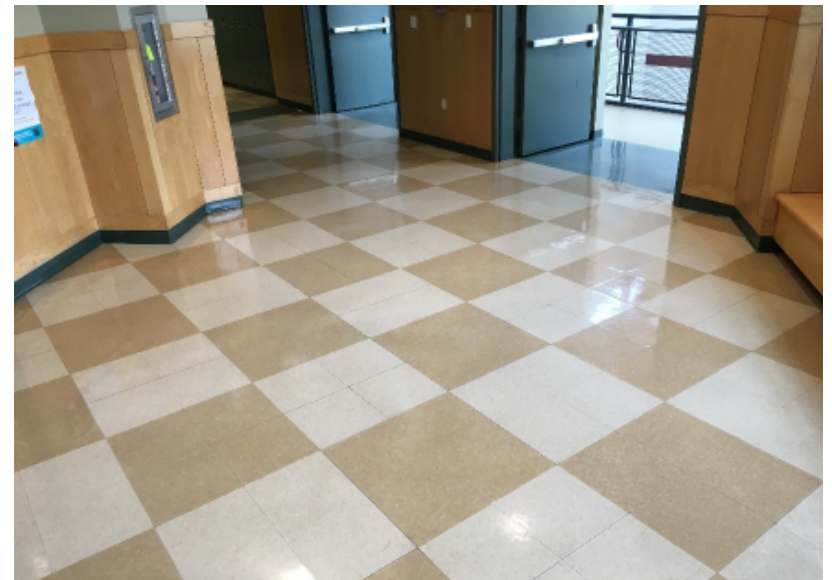
**Photo D8 - VCT**

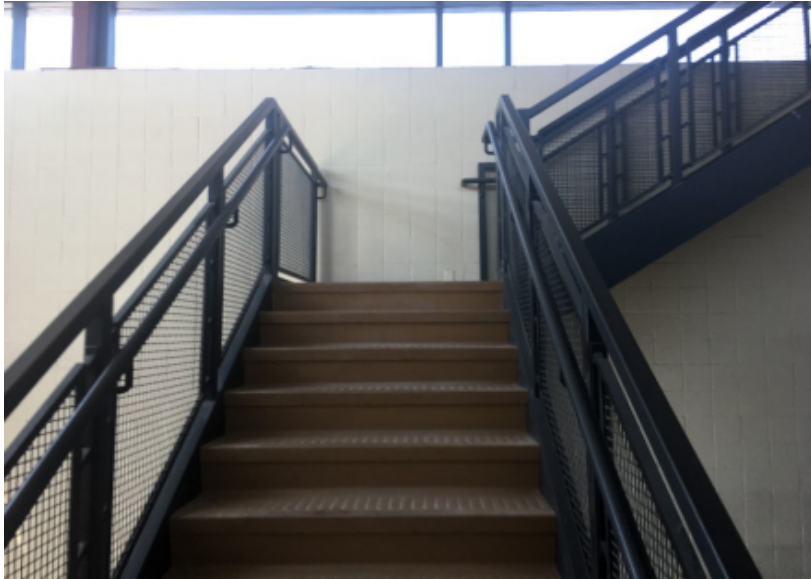
Photo D9 - Rubber Tile

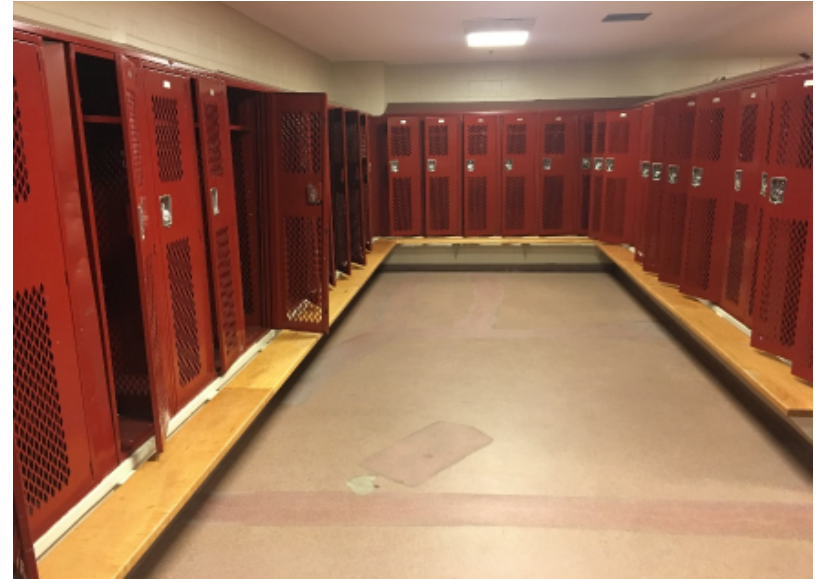
Photo D10 - Locker Rooms / Epoxy Flooring

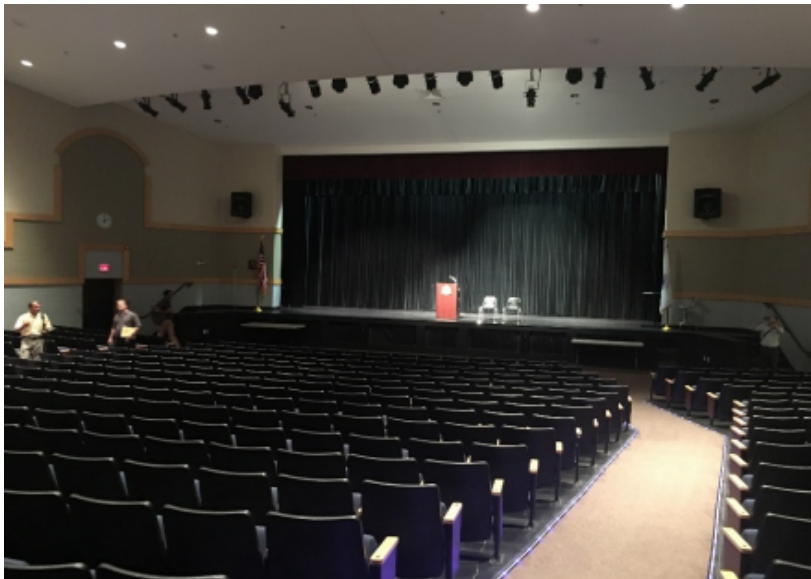
Photo D11 - Auditorium Carpet

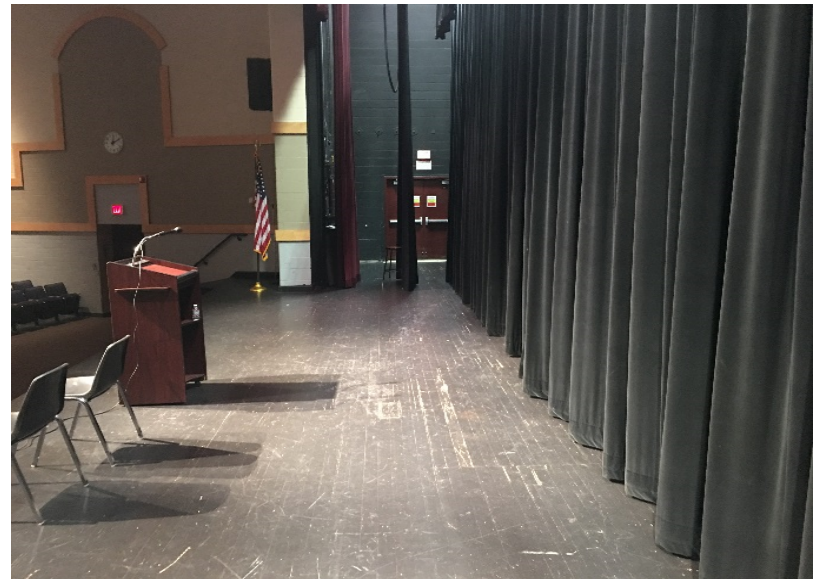
Photo D12 - Stage Flooring

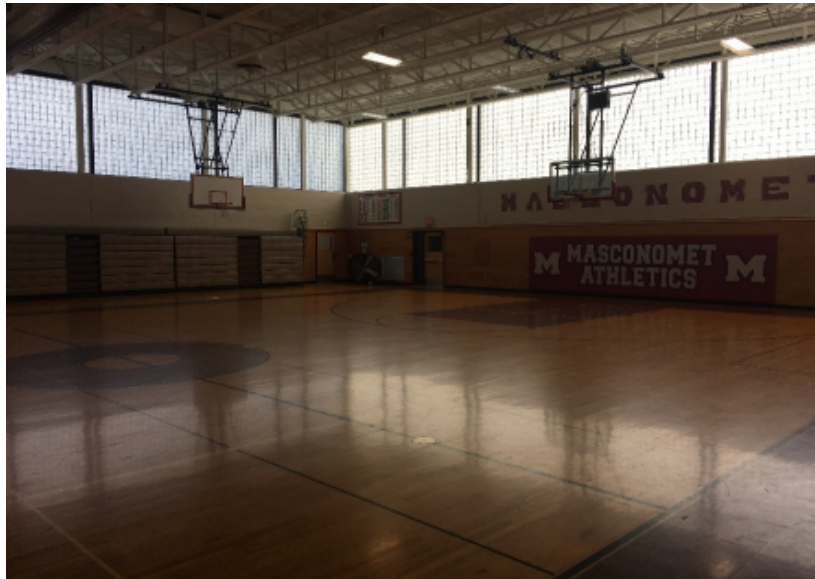
Photo D13 - Gymnasium Wood Flooring

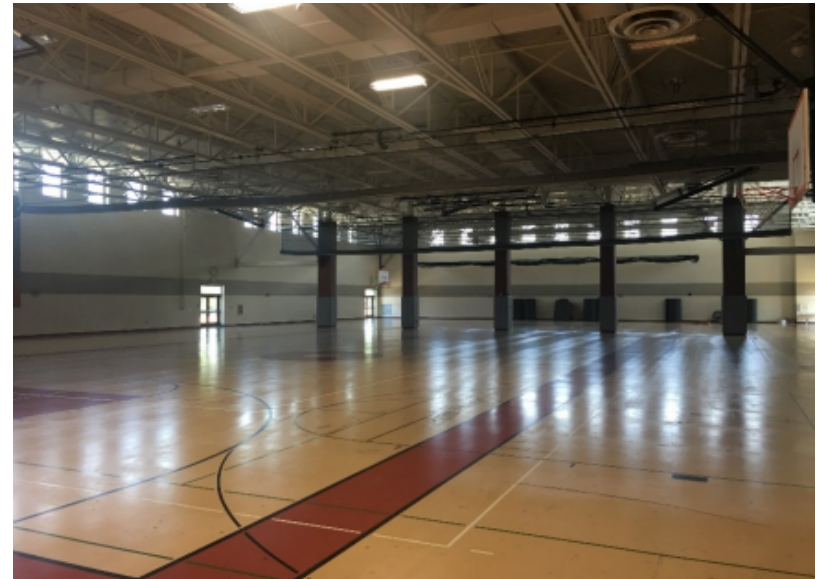
Photo D14 - Synthetic Gym Flooring

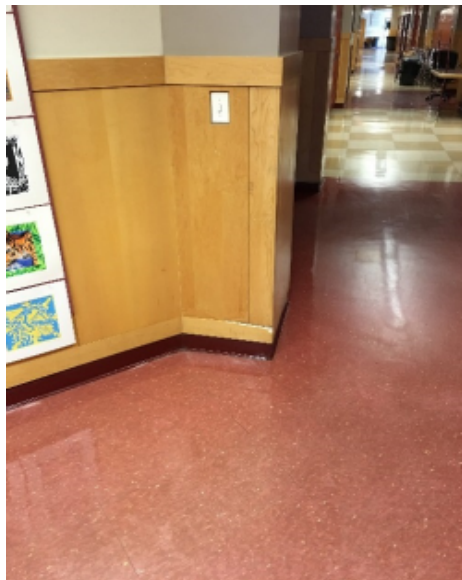
Photo D15 - Wood Wainscot

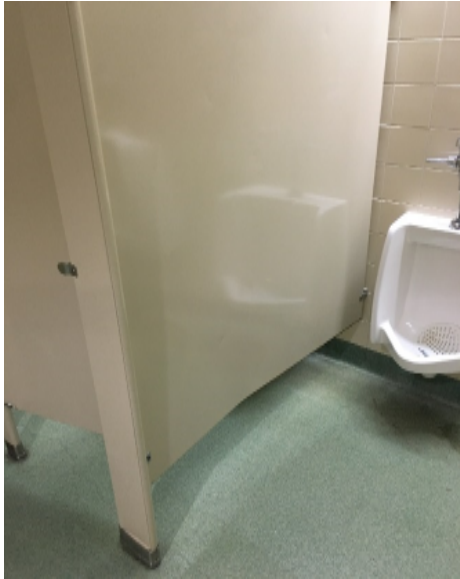
**Photo D17 - Toilet Partitions**

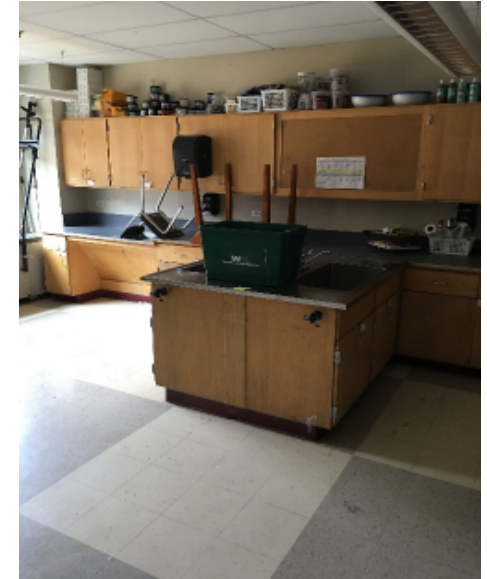
**Photo D18 - Casework**

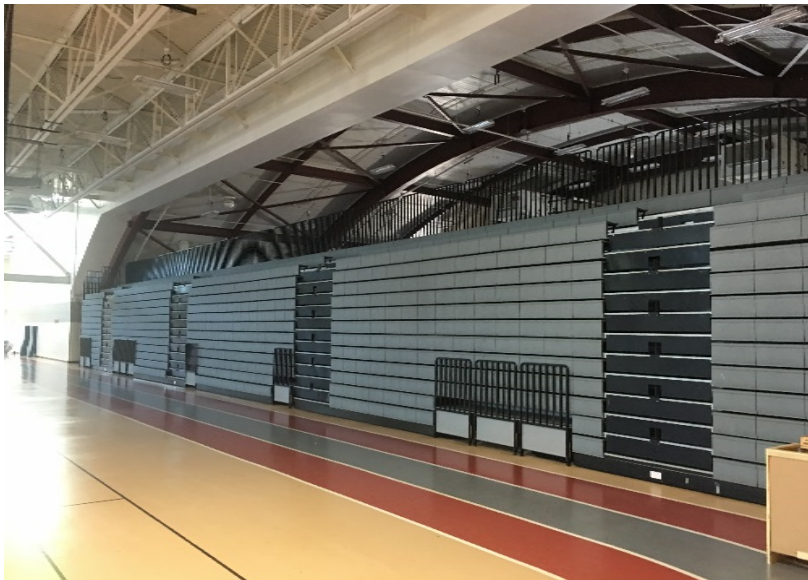
**Photo D19 - Bleachers**

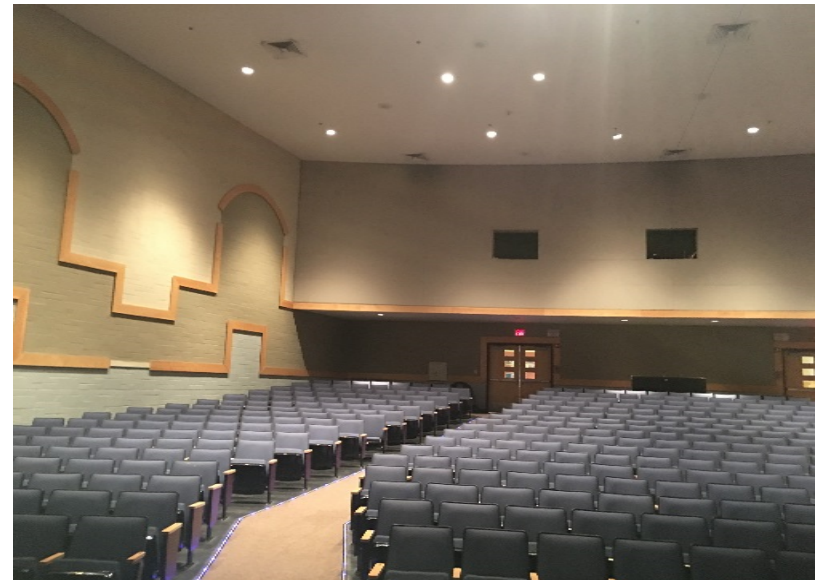
**Photo D20 - Auditorium Seating**

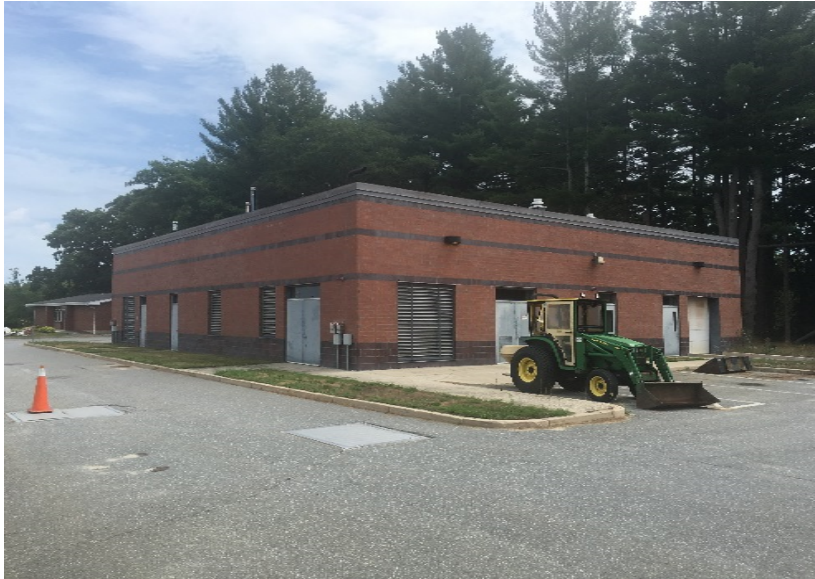
**Photo E1 - Sewage Treatment**

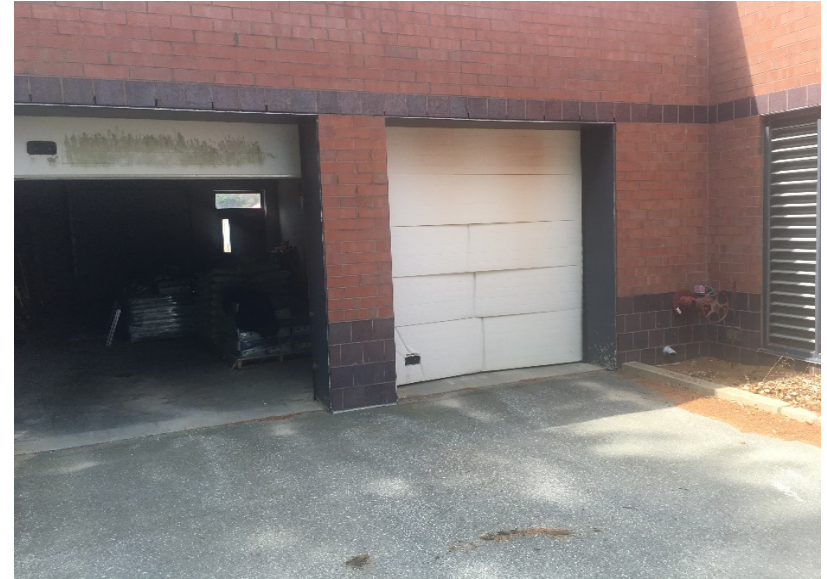
**Photo E2 - Exterior Openings**

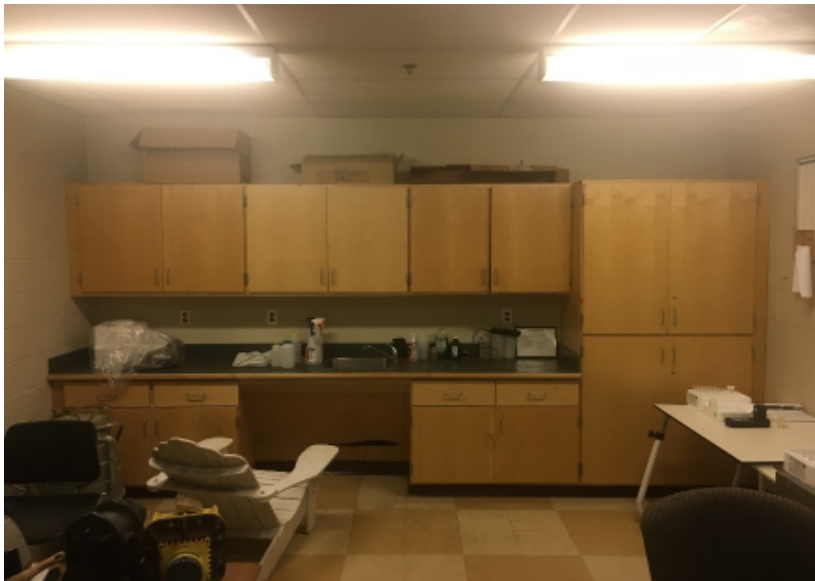
**Photo E3 - Interior**

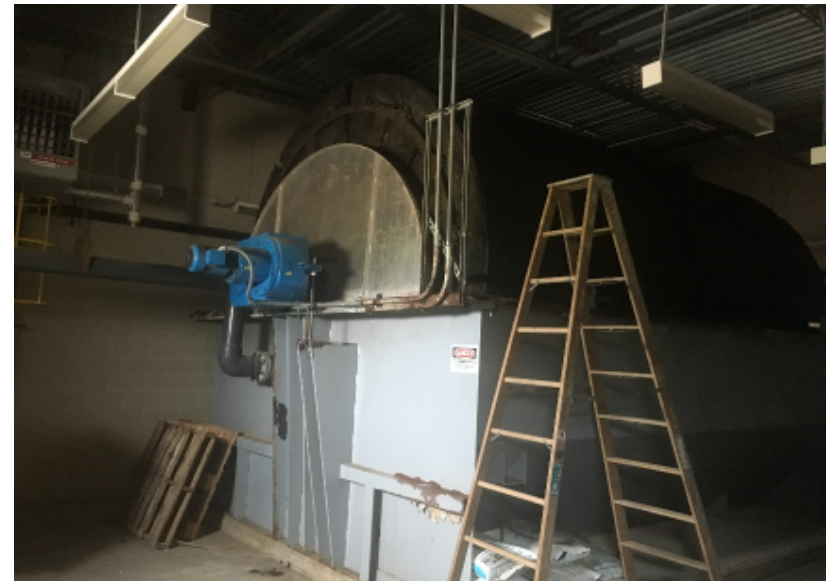
**Photo E4 - Treatment Equipment**

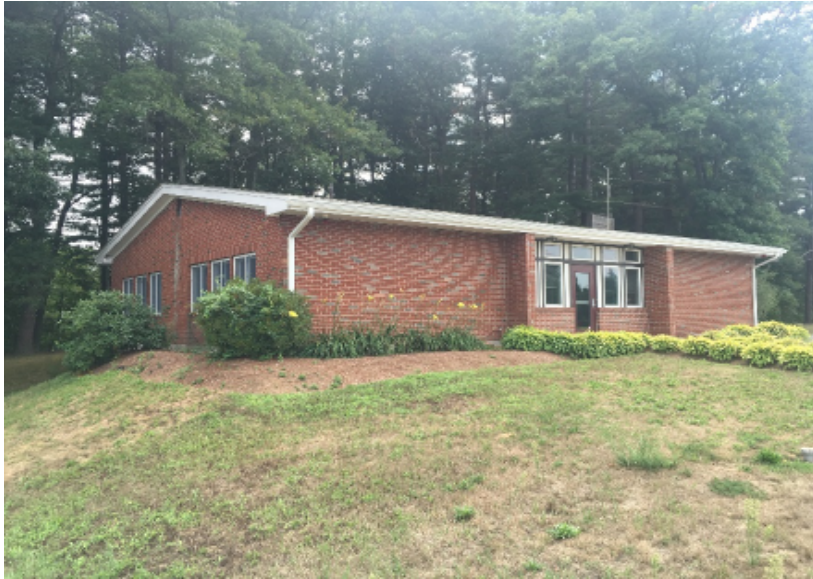
Photo F1 - Central Business Office

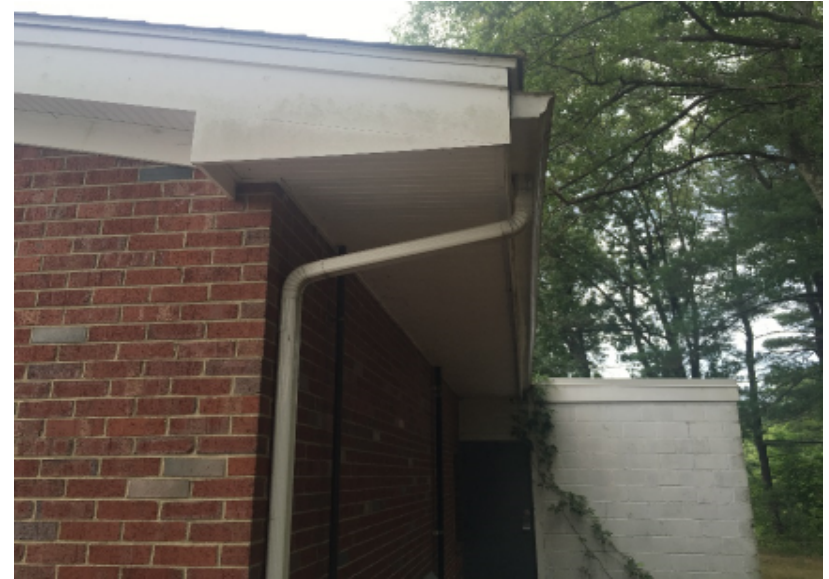
Photo F2 - Exterior Openings

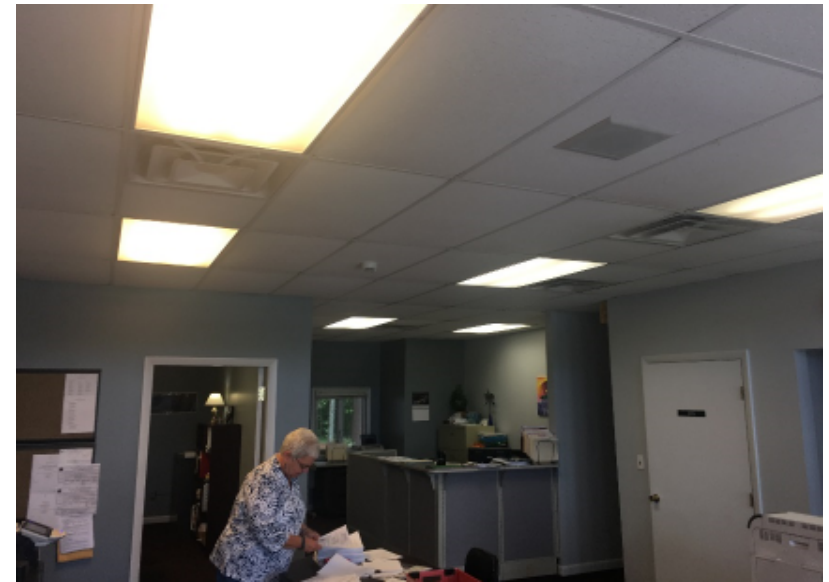
Photo F4 - Interior

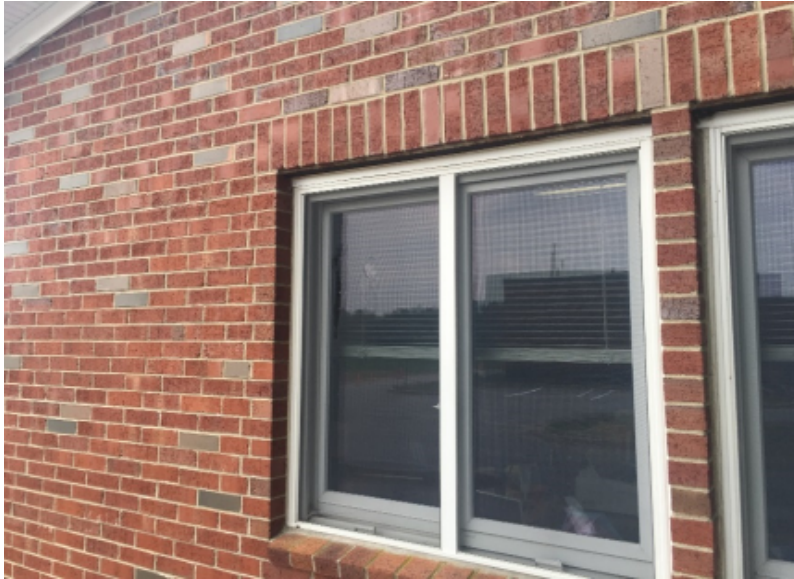
**Photo F5 - Windows**
