# MASCONOMET REGIONAL SCHOOL DISTRICT CAPITAL ASSET ASSESSMENT

20 Endicott Road  
Boxford, MA 01921

January 31, 2017  
JN 1607.00

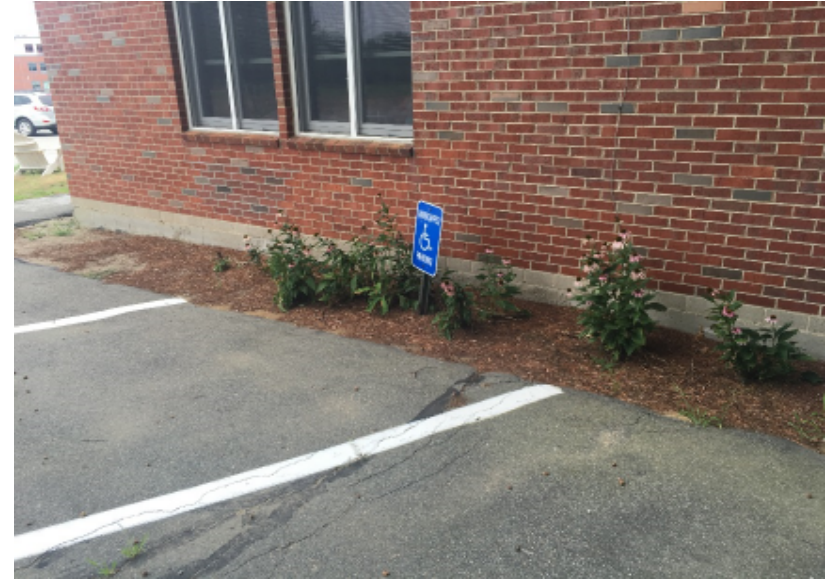
**Photo F6 - Accessible Parking**

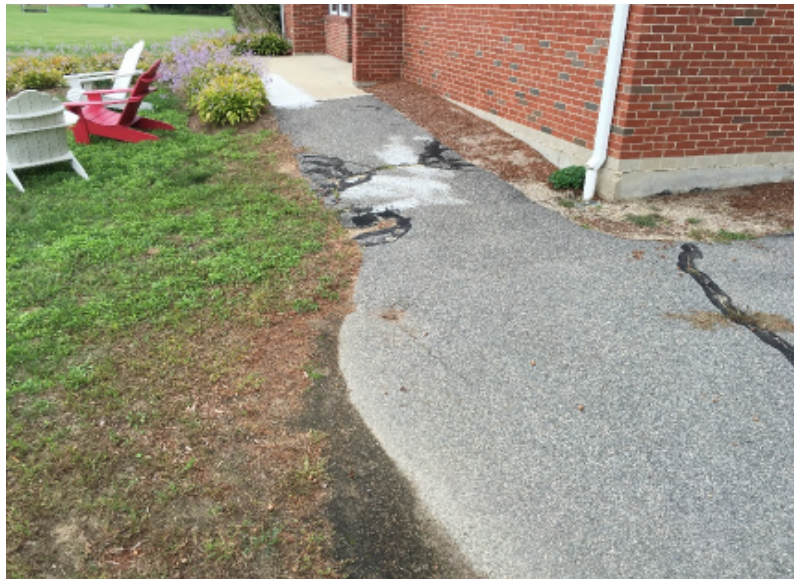
**Photo F7 - Sidewalks**

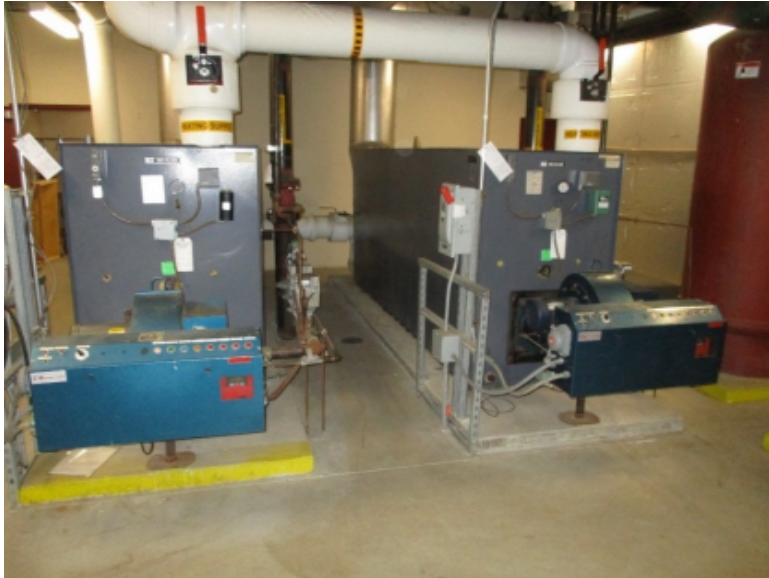
Photo G1 - High School Boiler Plant

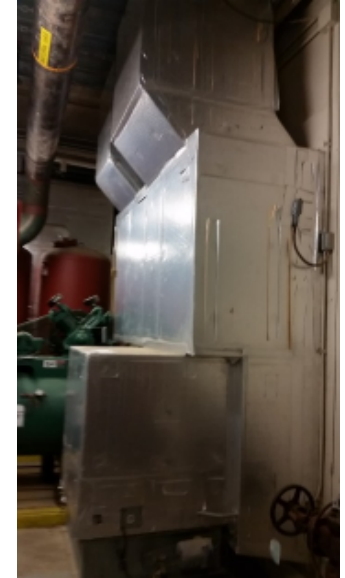
Photo G2 - High School Boiler Plant

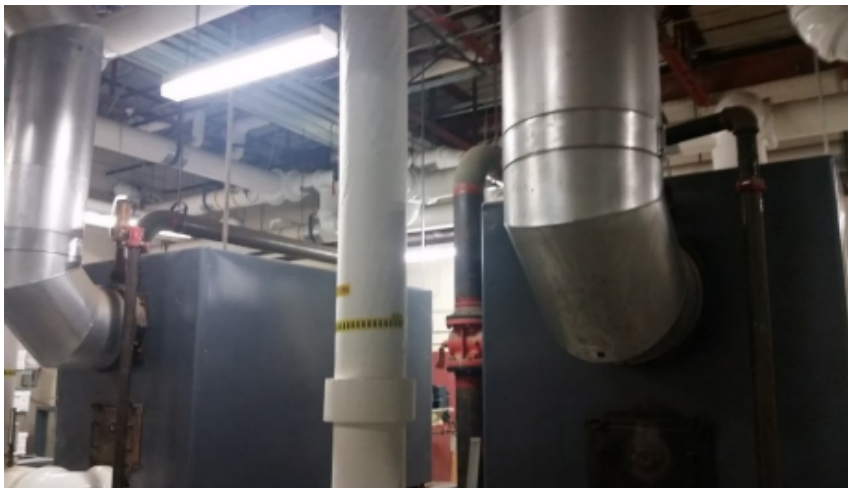
Photo G3 - Middle School Boiler Plant

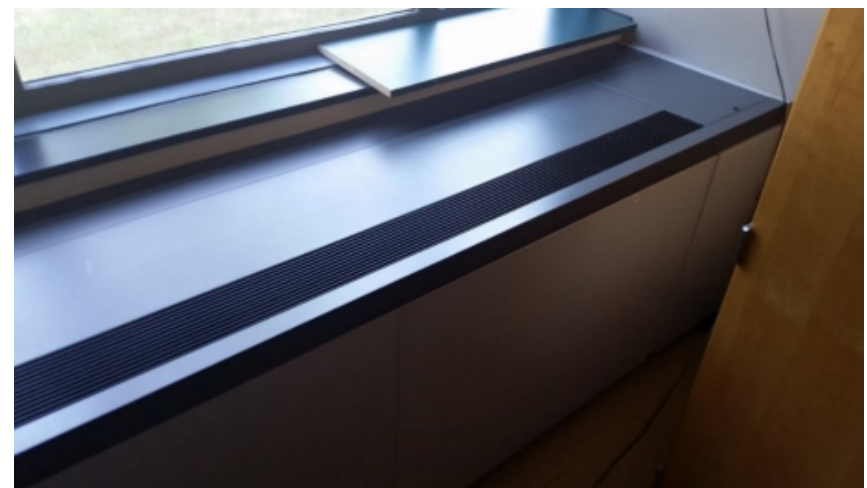
Photo G4 - Unit Ventilator

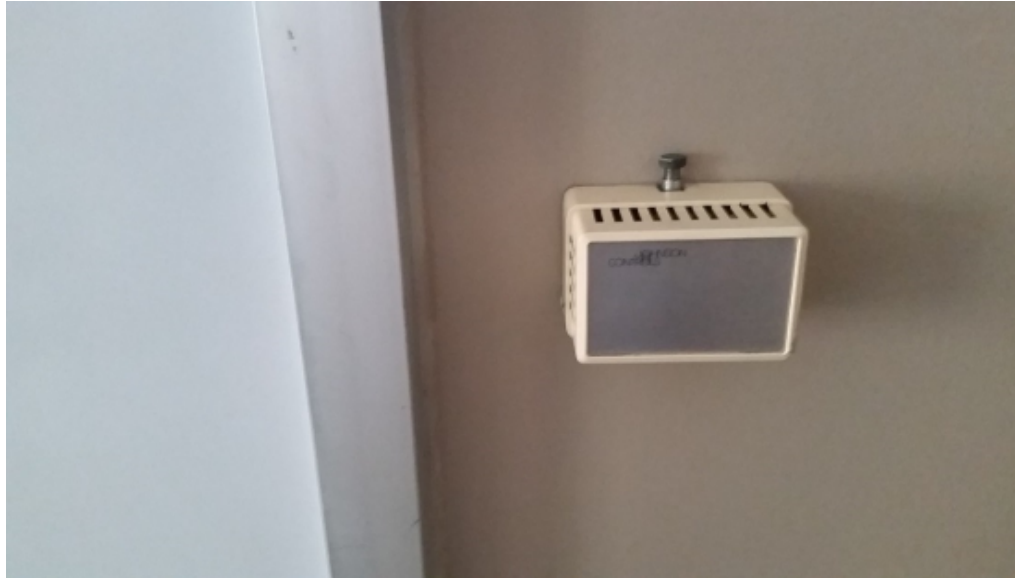
Photo G5 - Thermostat

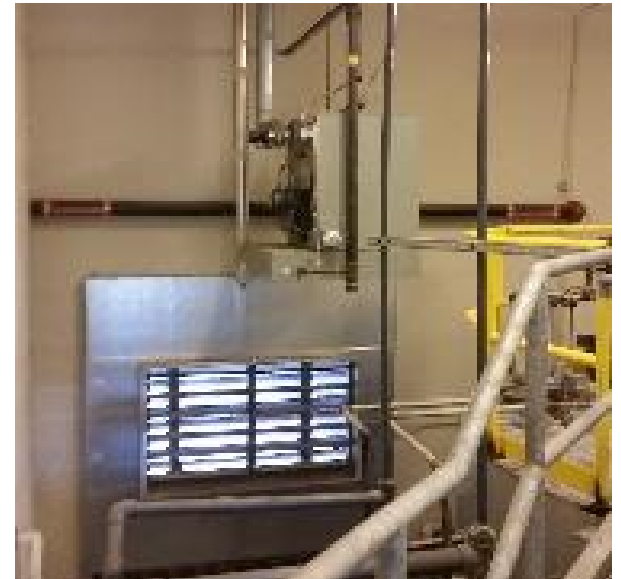
Photo G6 - Waste Water Treatment Plant

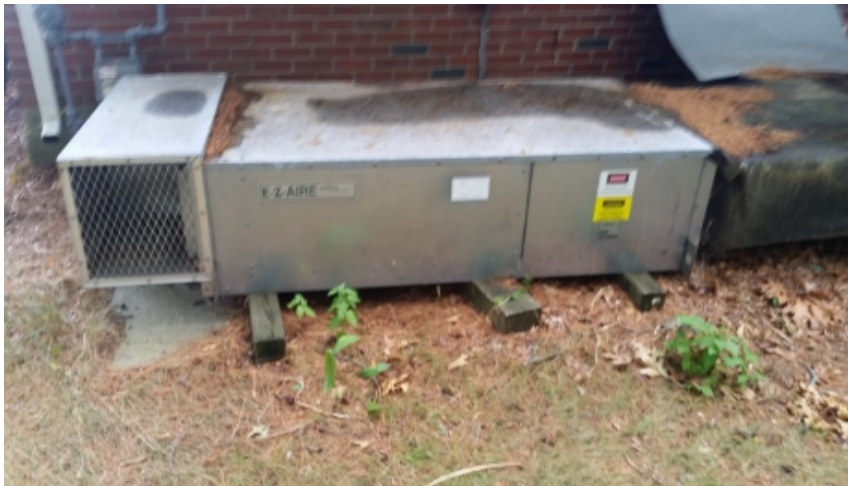
Photo G7 - Administration Air Handling Unit

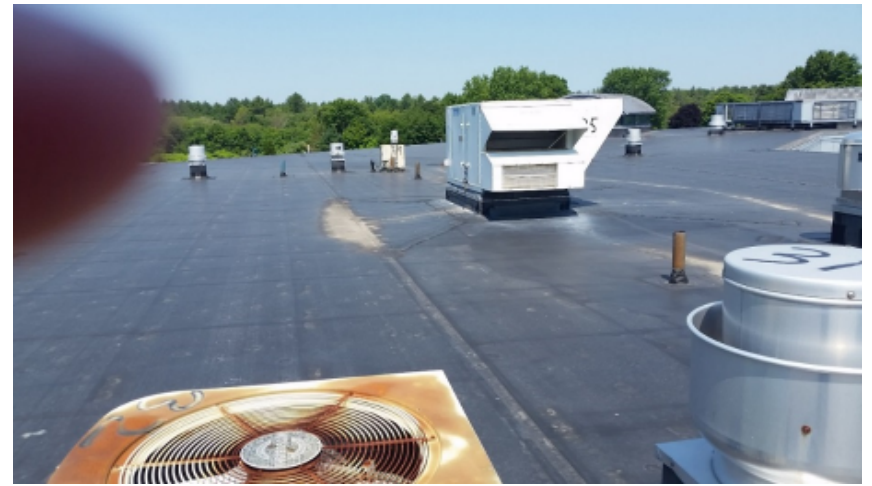
Photo G8 - Field House RTUs

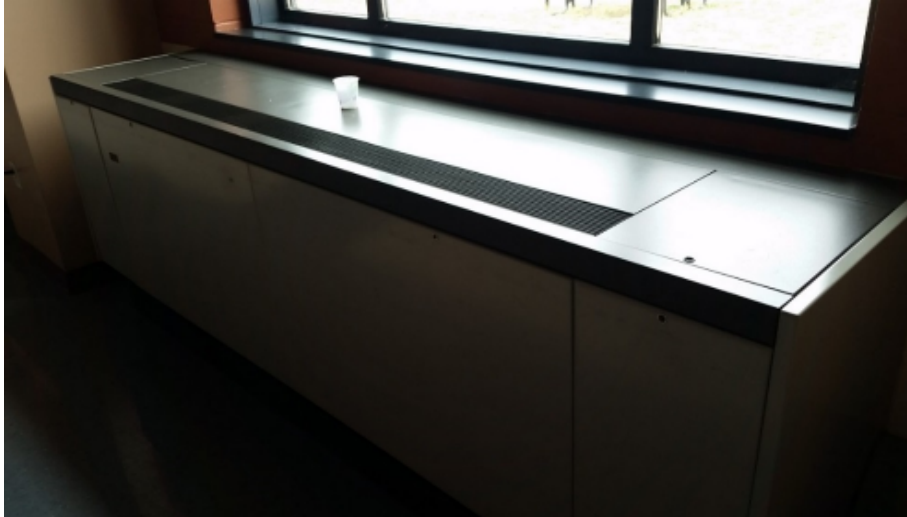
Photo G9 - Cafeteria Unit Ventilators

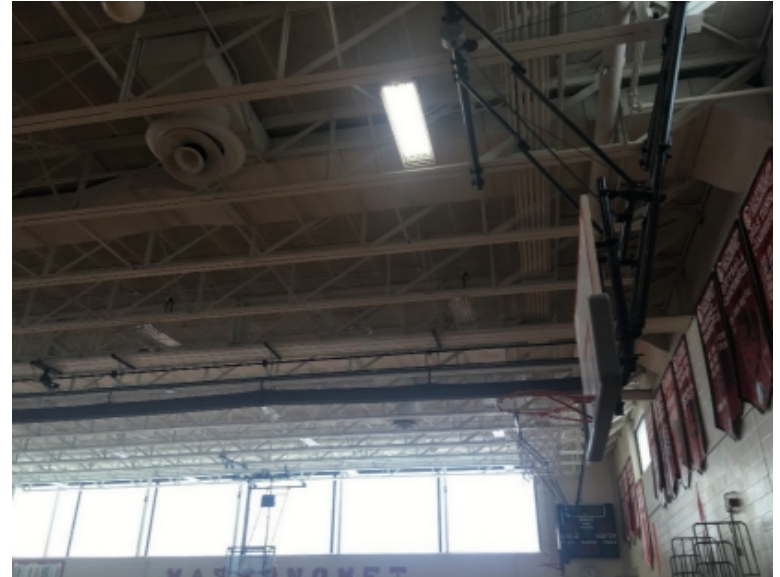
Photo G10 - Gymnasium

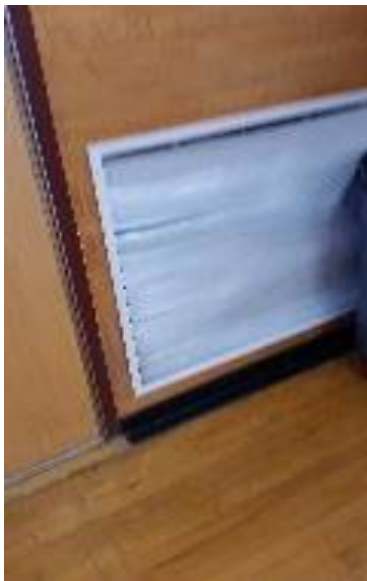
Photo G11 - Gymnasium Grilles

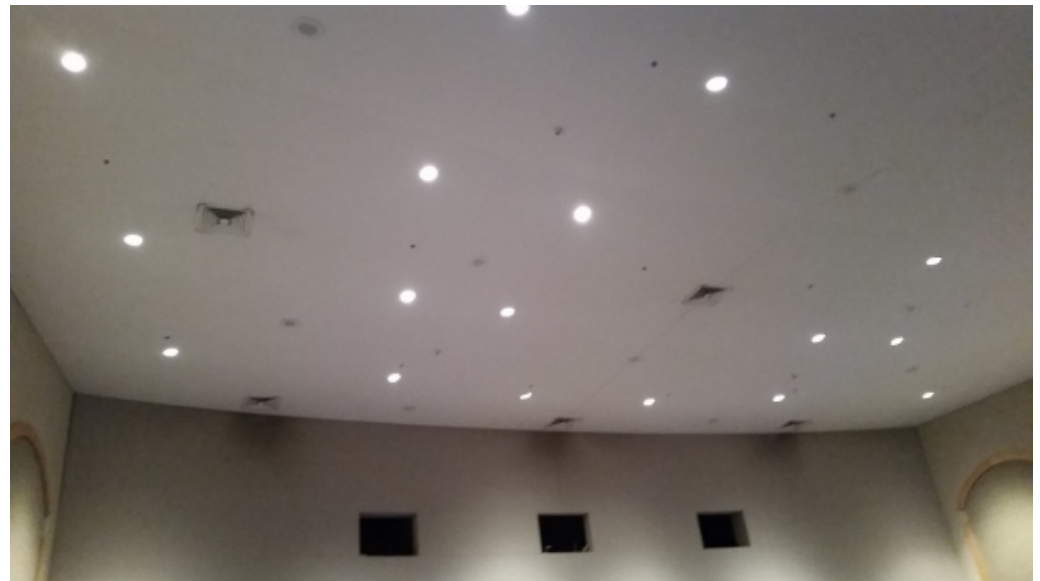
Photo G12 - Auditorium

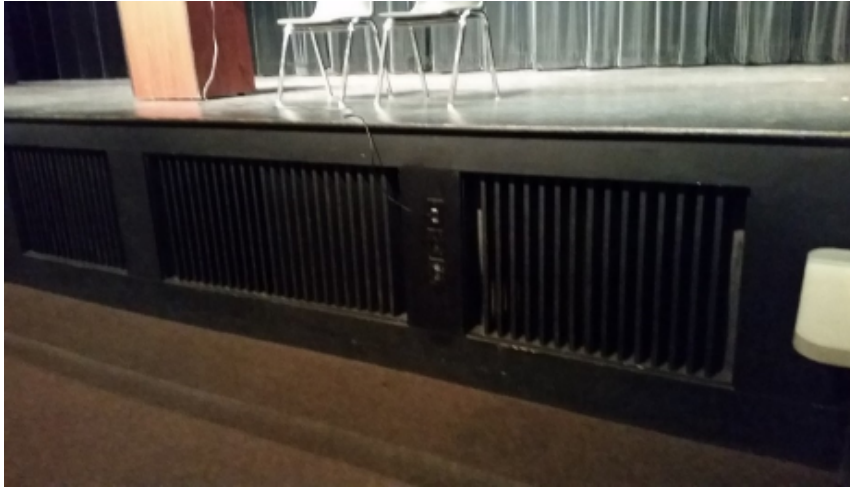
**Photo G12 - Stage**

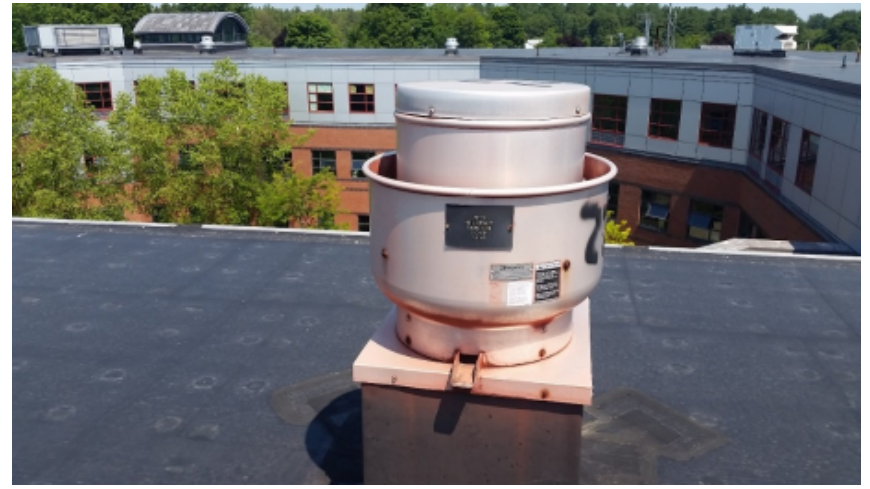
**Photo G13 - Exhaust Fans**

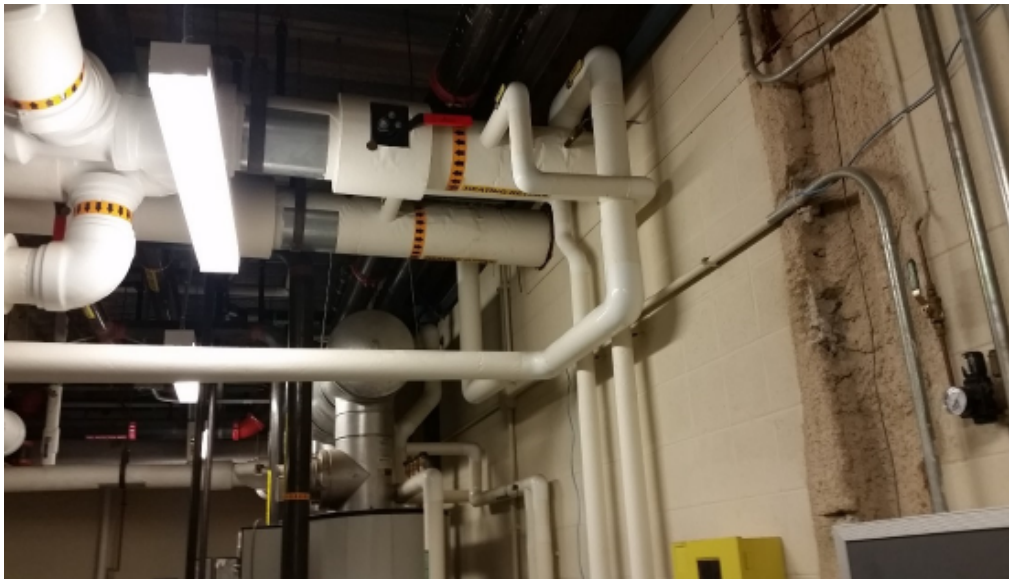
**Photo G14 - Piping Systems**

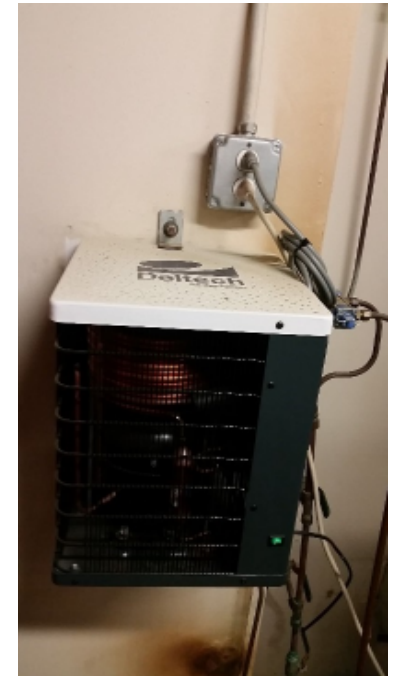
**Photo G15 - Automatic Temperature Controls**

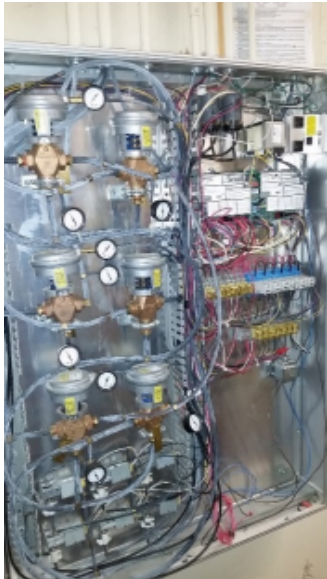
Photo G16 - Automatic Temperature Controls

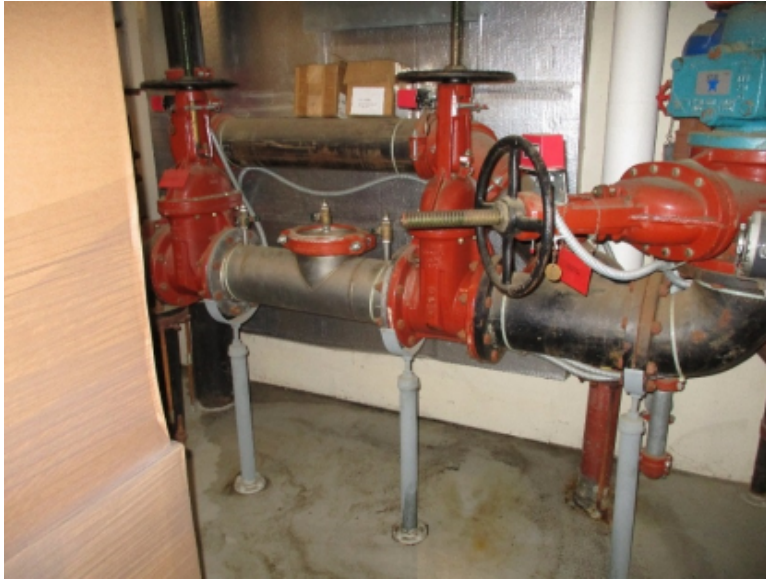
**Photo H1 - High School OS&Y Gate**

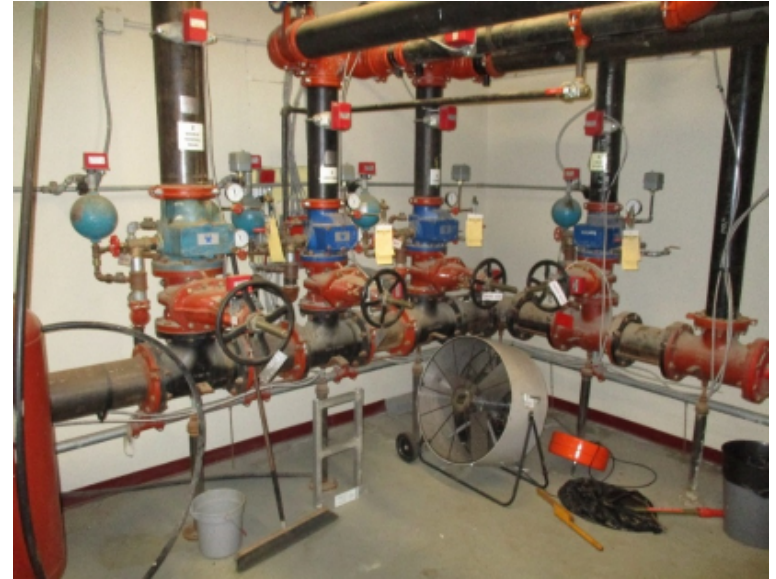
**Photo H2 - MS Service**

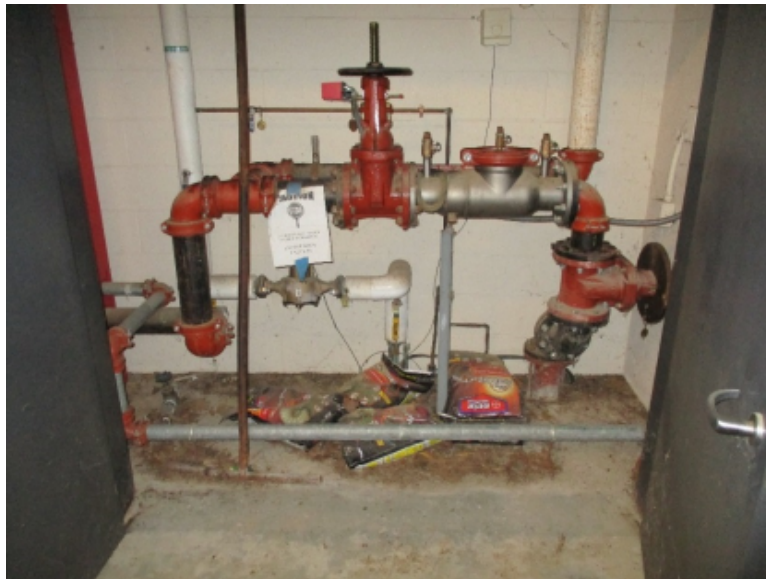
**Photo H3 - Waste Water Treatment Service**

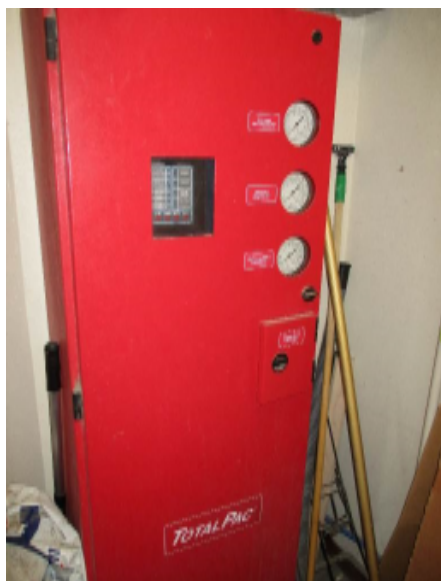
**Photo H4 - Wastewater Treatment Building Pre-Action System**

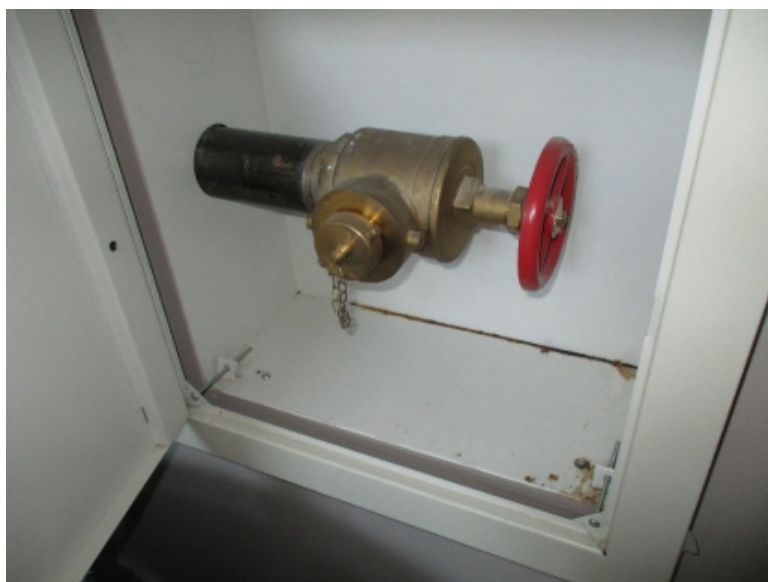
Photo H6 - HS FD Connection

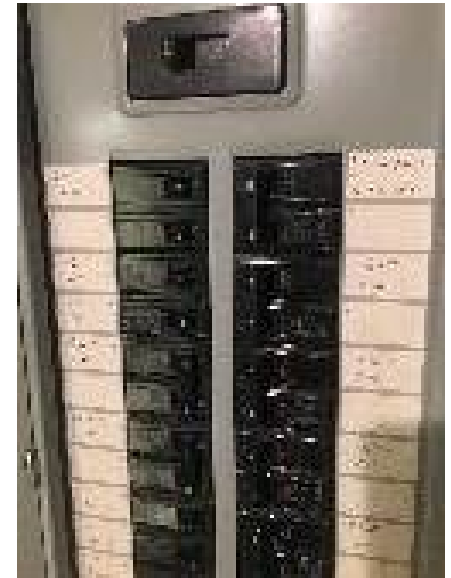
<b>K.2.1 The circuit breaker serving library should be tested for overload. Recommend separating loads and adding new feeder to library. Visual inspection of circuit breakers required.</b>			1	1	LS	\$30,000.00	\$30,000	\$40,500	\$40,500			
<b>K.3 Electrical Service Middle School Building:</b> The middle school building is served by a 2500A, 277 /480 Volt, 3 Phase Switchboard located in the main elec room. The equipment is manufactured by Siemens and is in good condition. It was reported that a feeder breaker serving the library has tripped on several occasions.		25										
<b>K.3.1 The service is only at 40% life, only visual inspection of breakers required.</b>			3	1	LS	\$4,000.00	\$4,000	\$5,400				\$5,400
<b>K.4 MS/HS Distribution System:</b> There are remote panels and feeders that were replaced as part of the renovation. The panelboards are in good condition. The distribution system appears to be in good condition.	I5	25

**Photo I5 - High/Middle School Distribution**

<b>K.4.1 All panelboards and feeders are at 40% life. Equipment should be visually inspected.</b>			3	1	LS	\$8,000.00	\$8,000	\$10,800				\$10,800
<b>K.5 MS/HS Branch Circuits:</b> The branch circuits appear to be in fair condition throughout. The wiring includes conduit and M/C cable. <b>No immediate deficiencies cited.</b>												
<b>K.6 MS/ HS Interior Lighting High School:</b> Interior lighting throughout generally has T8 fluorescent lamps and electronic ballasts. The general assessment of the fixtures is that they are in fair condition.	I10	15 / Ballasts 0										
<b>K.6.1 Replacement of fixtures should be done as an energy conservation measure.</b>			3	1	LS	\$2,544,000.00	\$2,544,000	\$3,434,400			\$3,434,400	
<b>K.7 MS/HS Interior Lighting Controls:</b> The existing automatic lighting controls consists of motion sensors which have failed.		5										
<b>K.7.1 Recommend installing schedule control from BMS. In addition, new occupancy sensors should be installed in all classrooms, offices, and corridors. A Bacnet gateway to be provided for interface to BMS.</b>			3	1	LS	\$487,000.00	\$487,000	\$657,450			\$657,450

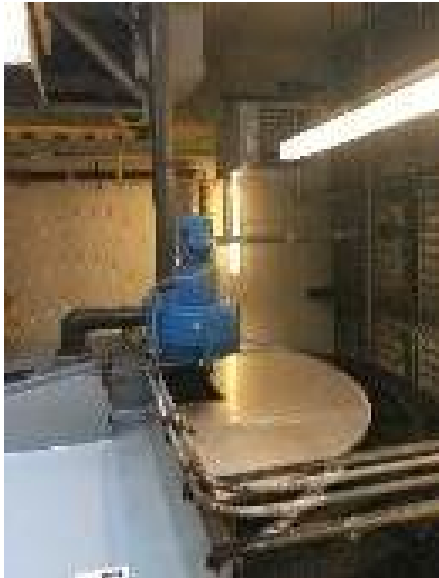
<b>K.20 Waste Water Treatment Plant Life Safety (Fire Alarm):</b> There is a manual fire present. The system is obsolete.	I24	5										
<b>K.20.1 Replace system. The life expectancy of fire alarm systems is 20 years.</b>			2	1	LS	\$21,500.00	\$21,500	\$29,025		\$29,025		
<b>ADMINISTRATION BUILDING</b>												
<b>K.21 Administration Building Electrical Service:</b> The existing service is 200 amp, 120/240 volt, single phase, 3 wire. It is fed from the treatment plant. Equipment is manufactured by Cuttler Hammer. Recommend changing service if required for new HVAC equipment	I3	25	3									
<b>K.22 Admin Building Distribution System:</b> The panelboards are located in Elec. Room in basement. Surge protection is present. Equipment is in fair condition. All panelboards and feeders are at 40% life. Equipment should be visually inspected.		25	3									
<b>K.23 Admin Building Branch Circuits:</b> Romex is used throughout for branch circuits. The wiring is residential and should be upgraded to "MC" cable as part of the renovation. It is however code compliant.	I8	35

**Photo I8 - Administration Building Branch Wiring**

<b>K.23.1 Wiring should only be replaced as part of renovation.</b>			3	1	LS	\$12,500.00	\$12,500	\$16,875				\$16,875
<b>K.24 Interior Lighting Administration Buildings:</b> Lighting fixtures are 2'x4' acrylic lens troffers. Fixtures have T8 lamps.												
<b>K24.1 Replacement of fixtures should be done as an energy conservation measure and safety of occupants. New fixtures should be recessed LED light panels with dimming drivers for daylight control.</b>			3	1	LS	\$20,000.00	\$20,000	\$27,000			\$27,000	
<b>K.25 Admin Building Interior Lighting Controls:</b> Only manual switches are present for lighting controls.		5										
<b>K.25.1 Recommend occupancy sensors and daylight dimming in all occupied spaces.</b>			3	1	LS	\$7,500.00	\$7,500	\$10,125			\$10,125	
<b>K.26 Admin Building Emergency Power:</b> None present. Battery units are used for emergency lighting. Replace battery units every 7-10 years or on-going maintenance.	I17	0	1

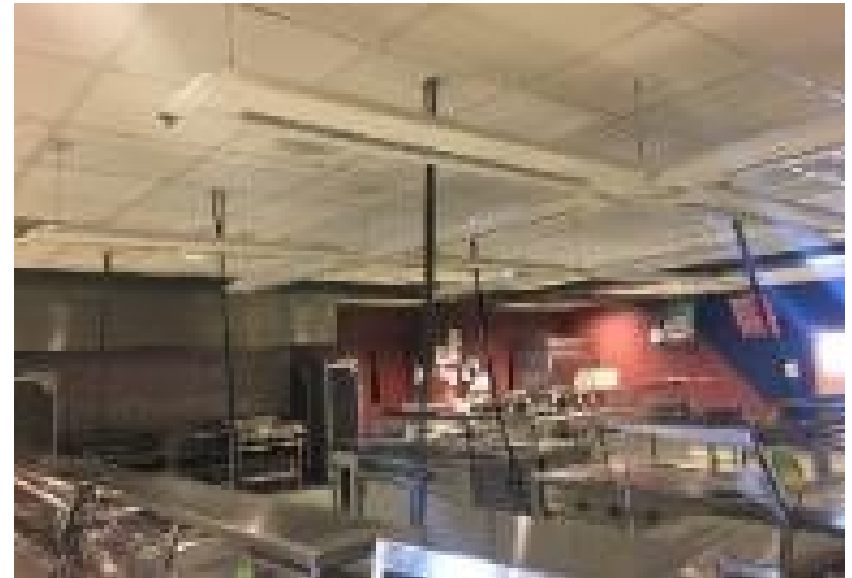
Photo I9 - Waste Water Treatment Building Branch Wiring

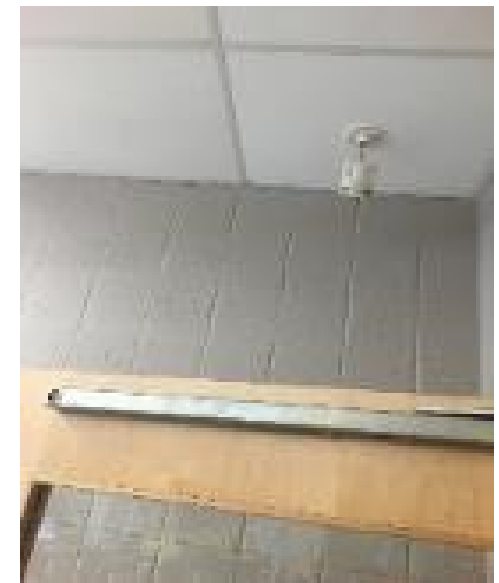
Photo I11 - Administration Building Lighting

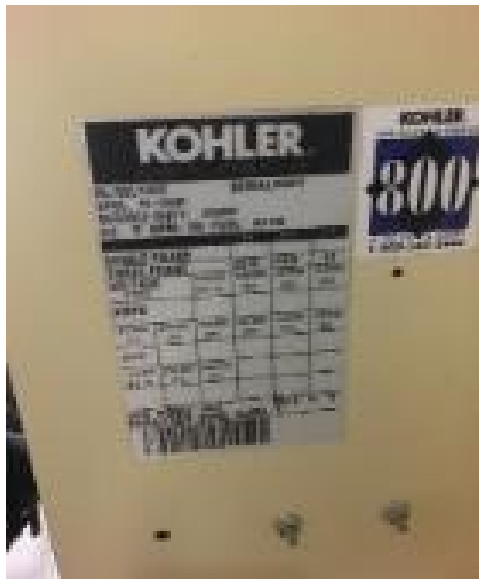
Photo I15 - High School Emergency Power

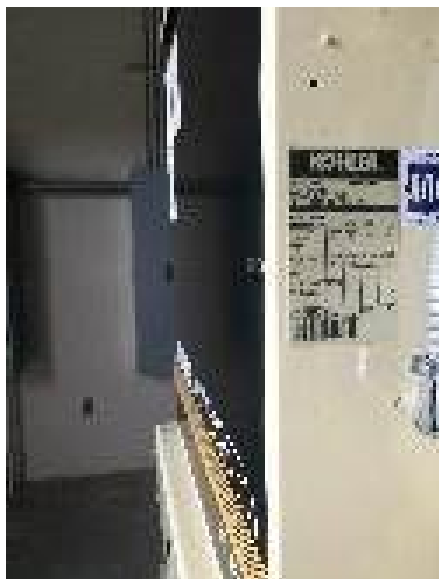
Photo I17 - Administration Building Emergency Power

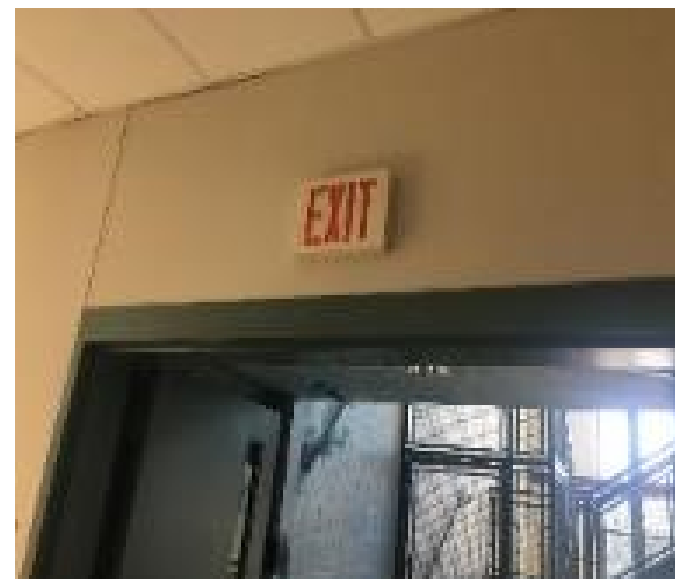
DESCRIPTION	Photograph Reference	Life Expectancy beyond 2016	Class	Qty	Unit	Unit Cost	Construction Costs	ESTIMATED COST with Soft Costs (35% premium)	FUNDING PRIORITY			
									Priority 1 1 year	Priority 2 1-5 years	Priority 3 6-10 years	Priority 4 10+ years
<b>K.17 Waste Water Treatment Plant Interior Lighting Controls:</b> Only manual switches are present for lighting controls.		5										
<b>K.17.1 Recommend occupancy sensors and daylight dimming in all occupied spaces.</b>			3	1	LS	\$12,900.00	\$12,900	\$17,415			\$17,415	
<b>K.18 Waste Water Treatment Plant Life Safety (Lighting):</b> The Facility is backed by generator for the majority of functions. The system is code compliant. Ongoing maintenance.	I21	15	3									
<b>K.19 Waste Water Treatment Plant Emergency Power:</b> The generator is 135KW located in dedicated room. The generator has a diesel base mounted tank. All in good condition. Ongoing maintenance.	I18	15	3

Photo I18 - Waste Water Treatment Emergency Power

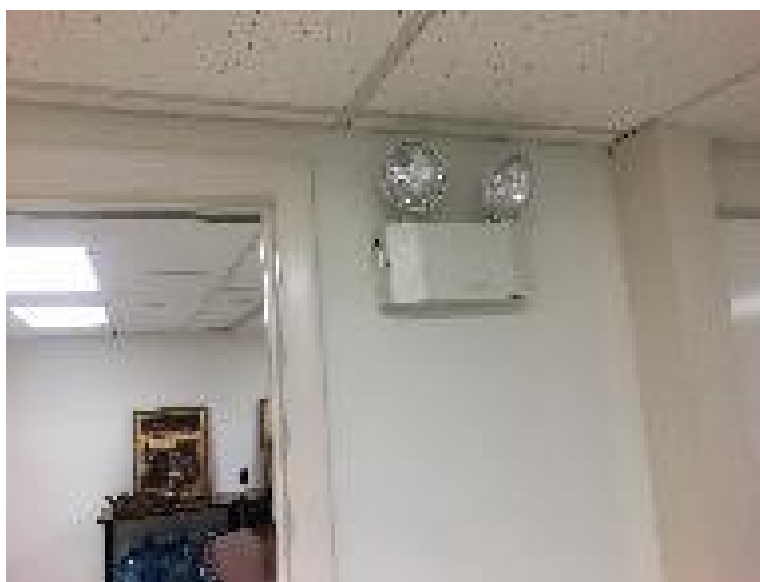
<b>K.10 Life Safety(Fire Alarm) Middle/ High School:</b> The facilities have Edwards's EST Addressable Fire Alarm Panels. The coverage of devices appear adequate. The system has ADA strobes in classrooms, but no horns. The system has reached its useful life and is reported by staff as problematic.	I22	5										
<b>K.10.1 Replace fire alarm panels.</b>			1	1	LS	\$65,000.00	\$65,000	\$87,750	\$87,750			
<b>K.10.2 Replace entire fire alarm system including speaker/strobe.</b>			2	1	LS	\$795,000.00	\$795,000	\$1,073,250		\$1,073,250		
<b>K.11 MS/ HS Life Safety (Lighting):</b> The school is served by the two emergency generator for emergency lighting and exit signs. The system appears to have sufficient capacity to serve loads other than life safety. The lighting is normal/emergency configuration in which light fixtures are used for the same purpose (it is code compliant). Exit signs appears to be adequate and weill maintained.	I19	15

Photo I19 - MS/HS Life Safety Lighting

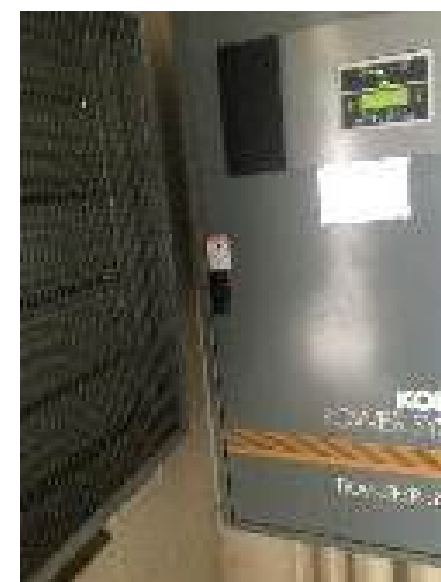
Photo I20 - Admin. Building Life Safety Lighting

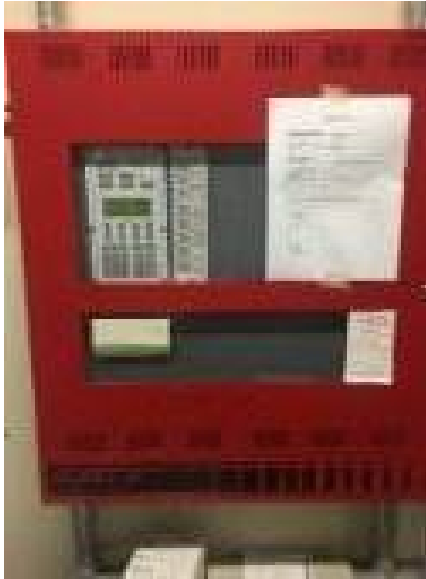
Photo I21 - Waste Water Treatment Plant Safety Lighting

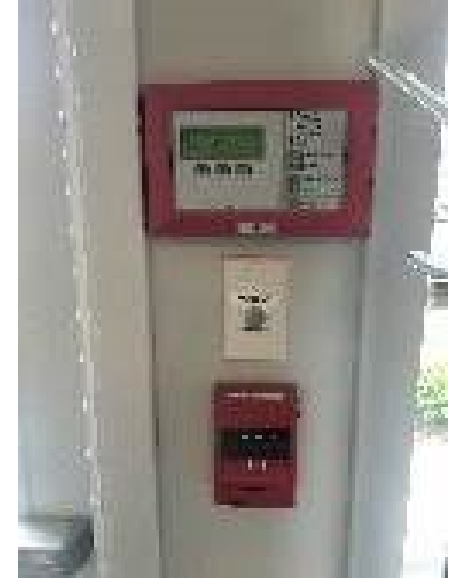
**Photo I22 - MS/HS Life Safety Fire Alarm**

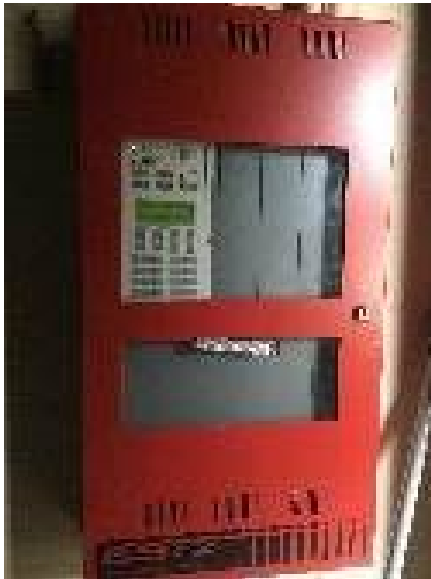
**Photo I23 - Admin. Building Life Safety Fire Alarm**

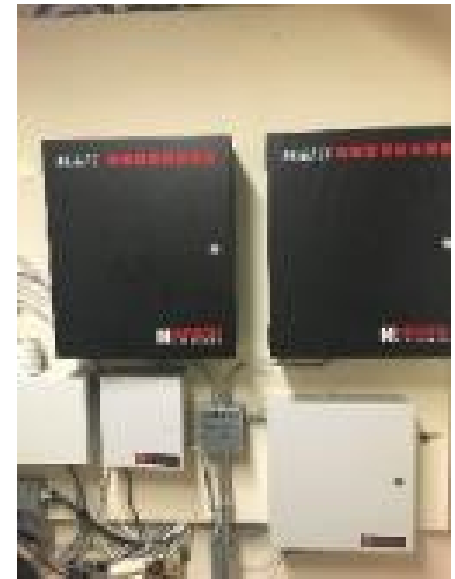
**Photo I24 - Waste Water Treatment Building Life Safety Fire Alarm**

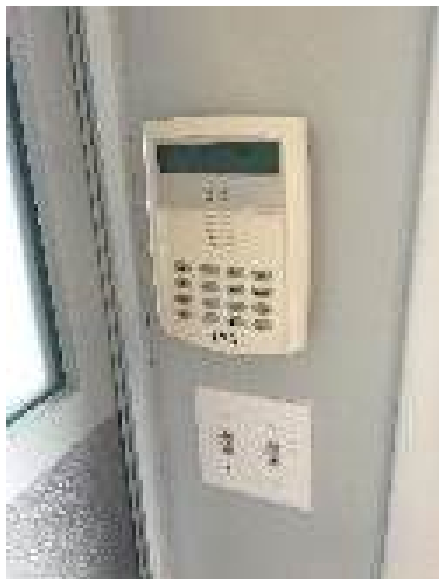
**Photo I25 - MS/HS Security System**

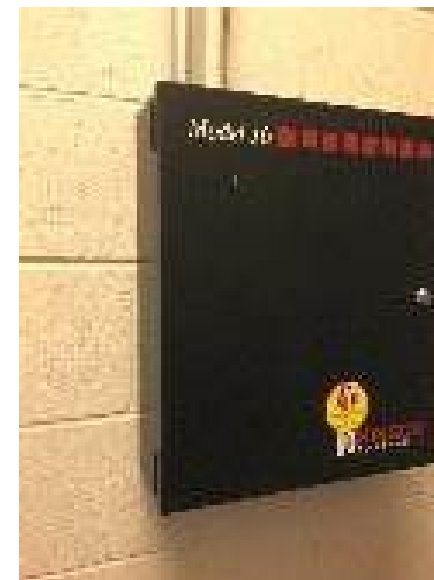
Photo I26 - Admin Building Security System

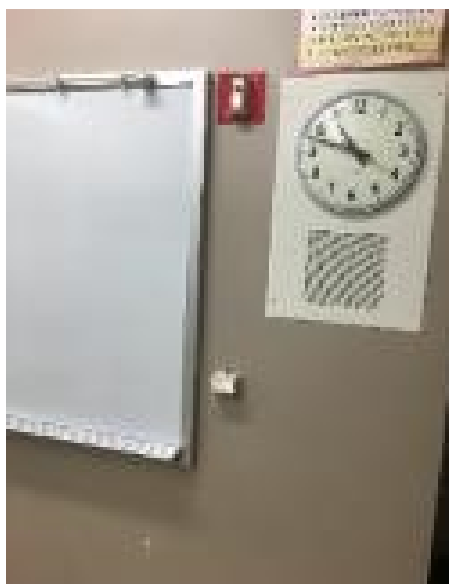
Photo I27 - Waste Water Treatment Security System

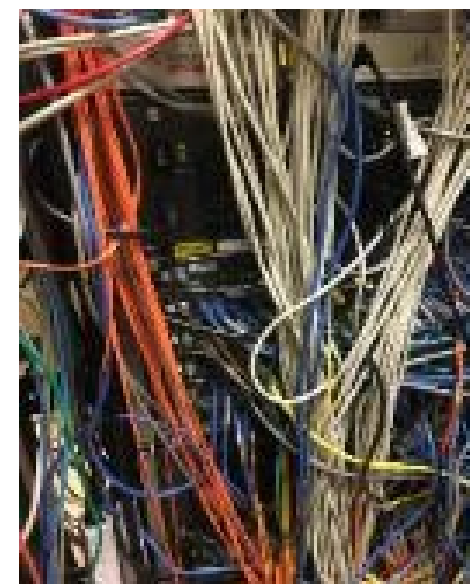
Photo I28 - MS/HS Clock/ Communications System
